**AIRCRAFT ACCIDENT  
INVESTIGATION REPORT**

**PRIVATELY OWNED  
J A 2 5 C H**

CONTACT WITH TOWLINE AND GLIDER  
PRIVATELY OWNED SCHEIBE SF25C FALKE  
(MOTOR GLIDER, TWO-SEATER), JA25CH  
KINUGAWA GLIDING FIELD,  
UTSUNOMIYA CITY, TOCHIGI PREFECTURE, JAPAN  
AROUND 13:03 JST, JUNE 14, 2014

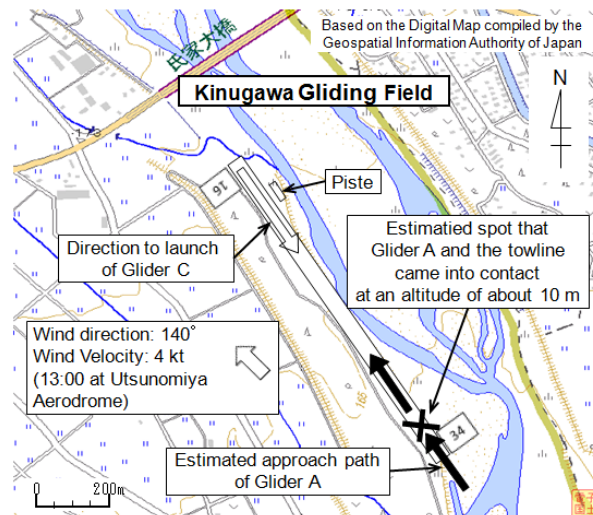
Glider A came into contact with the falling towline released from Glider C at an altitude about 10 m above the runway while approaching to runway 34. The left horizontal stabilizer of Glider A was broken, but the control feeling was as usual and the glider attitude did not change. Glider A landed on the runway at around 13:03, moved on its own to the parking area and stopped.

Fragments of the left horizontal stabilizer and the fuselage of Glider A were scattered on the Gliding Field, at around 100 m inside from the threshold of runway 34.

2.2 Injuries to Persons	None
2.3 Damage	<p>Extent of damage of Glider A: Substantially damaged</p> <ul style="list-style-type: none"> <li>• Propeller: Damaged</li> <li>• Left side of windshield: Breakage</li> <li>• Left landing gear strut: Damaged</li> <li>• Wing and fuselage around the root of the left wing: Damaged</li> <li>• Left horizontal stabilizer: Breakage</li> <li>• Lower surface of tail part of fuselage: Damaged</li> </ul>
