**AIRCRAFT ACCIDENT
INVESTIGATION REPORT**

ALL NIPPON HELICOPTER CO. LTD

J A 3 1 N H

ALL NIPPON HELICOPTER CO., LTD.
EUROCOPTER EC135T2 (ROTORCRAFT), JA31NH
ON THE MARSH LOCATED ABOUT 800m SOUTHWEST OF
SHIZUOKA HELIPORT
AT SHIZUOKA CITY, SHIZUOKA PREFECTURE, JAPAN
AT ABOUT 10:53 JST, DECEMBER 9, 2007

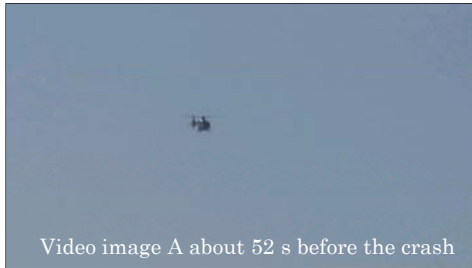
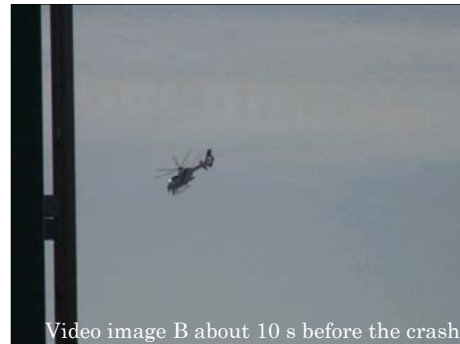
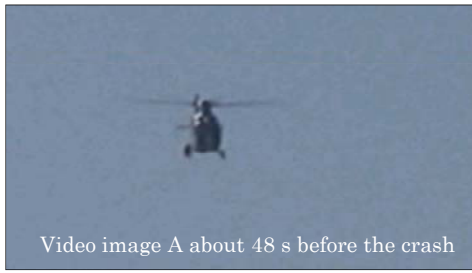
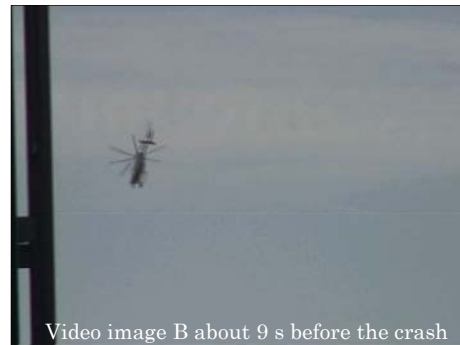
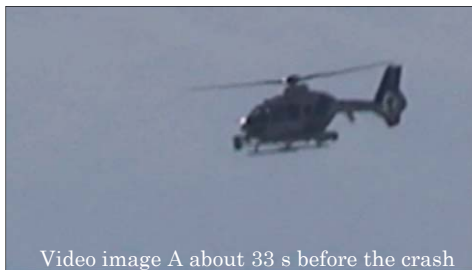
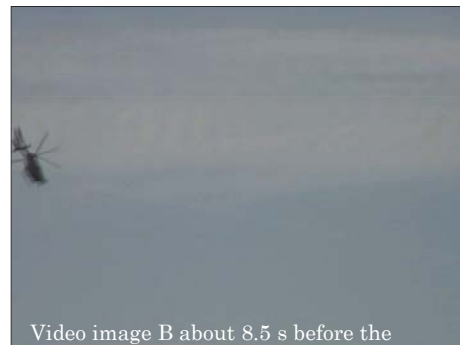
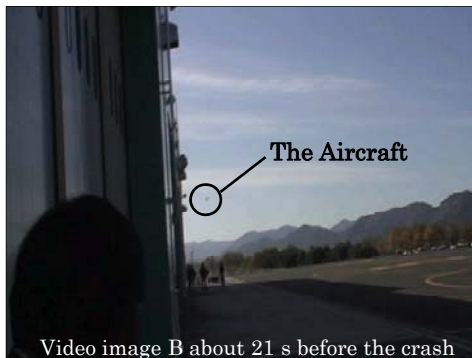
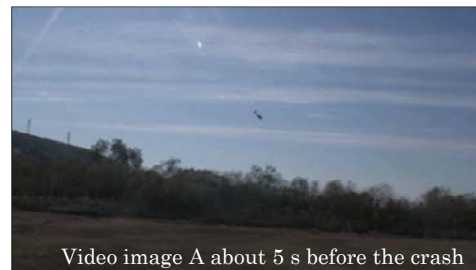
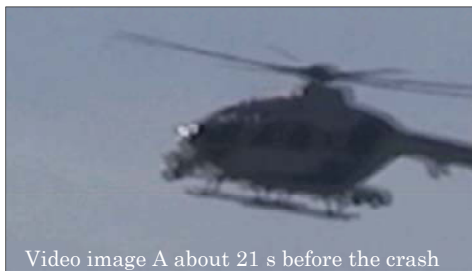
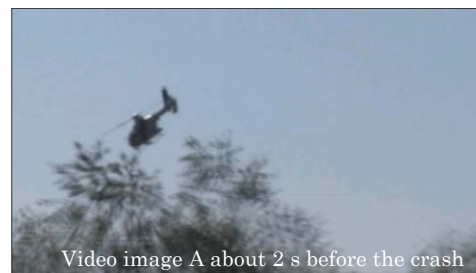
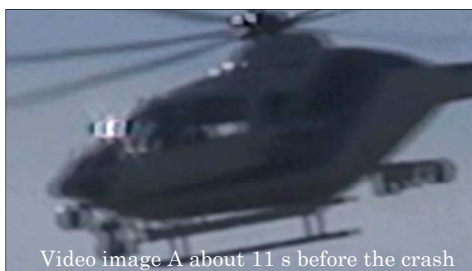
Figure 5 Video Images Taken by Eyewitnesses

Video image A about 52 s before the crash

Video image B about 10 s before the crash

Video image A about 48 s before the crash

Video image B about 9 s before the crash

Video image A about 33 s before the crash

Video image B about 8.5 s before the

Video image B about 21 s before the crash

Video image A about 5 s before the crash

Video image A about 21 s before the crash

Video image A about 2 s before the crash

Video image A about 11 s before the crash
