**AIRCRAFT SERIOUS INCIDENT
INVESTIGATION REPORT**

**JAPAN COAST GUARD
J A 3 9 3 A**

LOWER PART OF AFT FUSELAGE CONTACT ON RUNWAY
DURING GO-AROUND
JAPAN COAST GUARD
TEXTRON AVIATION 172S, JA393A
KITAKYUSHU AIRPORT, FUKUOKA PREFECTURE
AT 11:30 JST, FEBRUARY 3, 2021

January 7, 2022

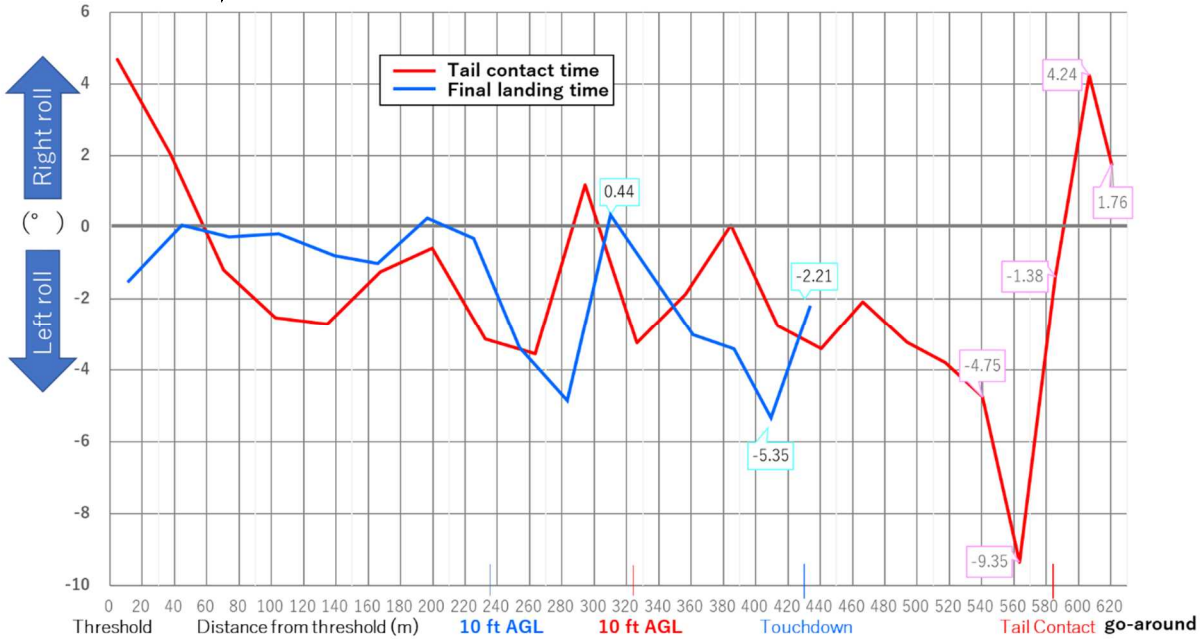
Figure 6 Comparative roll attitudes (°)

<p>it is possible that wind direction at the Contact Time was more westerly than the Final Landing Time.</p> <p>Besides, indicated air speed at the Contact Time was 41 kt, less than indicated air speed (43 kt) at the Final Landing time, both of which, however, maintained stall speed or higher.</p>
	Figure 6 Roll attitude	<p>At the Contact Time, left roll became large forming left roll angle of 9° immediately before contact. Then, rapid roll to the right occurred and contacted. Roll rate at that time was as high as 8° /second, which is probable to have been difficult to be corrected by instantly steering.</p> <p>The right roll is likely to have generated by relative increase of the ratio of crosswind component from the left against air speed as a result of the decreased air speed.</p> <p>At the Final Landing Time, approach was conducted with left wing-low method in response to left crosswind.</p>
