**AIRCRAFT ACCIDENT
INVESTIGATION REPORT**

**PRIVATELY OWNED
JA3989**

CRASH INTO THE VICINITY OF THE MOUNTAINTOP

CESSNA 172P, JA3989

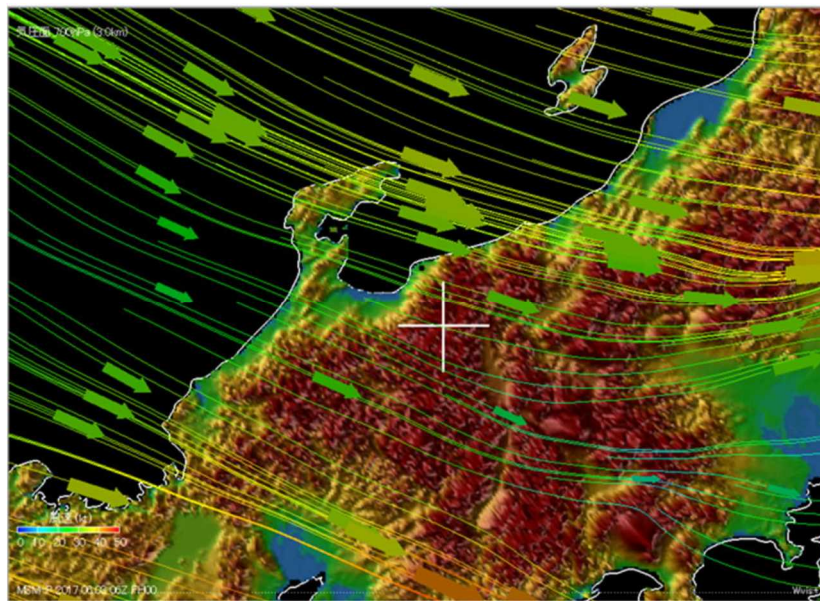
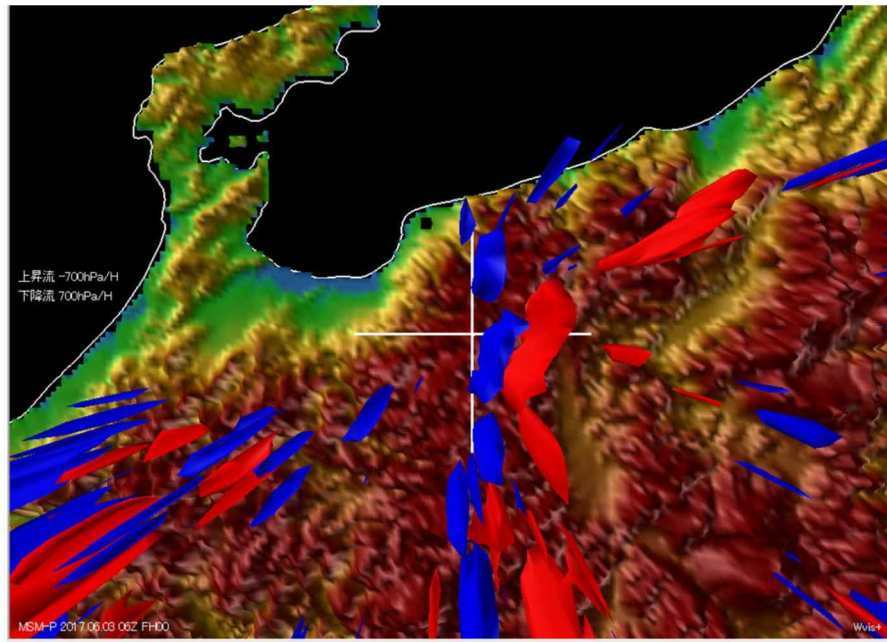
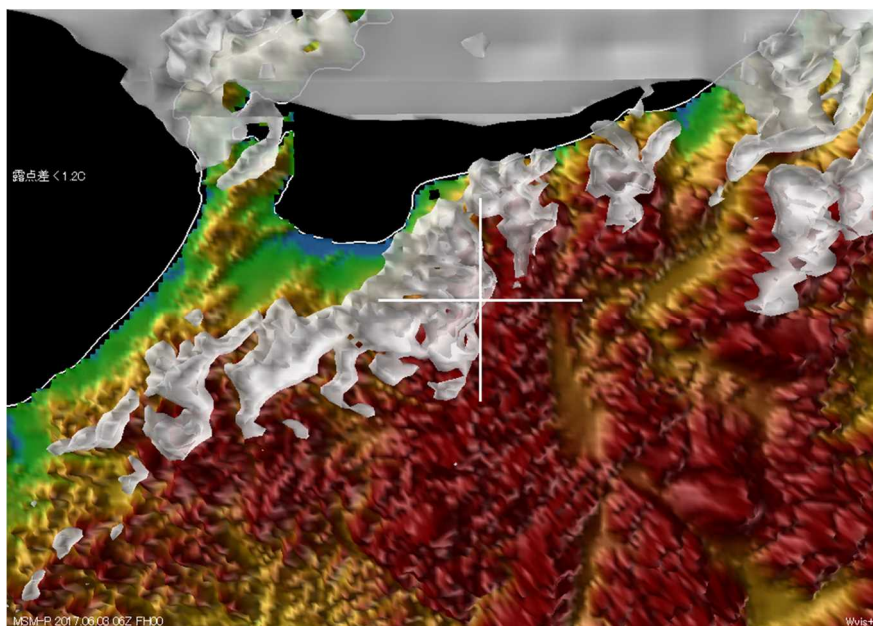
Figure 2: Numerical Analysis Detail²⁶

In order to confirm the meteorological conditions in the vicinity of the top of the Tateyama Mountain Range during the time period when the accident occurred, we commissioned the Tokai University Research & Information Center to conduct a numerical analysis. In this analysis, the statistical science super computer system in the Institute of Statistical Mathematics was used to create a higher resolution model and visualize it based on the numeric weather prediction model provided by the Japan Meteorological Agency. The result indicated the possibility that north-west wind was blowing at about 30 to 40 kt over the vicinity of the Tateyama Mountain Range at an altitude of about 10,000, and updraft and downdraft caused by that north-west wind might exist in the mountainous region. In addition, as for the humid air areas in the upper air and above the ground, it was shown that the humid air area²⁵ existed in the west side (Tateyama Caldera side) of the Tateyama Mountain Range, but not in the east side (Lake Kurobe side) of it, and there were no remarkable humid air area noted during the time period when the accident occurred. (See Figure 2.) (“+” shown in the following Figure indicates the accident site.)

confirming the latest images taken by live cameras installed in place on the planned flight route, which was described in 2.6.2. On the other hand, according to the numerical analysis detail shown in the Figure 2 ② of 2.6.2.8, at around 15:00 when the accident occurred, the humid air area existed in the west side of the Tateyama Mountain Range. But in the east side, no remarkable humid air area confirmed, which indicated the possibility that there were fewer clouds in the east side of the Tateyama Mountain Range than the west side of that. It is somewhat likely that the PIC, who was well familiar with the meteorological conditions in the mountain regions, made the same prediction about the weather.

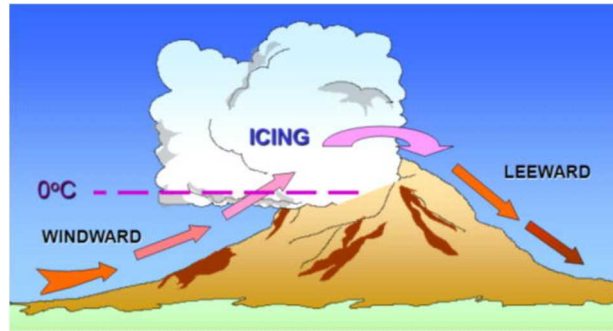
Figure 7: Icing in Mountain Regions

The most severe icing occurs above the crests and on the ridges' windward side. This zone usually extends to about 5,000 feet above the mountaintops, but can extend much higher if cumuliform clouds develop.

Icing with mountains can be especially hazardous because a pilot may be unable to descend to above freezing temperatures due to terrain elevation. If a pilot approaches a mountain ridge from the windward side, his aircraft may be unable to climb above the mountaintops, or even maintain altitude due to severe ice accumulation. The end result may be a crash.

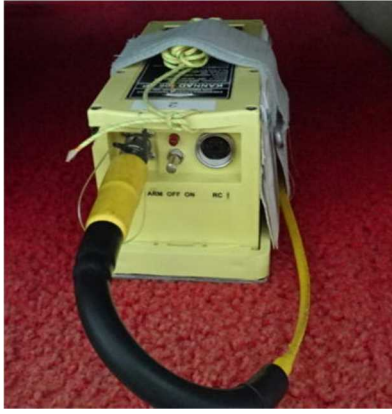
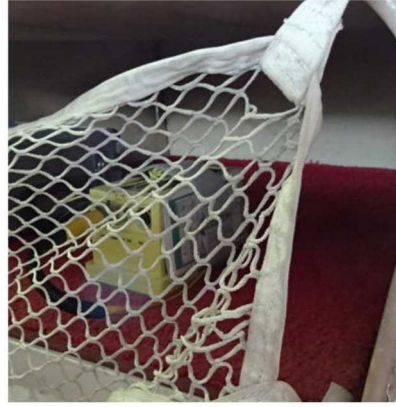
Photo 10 : Installation / Mounting State of an ELT
in the same Type of Aircraft

Besides, in the same type of aircraft, the Company did not stow the leaflet, which describes how to use the ELT for emergencies.

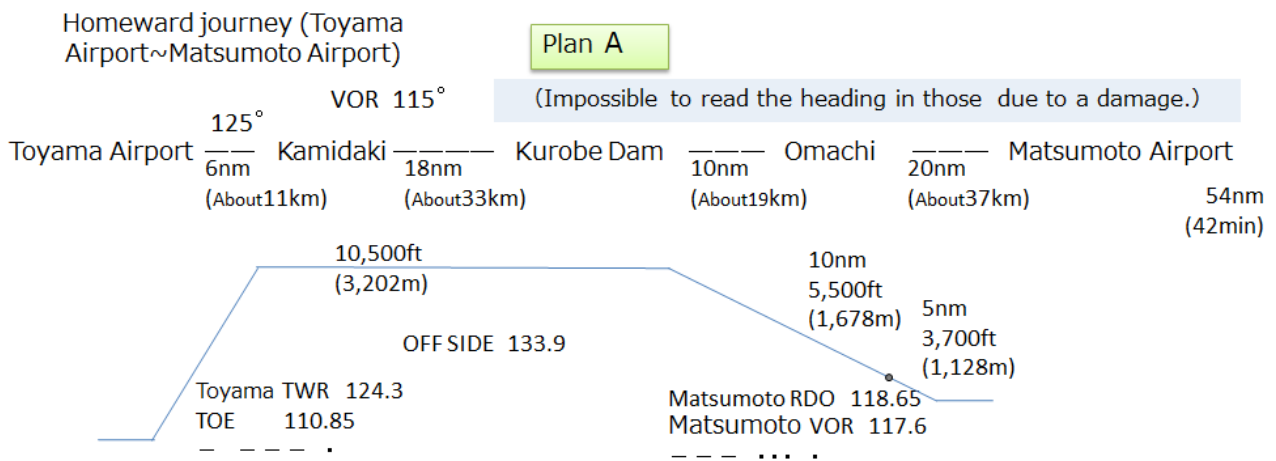
Figure 10: The Homeward Journey Flight Plan Found inside the Aircraft (Copied by JTSB)

Among those flight plans, Figure 10 shows the copied homeward journey Plan A relating to the accident. In addition to those key point targets like Kamidaki, Kurobe Dam and Omachi as well as the direction and distance of each flight sector, this flight Plan A described the planned flight altitude, frequencies / Morse codes of Toyama VOR (TOE) and Matsumoto VOR, Call sign / Frequencies (OFF SIDE / 133.9) concerning the Airspace of Self Defense Forces High Altitude Training / Test Areas (described in 2.19.3), and frequencies of air traffic control facilities like Toyama Tower (TWR) and Matsumoto Radio (RDO).

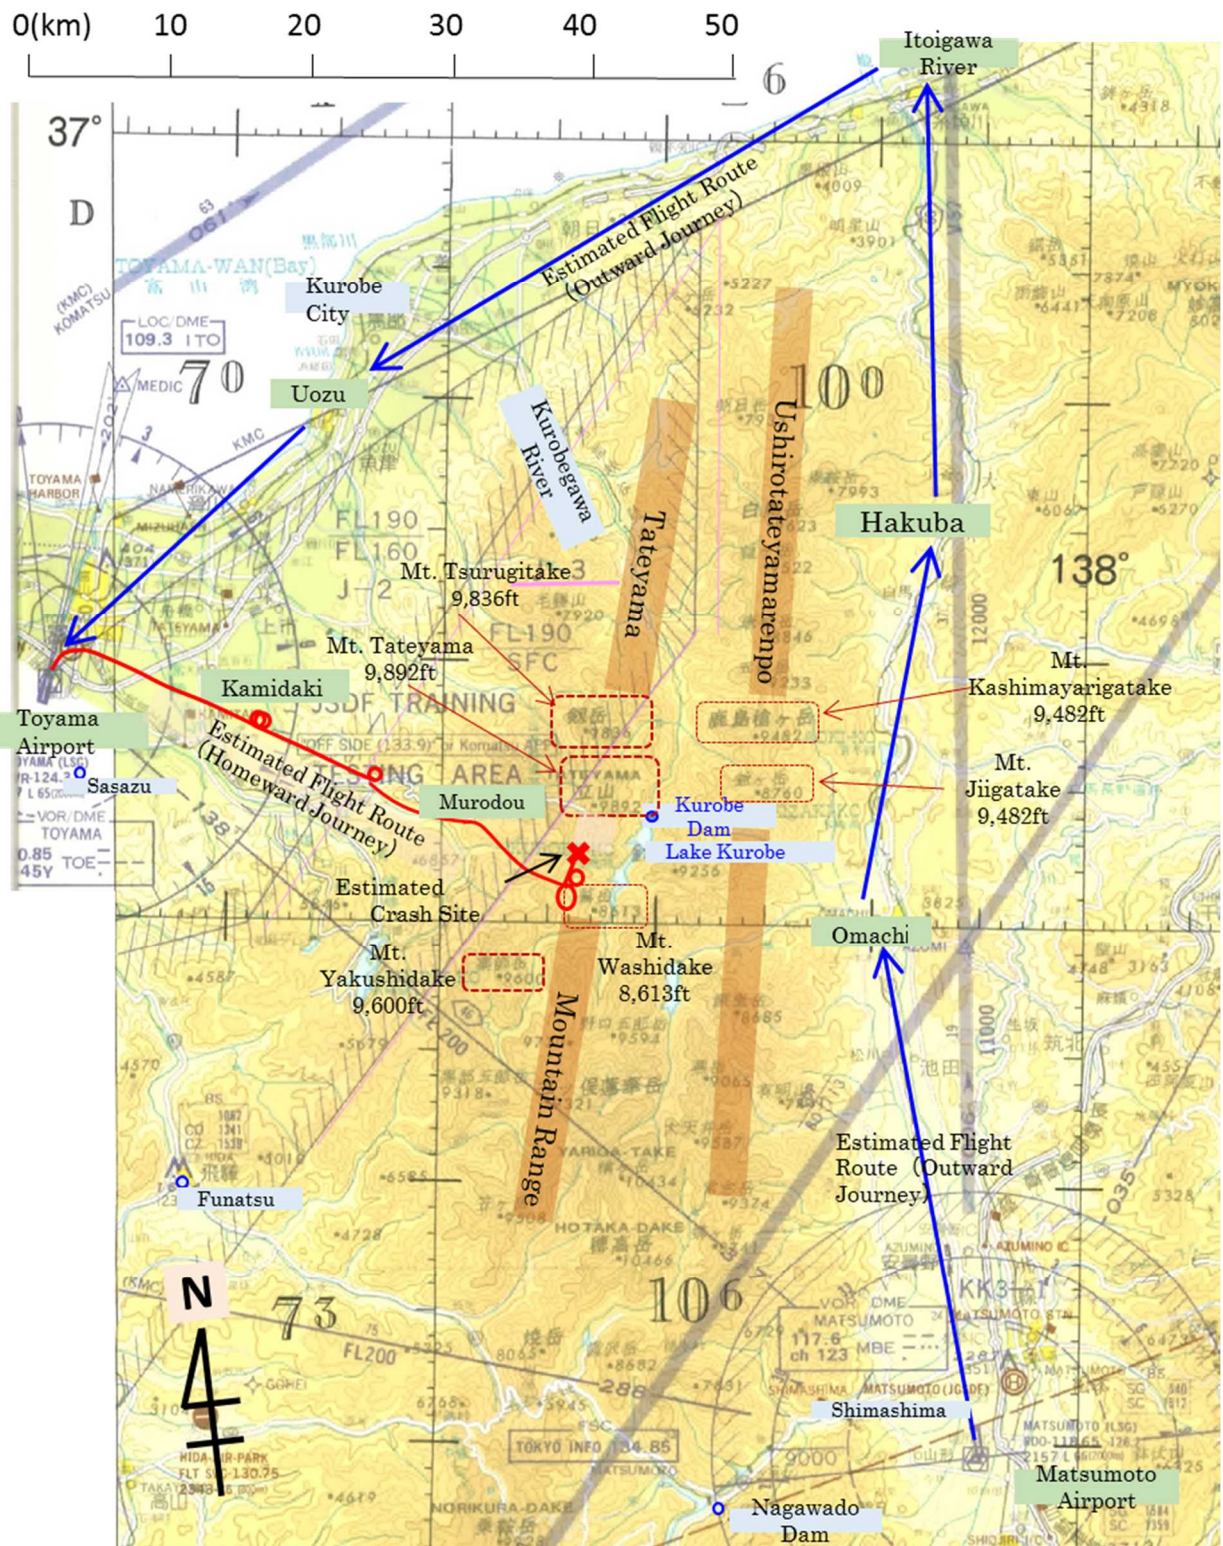
Appended Figure 1: Estimated Flight Route (1)

The division aeronautical map⁴¹ shown in Appended Figure 1 was found at the time of collecting the fuselage. This chart put “Mt. Tateyama: 9,892 ft” and “Mt. Washi-dake: 8,613 ft” as mountains involved in the flight route of the homeward journey, however, did not clarify the height of each mountain noted in Appended Figure 4.

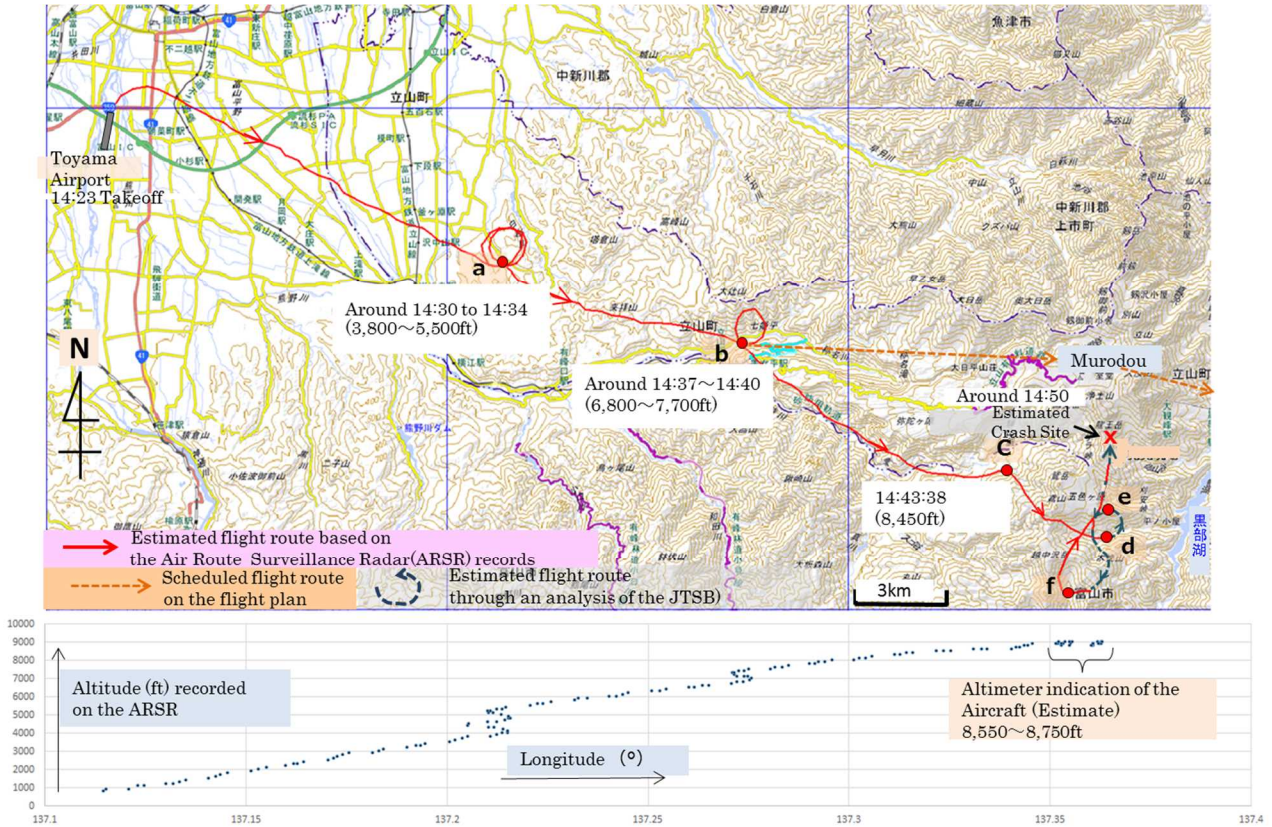
Appended Figure 2: Estimated Flight Route (2)

As shown in Appended Figure 2, after the Aircraft turned left at 360° two times at [Position a] at around 14:30 to 14:34, it also turned left at 360° one time at [Position b] at around 14:37 to 14:40. Probably, it is because it had to obtain height in order to reach the altitude necessary to cross the mountains by taking 360° turns, since the strong westerly winds were blowing during the flight.

The Aircraft planned to fly from Kamidaki to Murodo, but as shown in Appended Figure 2, it did not fly from [Point b] toward Midagahara / Murodo, and it changed to go on a southerly route. It is probably because as described in 2.6.2.2, the Tateyama Mountain Range was covered with clouds as shown in the images taken by a live camera at Position B in Figure 1 at the time of the occurrence of the accident. Midagahara and Murodo were entirely covered with clouds as shown in Photo 1 and Photo 3.

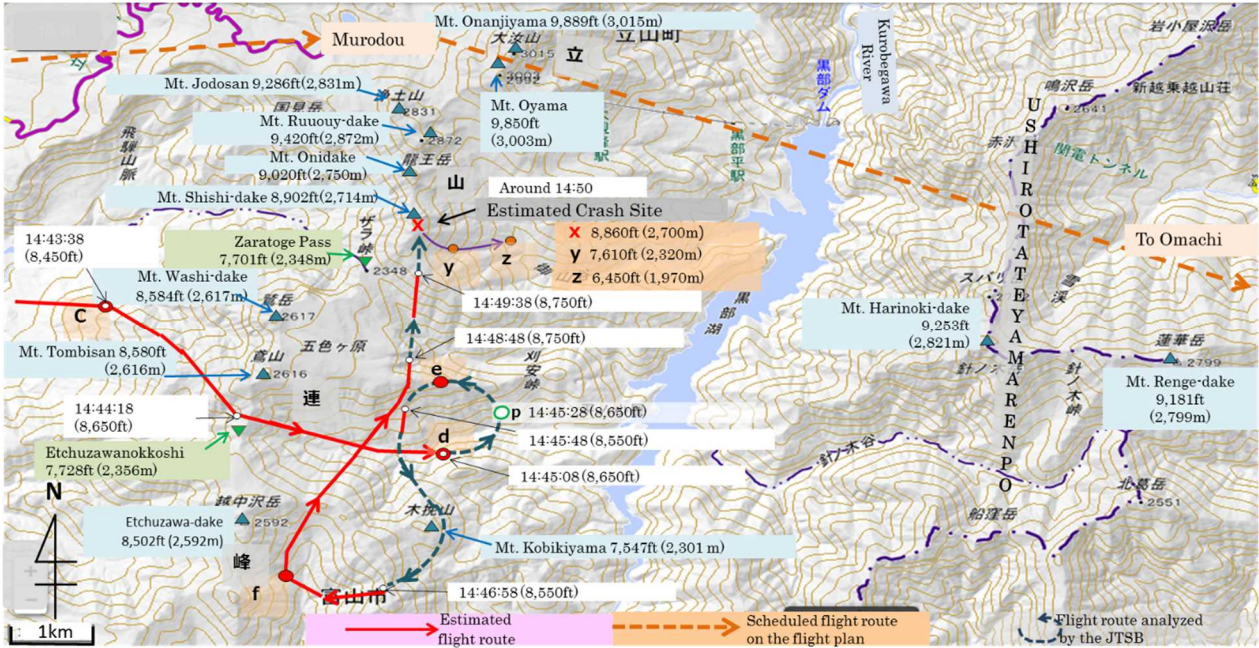
Appended Figure 4: Estimated Flight Route (4)

The Aircraft was found at [Point y]²⁷ shown in Appended Figure 4 in the southeast slope of Mt. Shishi-dake in the Tateyama Mountain Range. As shown in Appended Figure 1 to 4, the accident site is surrounded by the Tateyama Caldera, the Ushiroateyama Mountain Range, and

As shown in Appended Figure 4, the Aircraft passed through the Etchuzawanokoshi, flew over the Tateyama Mountain Range and reached [Position d] at 14:45:08. However, as shown in Appended Figure 2, after flying to the east side of the Tateyama Mountain Range, the Aircraft turned back at once. As to be described in 3.7, it is probable that around the time when the Aircraft commenced to cross the mountains, it would get into in-cloud flight without being able to avoid clouds. Besides, it is also probable that the PIC and the Pilot noticed the ice build-up on the Aircraft and tried to turn back.

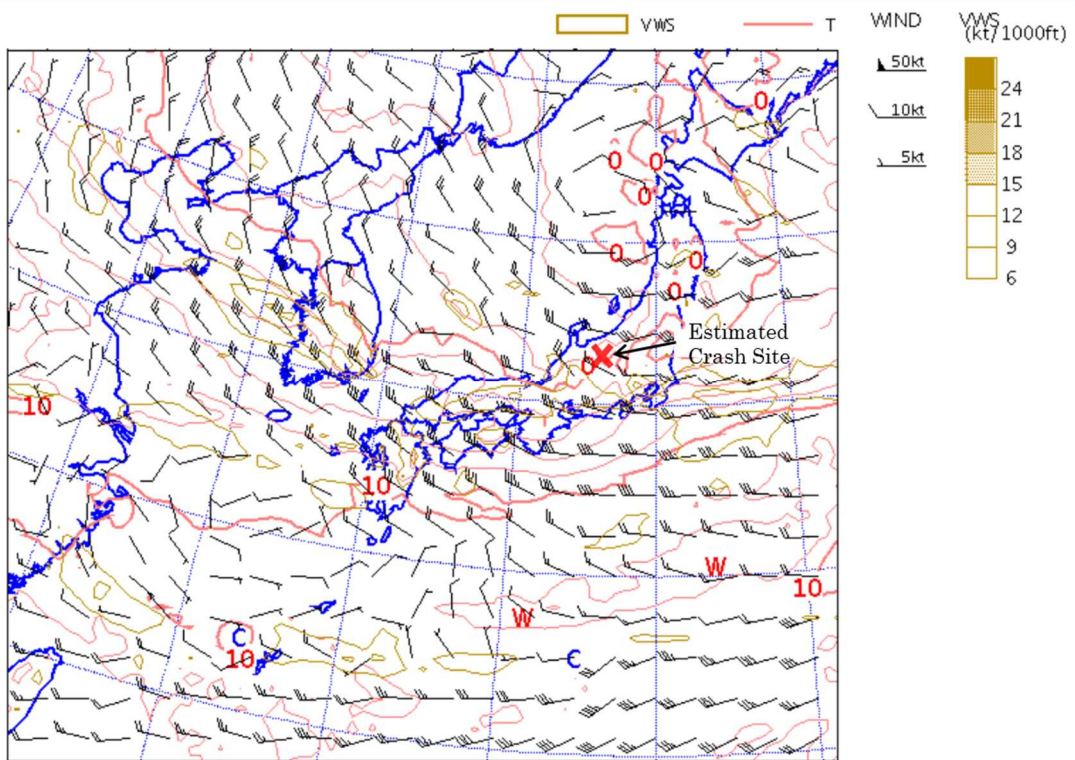
Appended Figure 11: Meteorological Information (3)

As shown in Appended Figure 11: Hourly-Analysis Chart at 9,000 ft at 15:00 on June 3, 2017, westerly wind at about 30 kt was observed in the vicinity of the accident site. And as shown in Appended Figure 12: Significant Weather Prognostic Chart of Lower Layers, the westerly wind was also forecast at about 30 kt at an altitude of 10,000 ft. In addition, as described in 2.6.2.5, a

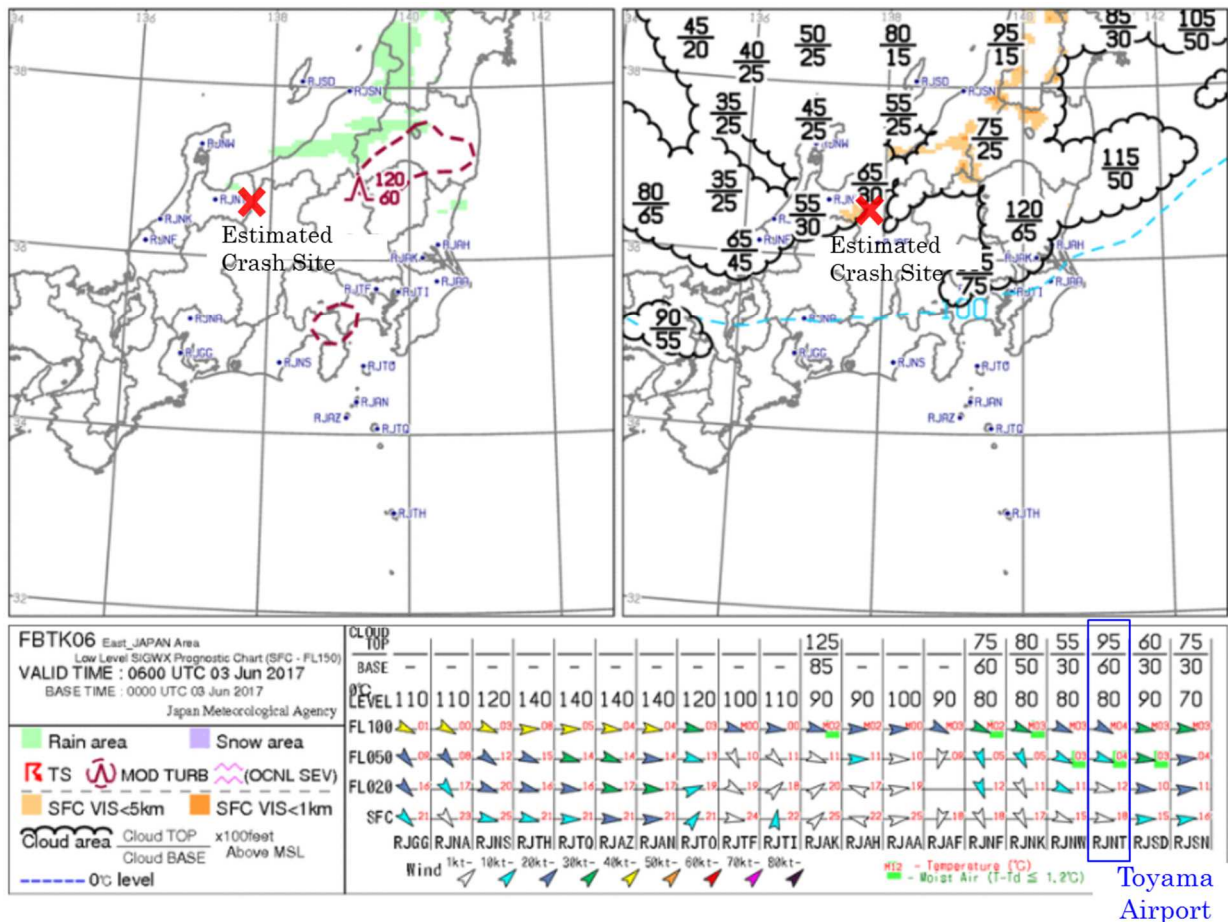
Appended Figure 12: Meteorological Information (4)

On the other hand, as shown in Appended Figure 12: Significant Weather Prognostic Chart of Lower Layers, in the east of Toyama Prefecture, it was forecast that there would be clouds of about 3,000 – 6,500 ft AGL, a humid air area around 5,000 ft above Toyama Airport, and the temperature of an altitude of 10,000 ft would be -4°C. In addition, as described in 2.6.2.2, it was confirmed with the image taken by the live camera during 13:00 to 15:00 that the top of the Tateyama Mountain Range was covered with clouds. And as shown in Photo 2 to 6, it is probable that during the time period when the accident occurred, all around the area where the Aircraft flew through was invisible and covered with fogs and clouds. As described in 2.16.1.3 “FAA Document: Tips on Mountain Flying”, it is recommended that pilots should have at least 15 miles (about 24 km) of visibility before attempting mountain flights. Therefore, it was anticipated that under those weather conditions, this mountain flight would be difficult for the Aircraft at the time of taking off from Toyama Airport.
