AIRCRAFT ACCIDENT INVESTIGATION REPORT

March 29, 2013

BIRD STRIKE DURING TAKEOFF CLIMB IBEX AVIATION CO., LTD. CESSNA 172P, JA4135 ABOVE RYUGASAKI AIRFIELD RYUGASAKI CITY, IBARAKI PREFECTURE, JAPAN AT 14:40 LOCAL TIME, JUNE 18, 2012

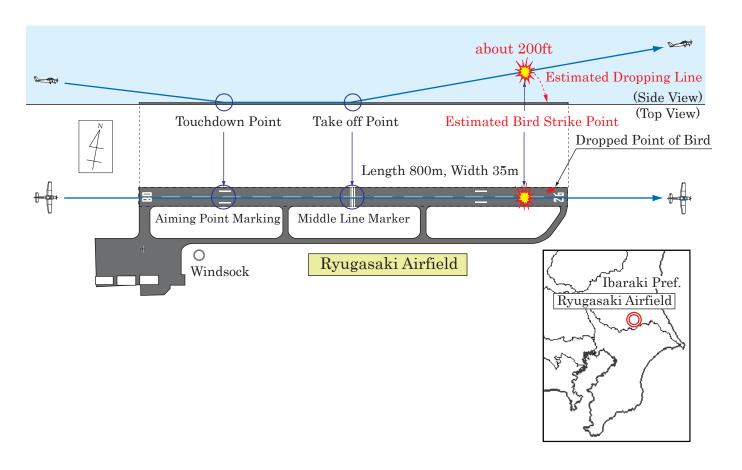
Figure Estimated Flight Path

3.1	Involvement of	None
	Weather	
3.2	Involvement of	None
	Pilots	
3.3	Involvement of	None
	Airplane	
3.4	Analysis of	It is probable that it was difficult for the airplane to avoid the collision
	Findings	with the suddenly emerged bird, as it was in the middle of during takeoff
		climb with insufficient airspeed and altitude in which abrupt attitude
		change should be avoided.
		It is highly probable that the damage to the left wing of it was caused
		by the collision with the bird.
