**AIRCRAFT ACCIDENT
INVESTIGATION REPORT**

OBIHIRO BRANCH SCHOOL OF THE CIVIL AVIATION COLLEGE

J A 4 2 1 5

CRASH INTO THE MOUNTAIN SLOPE
OBIHIRO BRANCH SCHOOL OF THE CIVIL AVIATION COLLEGE,
BEECHCRAFT A36, JA4215
Mt. TSURUGI, MEMURO-CHO, KASAI-GUN, HOKKAIDO, JAPAN
AT ABOUT 09:22 JST, JULY 28, 2011

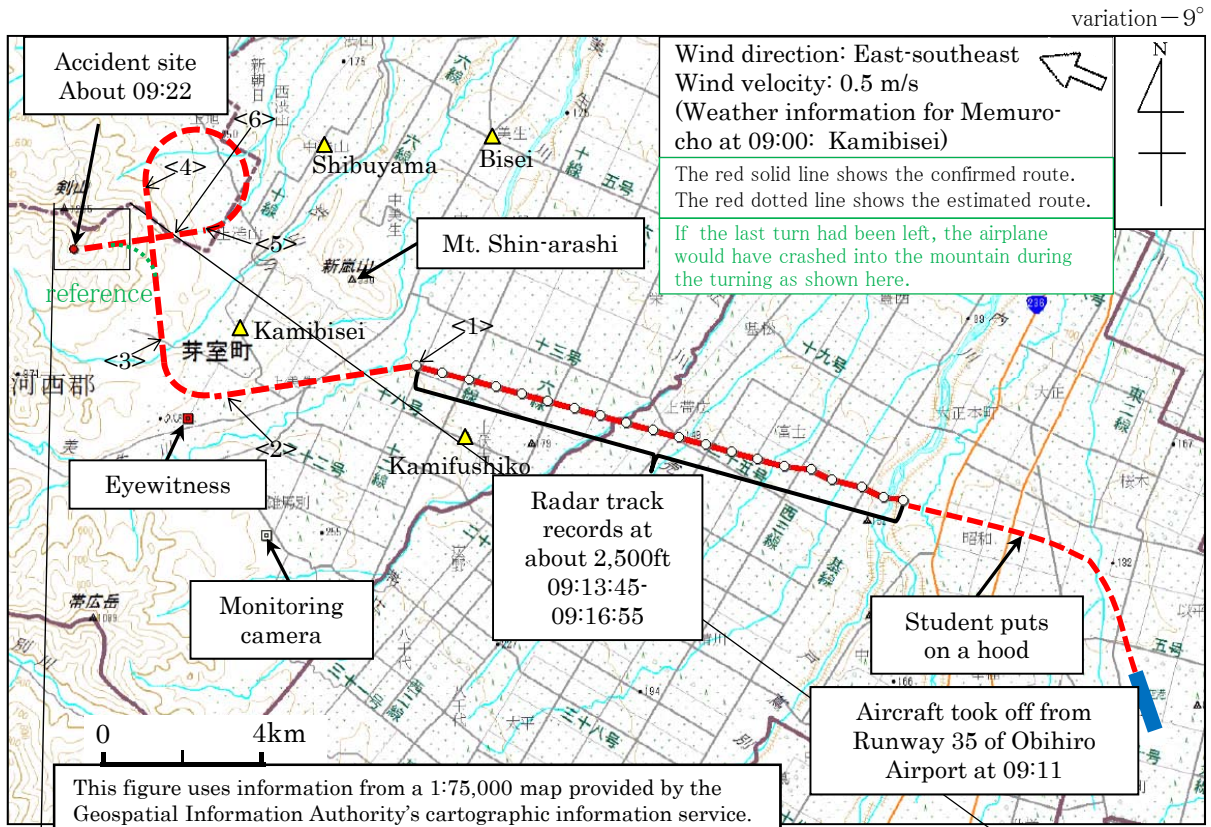
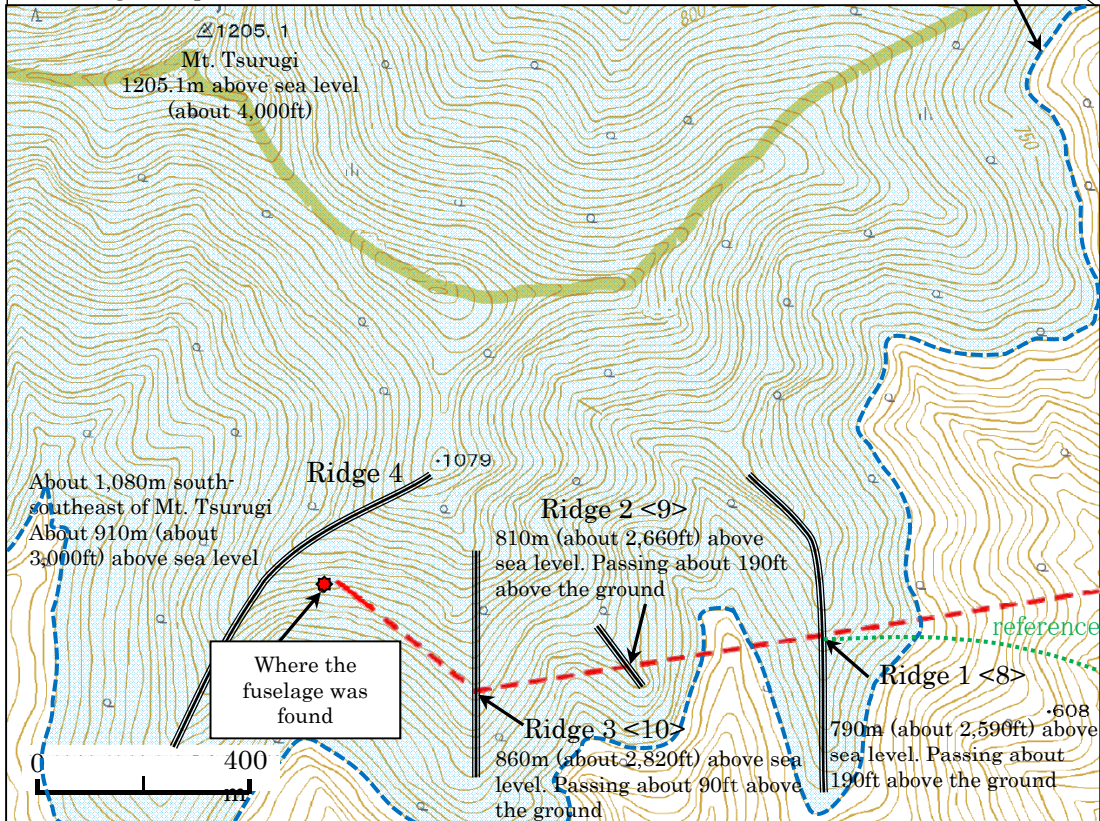
Figure 2: Estimated Flight Route

It is probable that the last turn was right 270° turn because: just before the accident, the airplane was climbing leaving track of 270° and if it had been a left 90° turn it would have crashed into the mountain; and Student A recalled that the last turn was not the one of short duration as long as 30 seconds. Based on this assumption, the estimated flight route after 09:16:55, the last confirmed point on the radar trajectory records, was generated as shown in Figure 2.

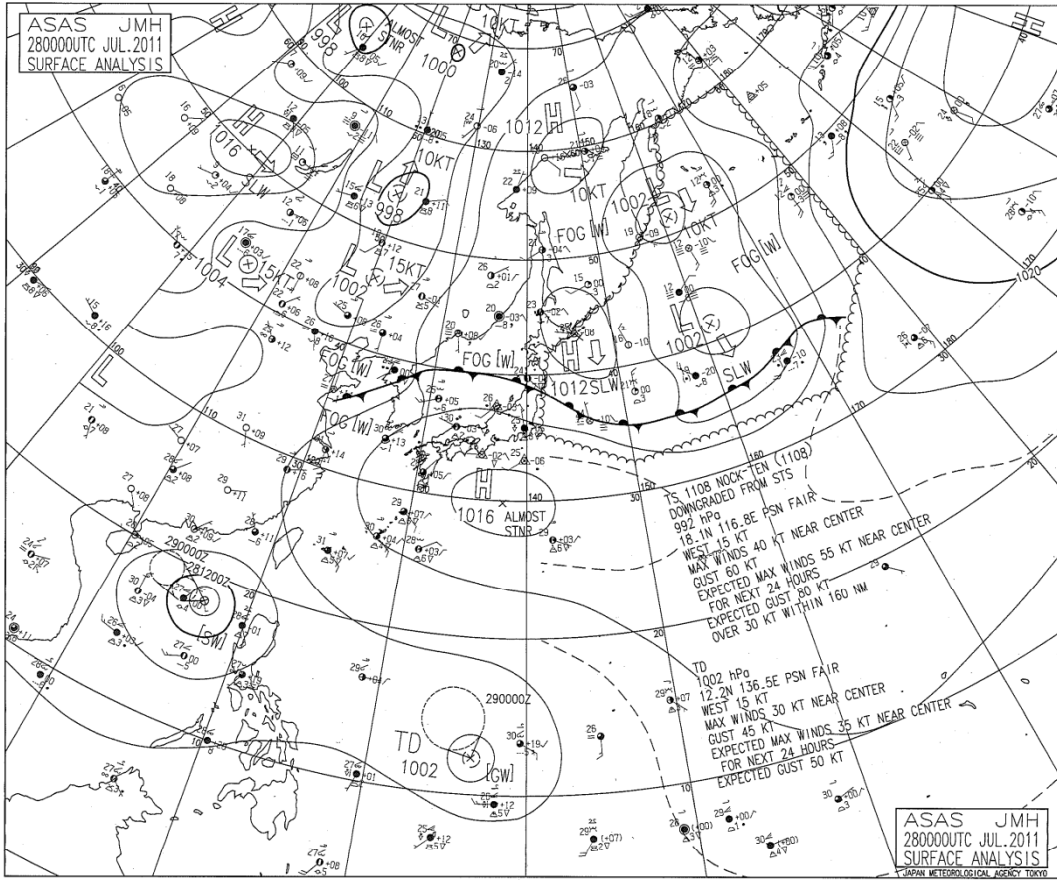
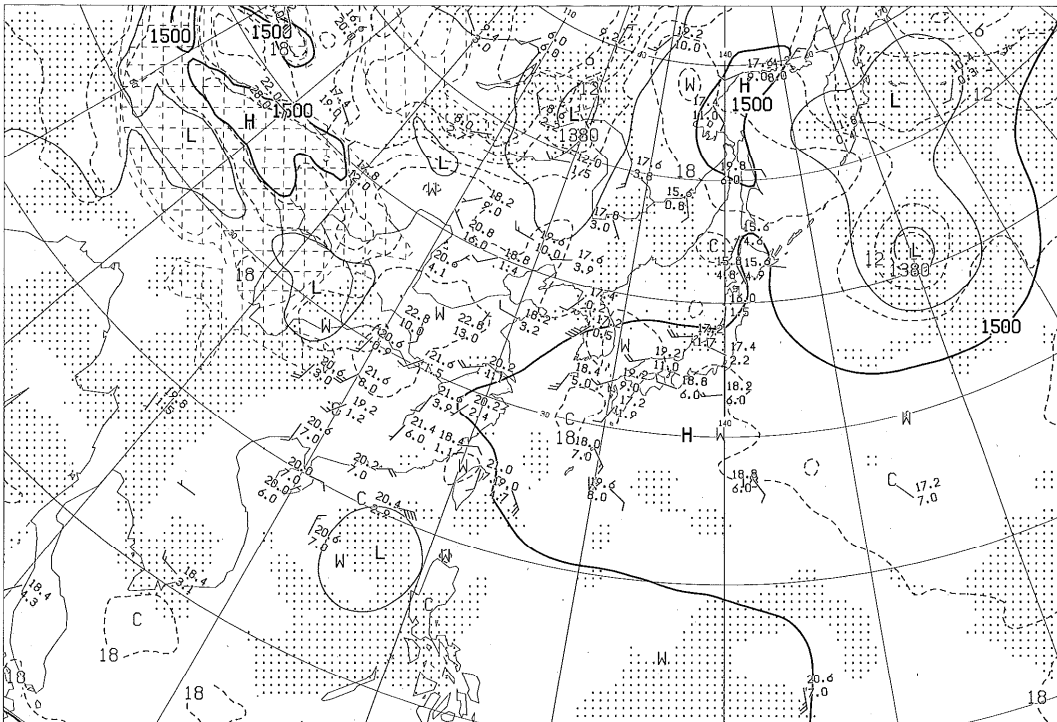
Figure 4: Weather Maps

On the day of the accident, the ridges of the mountains were slightly covered with clouds, but the wind was weak, and no unusual meteorological phenomenon was observed.

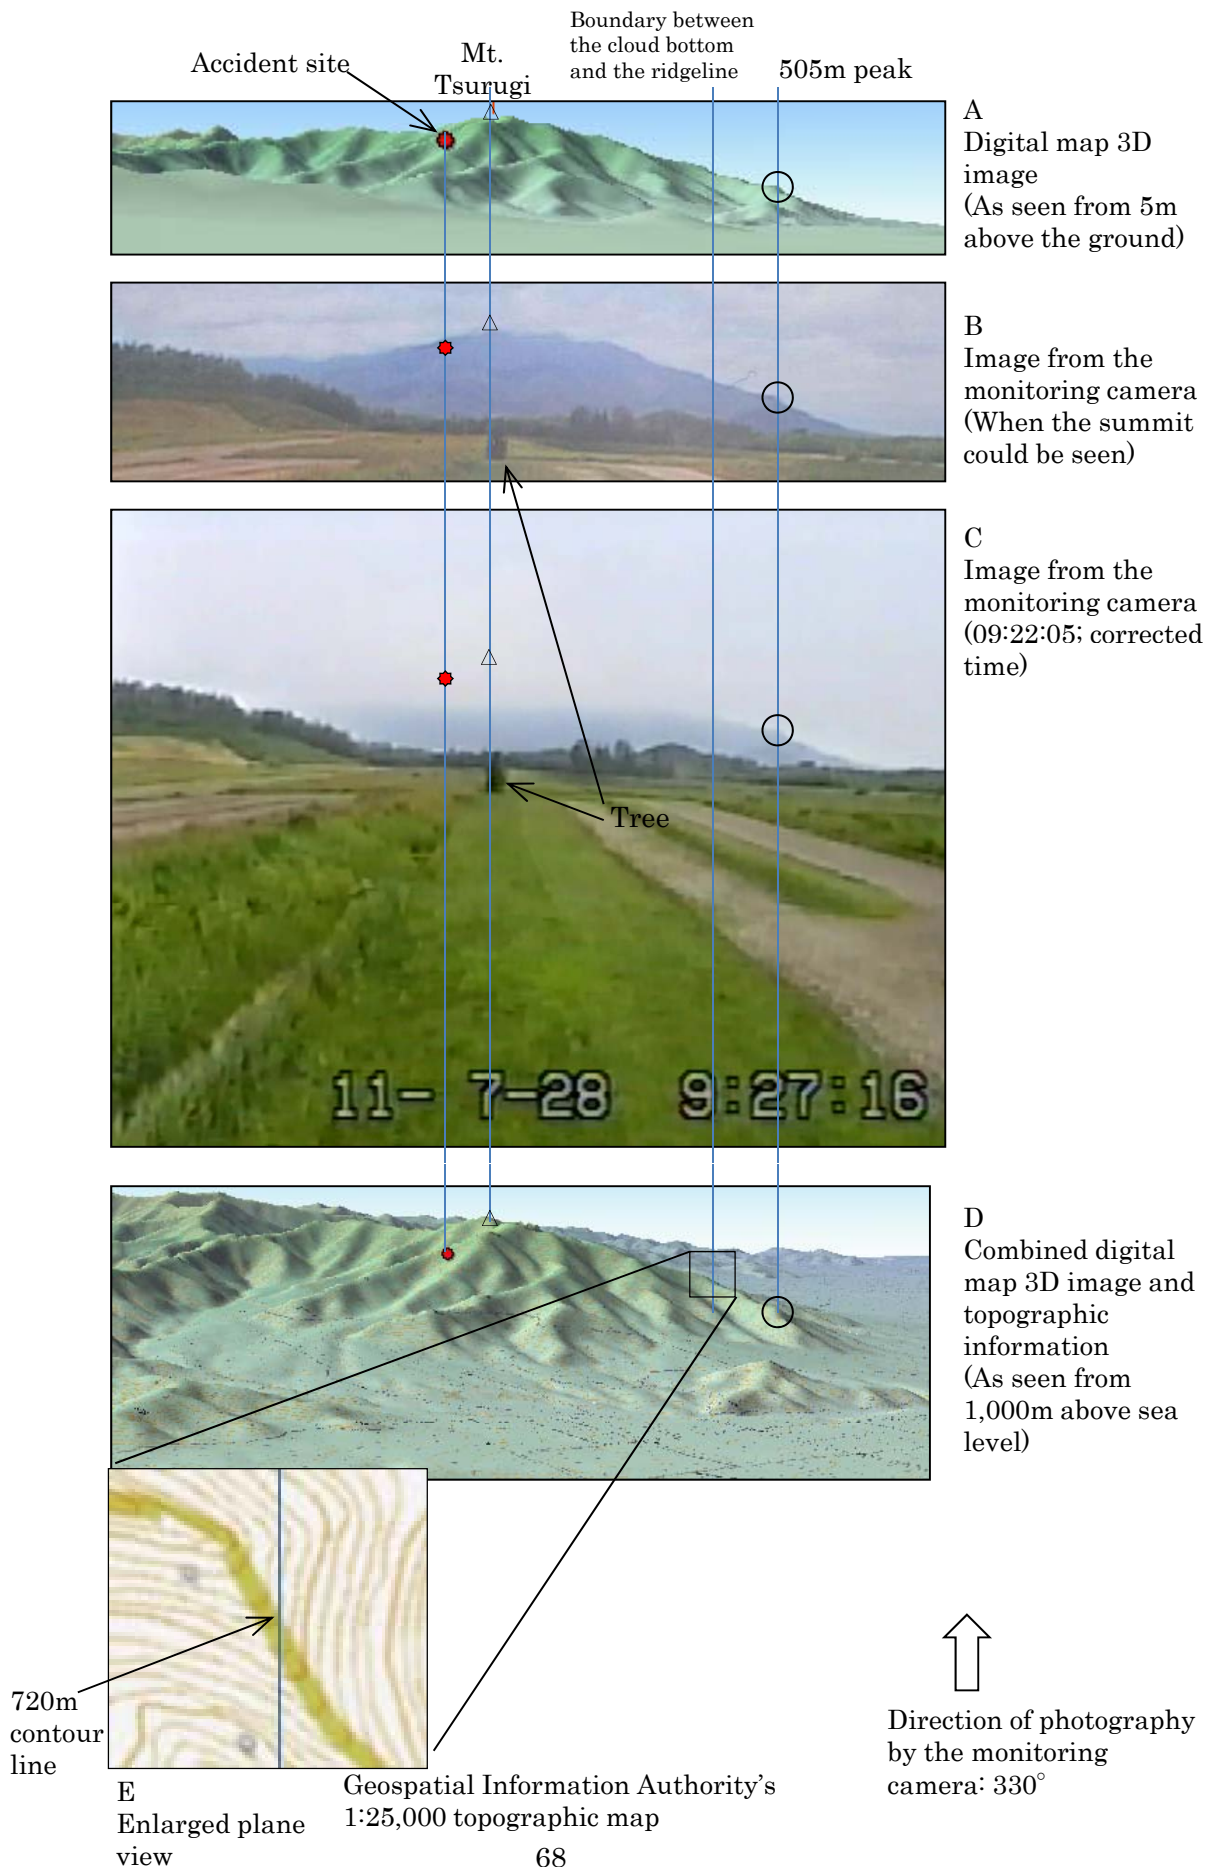
Figure 5: Clouds Observed at the Time of the Accident

As described in 2.6.5(1), the image of Mt. Tsurugi recorded by the monitoring camera at 09:22:05 on the day of the accident is as shown in “C: Image from the monitoring camera (09:22:05; corrected time)” of Figure 5 “Clouds Observed at the Time of the Accident.” The upper half of Mt. Tsurugi was covered with clouds. The image of the entire mountain up to its peak is shown in “B: Image from the Monitoring Camera (when the Top could be seen)” of Figure 5. The 3D images of Mt. Tsurugi with the view point at five meters above the ground, where the monitoring camera was installed, and 1,000 meters above sea level, which were created using digital maps issued by the Geospatial Information Authority, are as shown in “A: Digital map 3D image (As Seen from Five Meters)” and “D: Combined digital map 3D image and topographic information (As Seen from 1,000 Meters above Sea Level)” of Figure 5.

In Figure 5 the images of A, B, C, and D are arranged to align the following in a straight line: top of Mt. Tsurugi, the 505-meter-high ridge (a conspicuous geographic feature of the mountain), and the tree close to the monitoring camera. According to the Image D and the Image E that is an enlarged plane view of the former, the line between the cloud bottom and the ridgeline crosses the 720-meter contour line. Though the cloud base is constantly changing and it is obscured in many cases, judging from each image of Figure 5, it is somewhat likely that at around the time when the accident occurred, Mt. Tsurugi and its vicinity were covered with clouds
