**AIRCRAFT ACCIDENT  
INVESTIGATION REPORT**

**AIRCRAFT DAMAGE DUE TO ROLLOVER AFTER LANDING**

**HIRATA GAKUEN**

**EUROCOPTER AS350 B3 (ROTORCRAFT), JA500H**

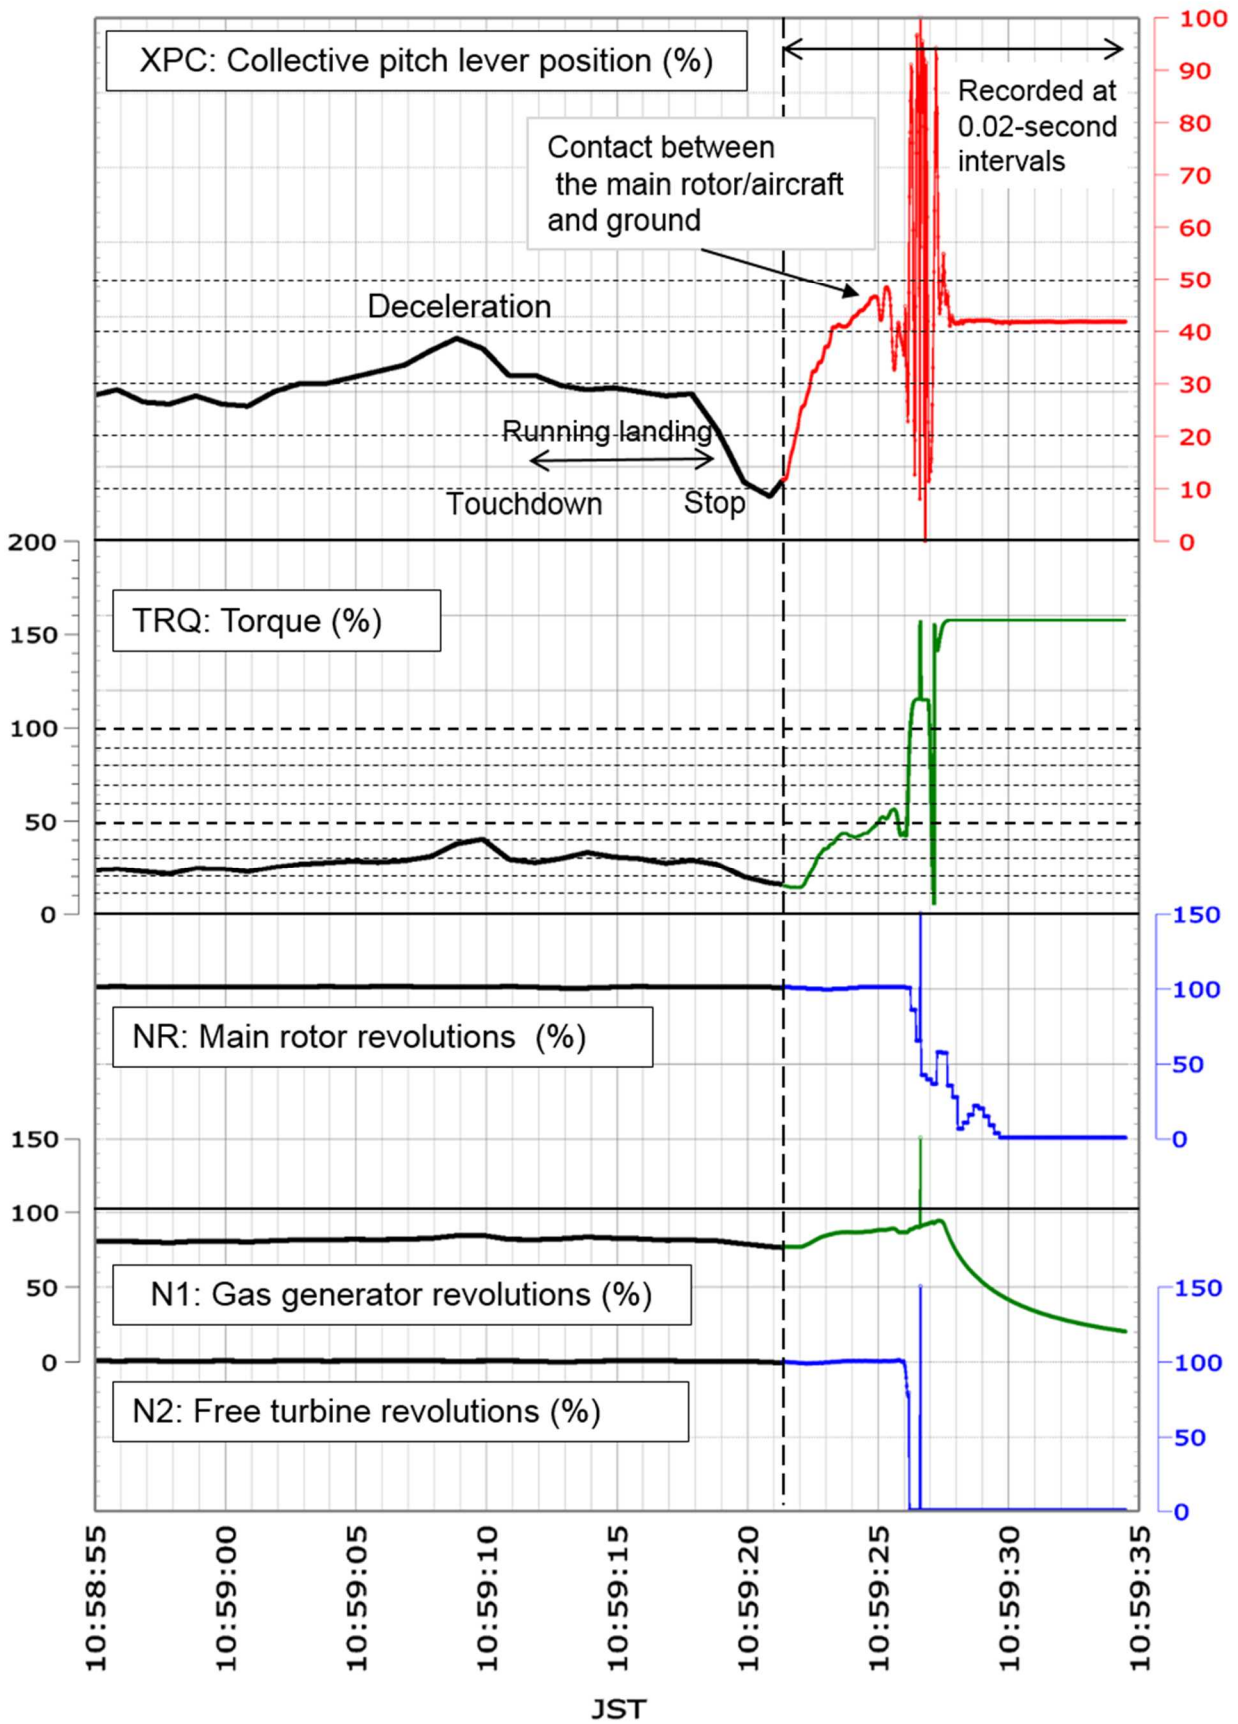
### Appendix Figure 3 EDR Data

Regarding the parameters of Table 2, engine data recorded in the EDR are provided in Table 3. An event indicating an XPC\_1 failure collective pitch anticipator position abnormality was recorded at 3,913.16 seconds (1 hour, 5 minutes, and 13.16 seconds) from the record start.

| Time (sec) | Condition | P0 (mbar) | XPC (%) | TRQ (%) | NR (%) | N1 (%) | N2 (%) |
|---|---|---|---|---|---|---|---|
| 3,913.16 | XPC_1 failure | 1,010.5 | 32 | 74 | 100 | 86.9 | 76.3 |

From 2.7 and the EDR data of Appendix Figure 3, at around 10:59:08, speed was reduced with raising of the collective pitch lever and torque was temporarily rose from 25% to 40% to conduct a running landing. The Helicopter touched down at around 10:59:12 and at around 10:59:18 torque fell to 15% with lowering of the collective pitch XPC value of the lever and stopped. The collective pitch XPC value of the lever was lowered to its lowest position at around 10:59:21. However, the XPC value of the lever was not kept still but was instead raised to approximately 40%, and at around 10:59:26 there was a sudden change with four or five up and down cycles between 0% and 100% between 10:59:26 and 10:59:27, after which it stopped near 40%. Given that the movement of the collective pitch XPC value of the lever after the main rotor blades contacted with the ground was approximately 90 cm/second, it is probable that a position sensor error occurred following contact with the ground. Torque followed the movements of the collective pitch XPC value of the lever, becoming 40% at around 10:59:23 and reaching its maximum value together with the other engine

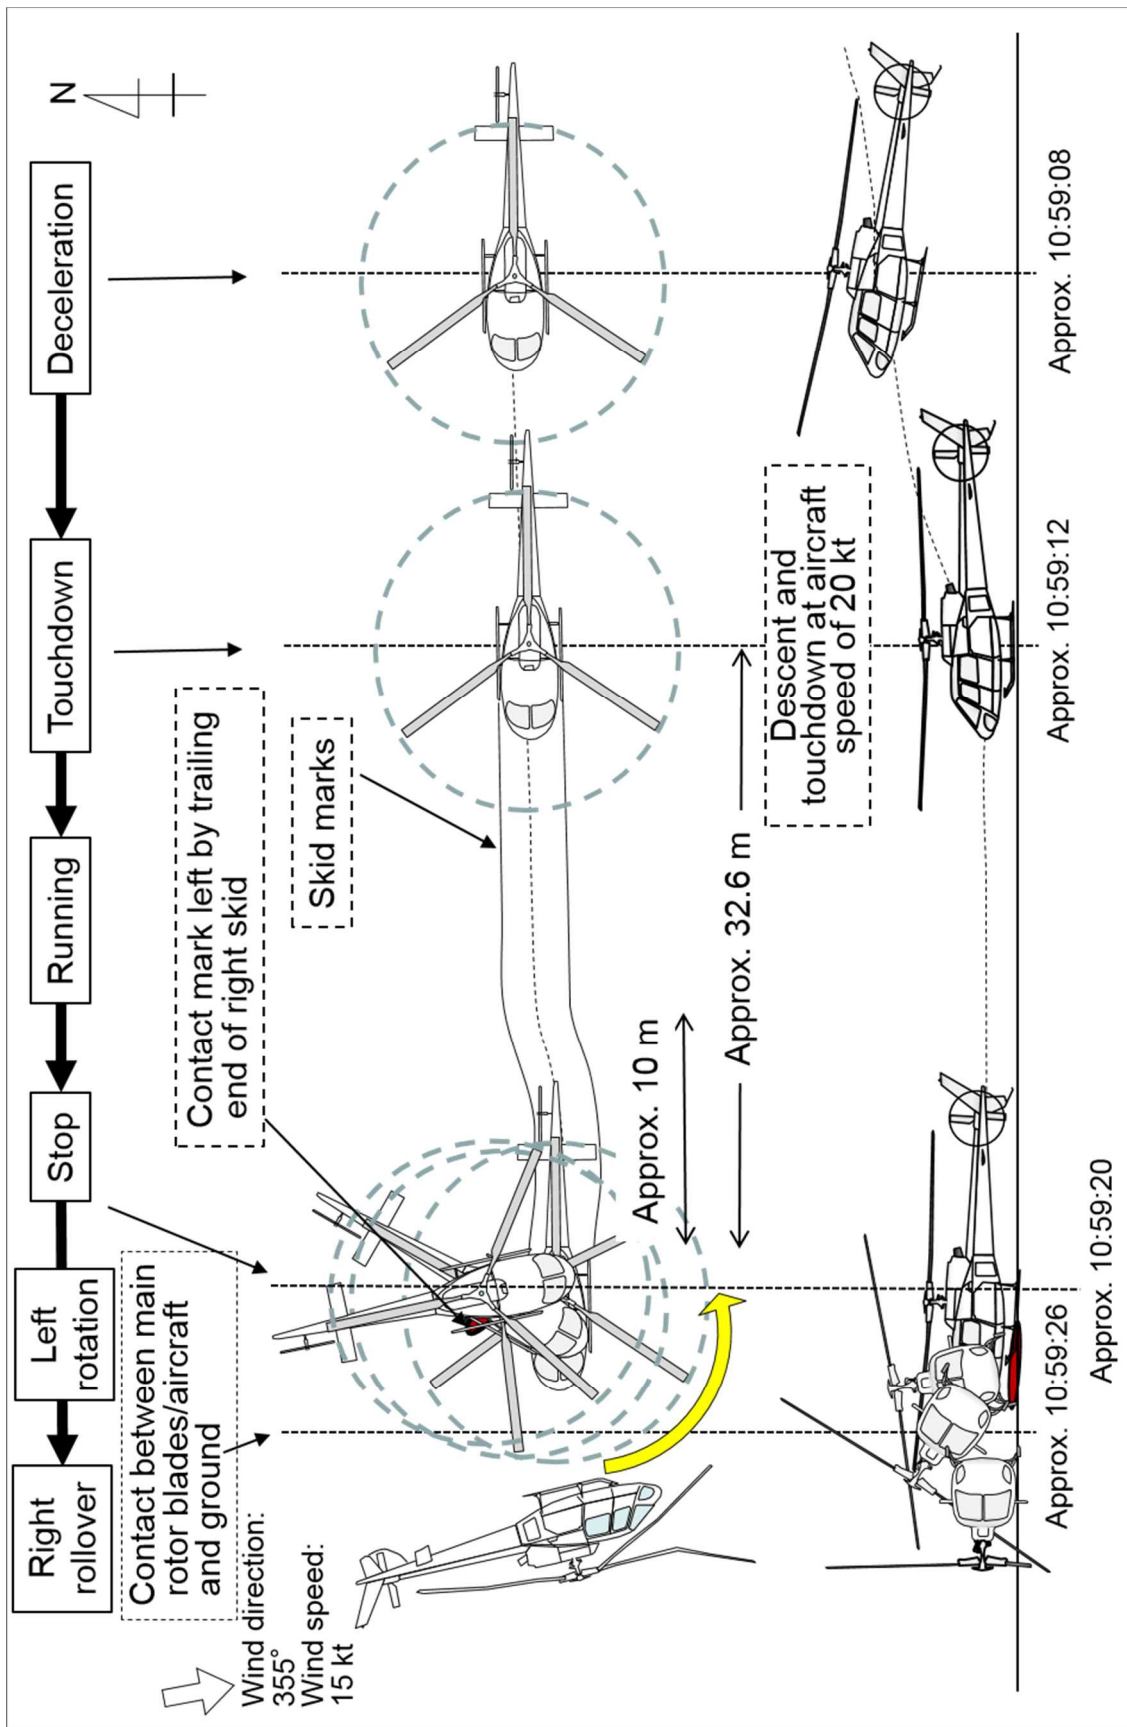
# Appendix 4 Estimated Flight Situation of the JA500H at the Time of the Accident

After completing continuous takeoff-and-landing practice at the Airport, the PIC created a practice hydraulic failure by using the ACCU TST push button while they were flying down wind on the south side. Pilot A immediately set the air speed to approximately 60 kt and set the Hydraulic Cut Off switch to OFF as an emergency operating procedure. While approaching, operation of the left rudder to control direction became more involved and gradually became heavier. He made a running landing in the Grass Area with air speed of approximately 20 kt at the time of touchdown. As for the condition of the Grass Area, the
