**AIRCRAFT SERIOUS INCIDENT
INVESTIGATION REPORT**

**ALL NIPPON AIRWAYS CO., LTD.
J A 5 7 A N**

OVERRUN
ALL NIPPON AIRWAYS CO., LTD.
BOEING 737-800, JA57AN
EAST END OF THE RUNWAY AT SHONAI AIRPORT, JAPAN
AT ABOUT 22:26 JST, DECEMBER 8, 2012

August 22, 2014

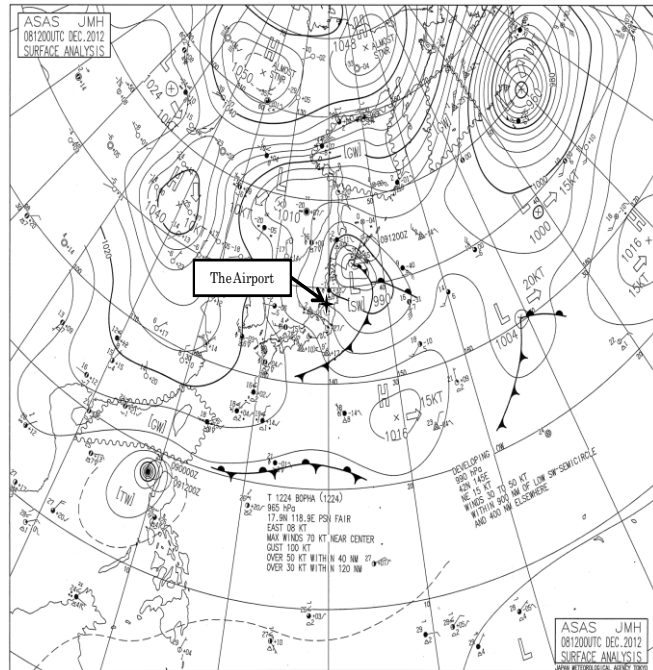
According to the Asia Pacific Surface Analysis Chart at 21:00 on December 8, 2012 (the chart), a well-developed low pressure system southeast of Hokkaido was moving northeast. Japan was covered by a typical winter pressure pattern marked by a high pressure system to the west and a low pressure system to the east. Isobar spacing in the vicinity of the Tohoku Region, where the Airport is located, were very close.

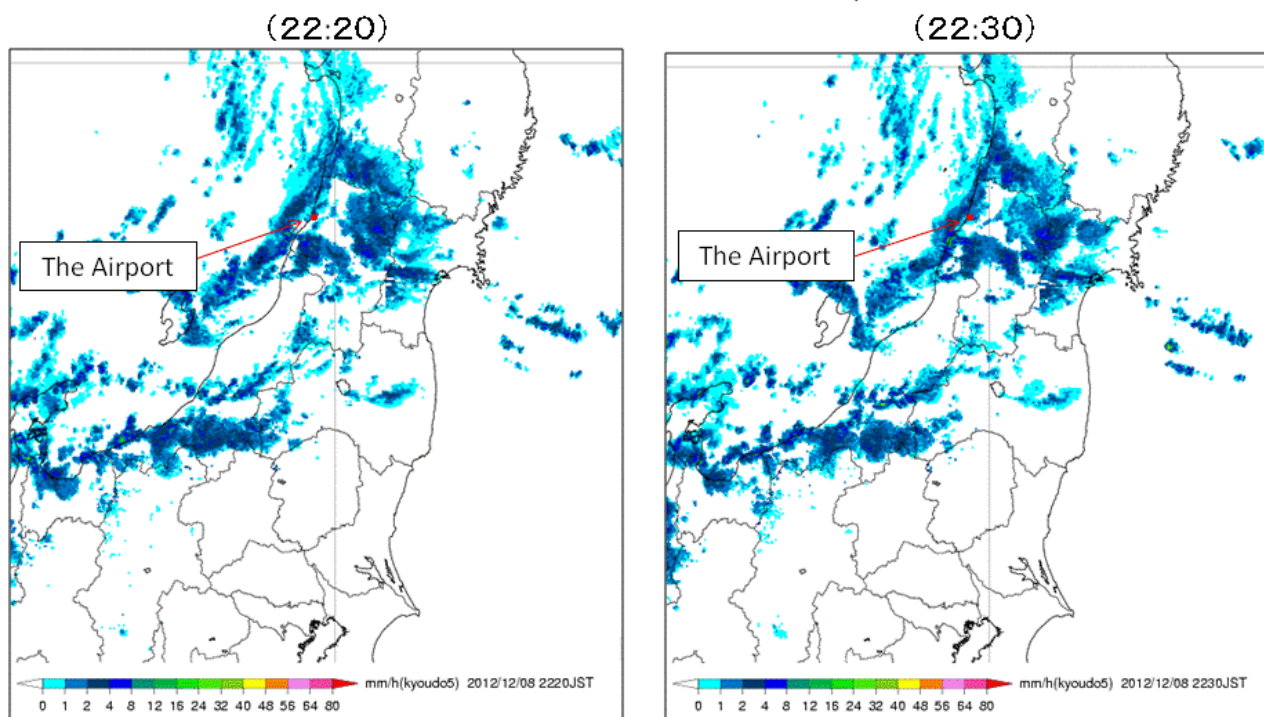
Radar observation data (Intensity)

The following charts depict the radar returns from snow clouds, which were observed at the Airport during the time frame of the serious incident. The radar returns formed north-south streaky shape near the Airport with the overall peak altitude of approx. 6,700-13,300 ft (2-4 km), some reaching approx. 13,300-20,000 ft (4-6 km). The radar returns as a whole were moving southeast. The Airport was located at the northwest edge of the streak at 22:20, and was fully covered by the snow clouds that had strong radar returns at 22:30.

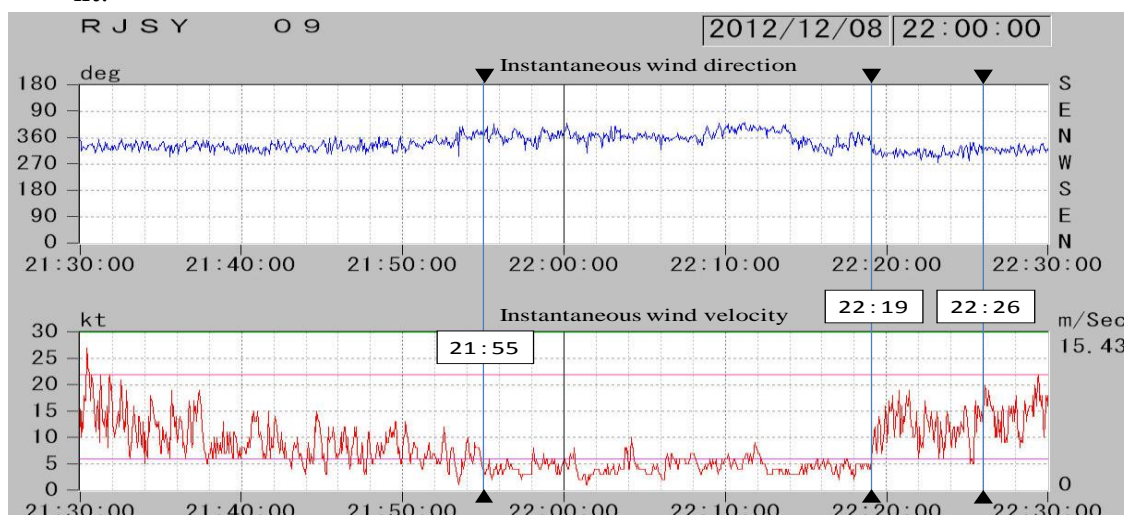
The following charts depict the instantaneous fluctuation of wind direction and velocity near touchdown point of runway 09 during the time frame of the serious incident.

At about 21:30, general wind direction was northwest, and instantaneous wind velocities exceeded 25 kt. However, the winds gradually abated by about 21:55. Between about 21:55 and 22:19, the wind direction fluctuated between northwest and northeast; the instantaneous wind velocity exceeded 10 kt twice and exceeded 5 kt several times. In general the instantaneous wind velocity remained near 5 kt or less. Starting at 22:19, the instantaneous wind velocity suddenly exceeded 10 kt. The wind direction stabilized approximately in the northwest direction. At 22:26:09, the wind from 332° exceeded 20 kt.

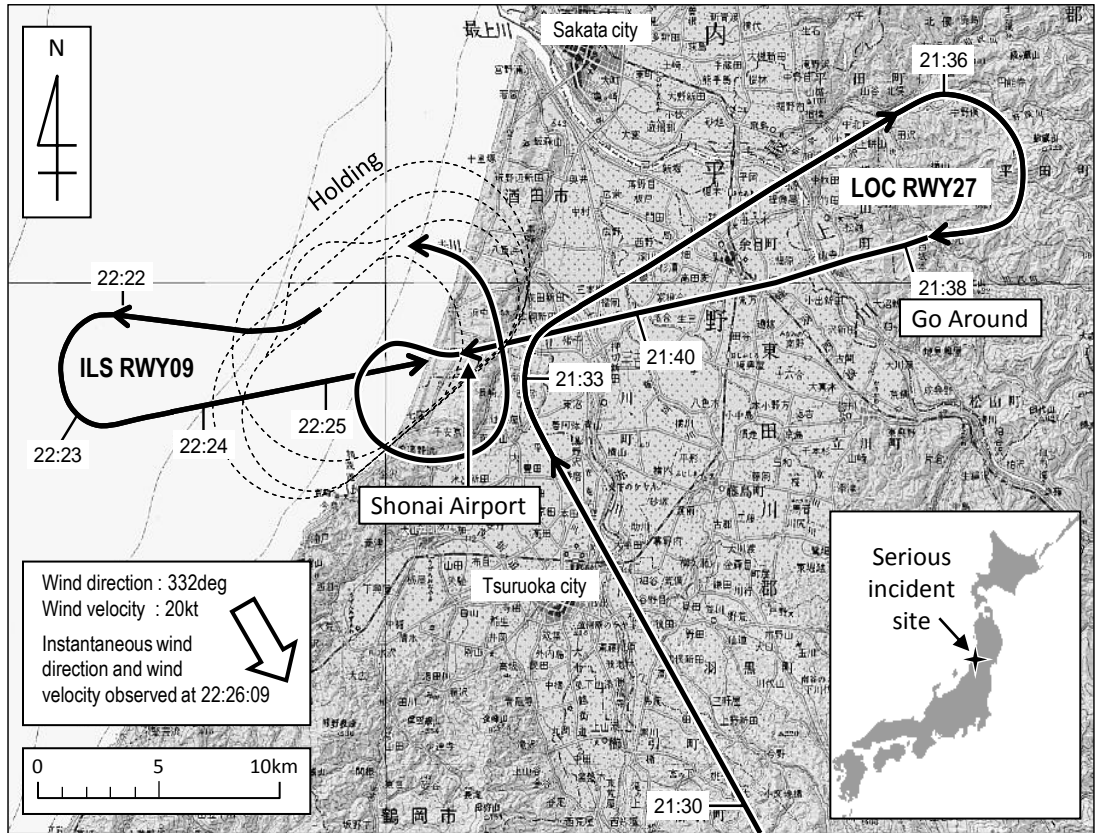
Figure 1: Estimated Flight Route

(See Figure 1 “Estimated Flight Route”)

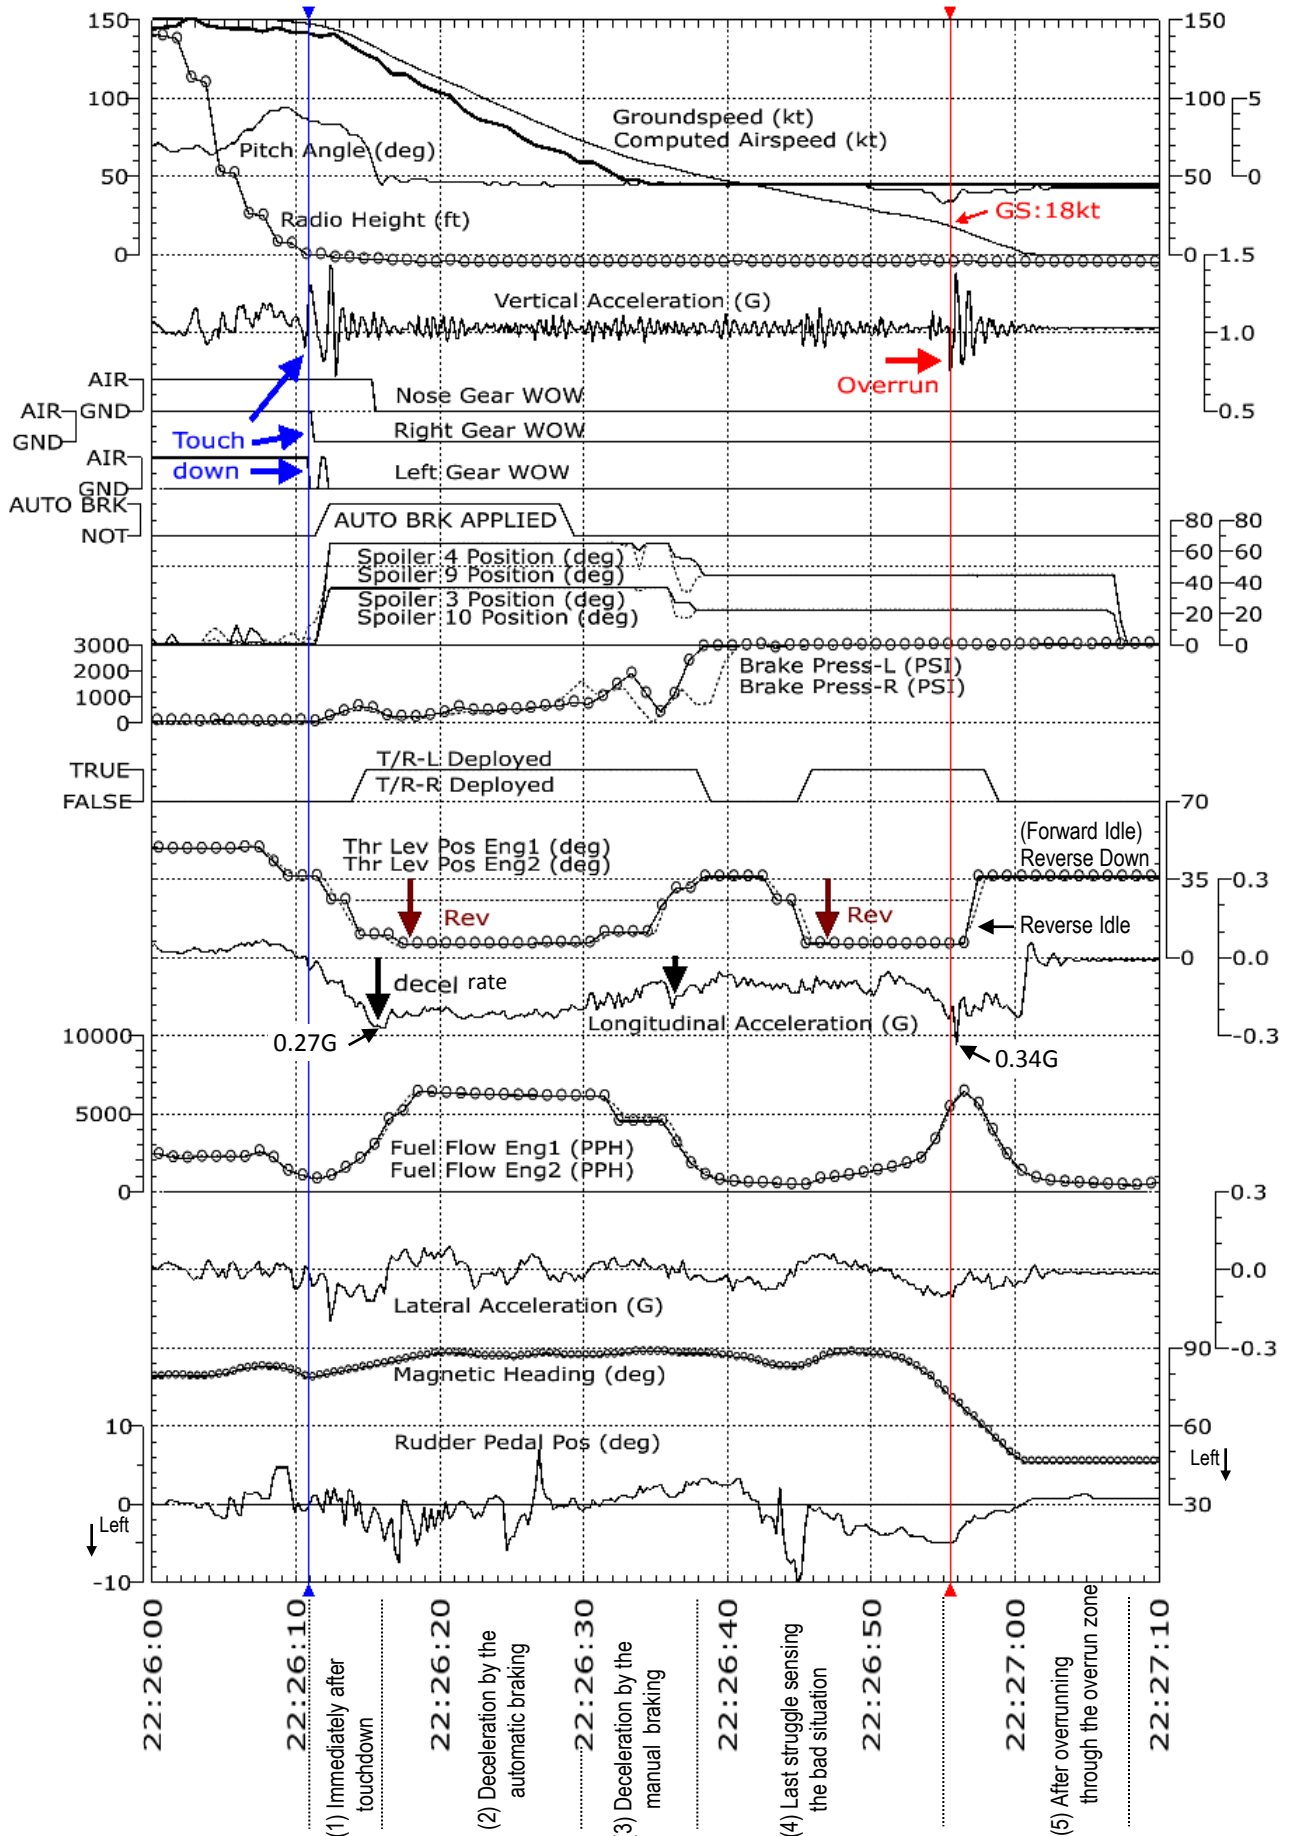
Figure 2: Records of the DFDR

(See Figure 1 “Estimated Flight Route” and Figure 2 “Records of the DFDR.”)
