# SUMMARY OF AIRCRAFT ACCIDENT INVESTIGATION REPORT

ACE HELICOPTER

AEROSPACIAL SA330J, JA6706

WHICH CRASHED DURING APPROACH TO A TEMPORARY  
HELIPAD IN MOUNTAINS, TOYAMA, JAPAN

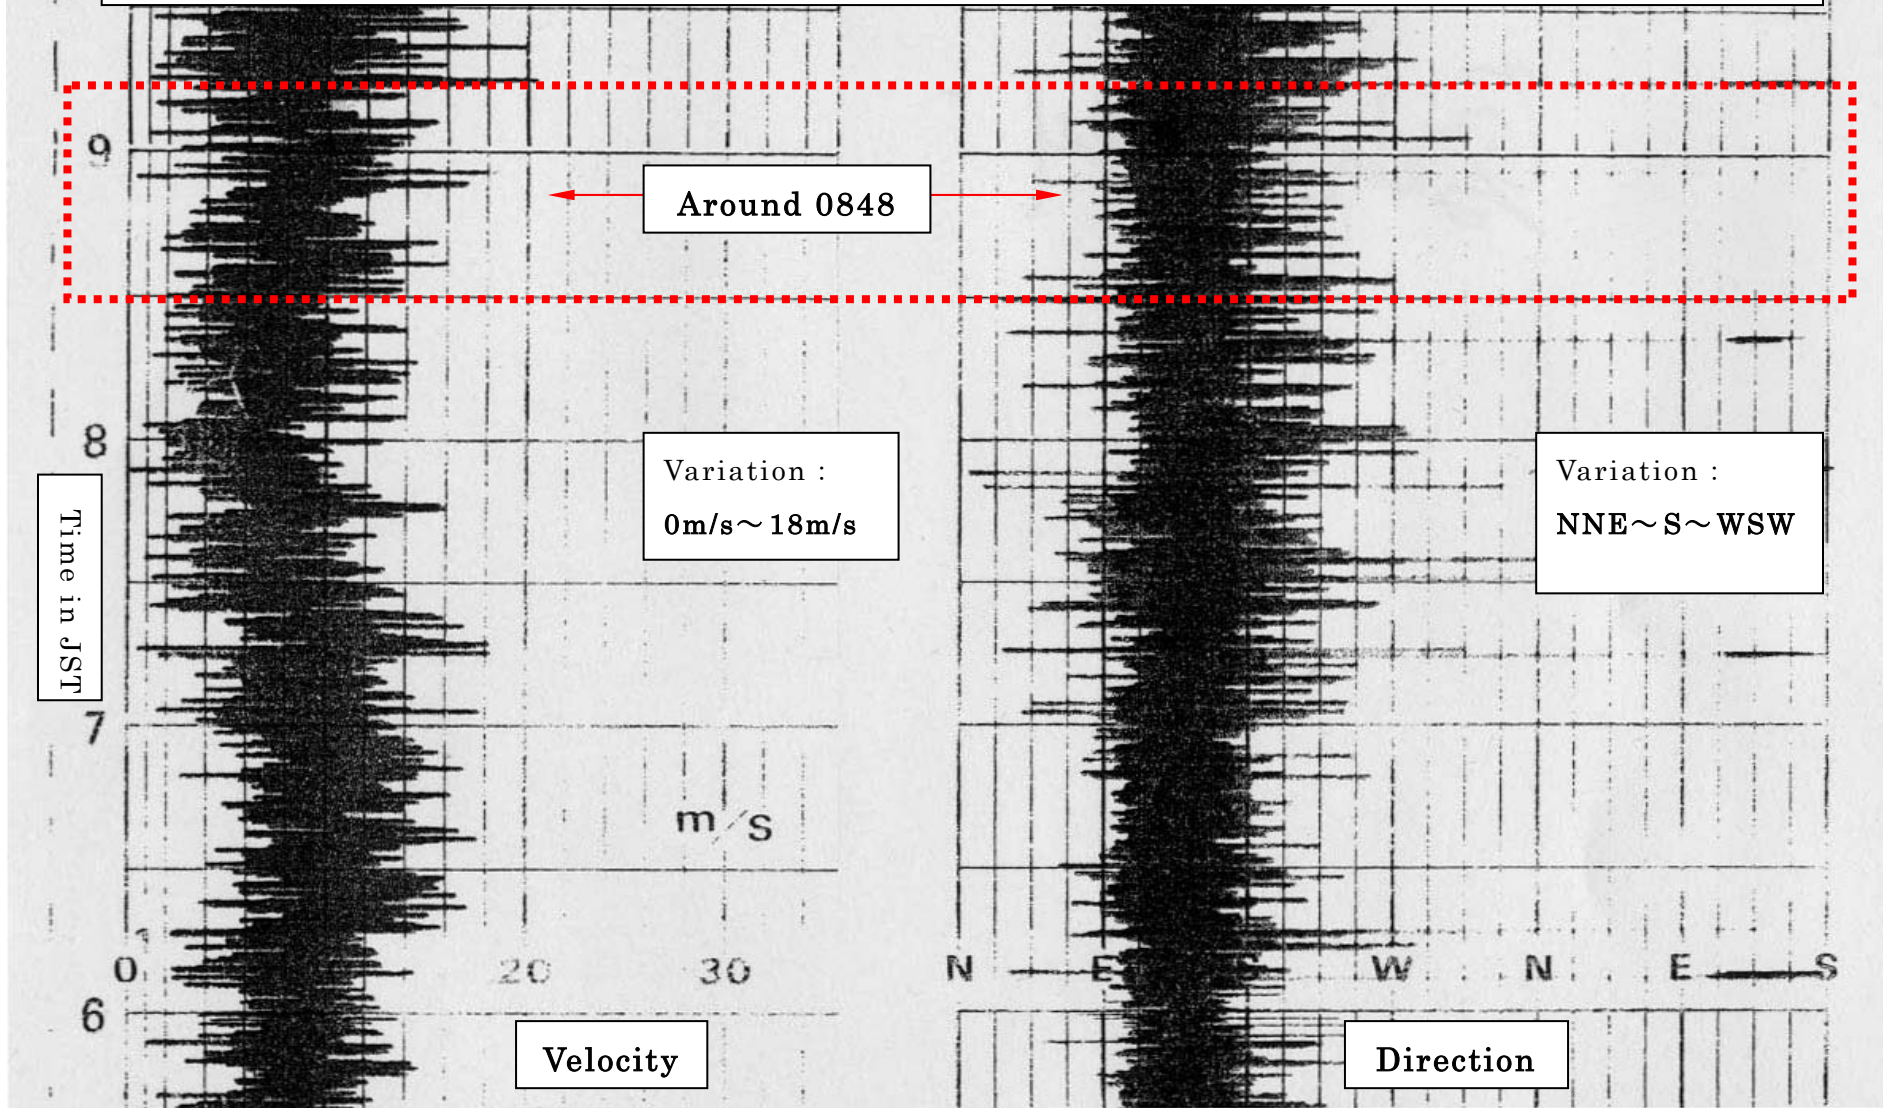
Figure 5 Wind velocity and direction at Murodou  
(Accident occurred around 0848JST.)

The following meteorological observations for Murodou on the day of the accident were made by the Murodou Operation Center of the Tateyama-Kurobe Sightseeing Company located in Murodou Terminal, which is near the accident site. Further, as shown in Figure 5 (Murodou wind speed and direction data), there were large variations in wind velocity, with the wind direction varying from north-north-east to south to west-south-west over a range of around 225°, and wind speed varying between 0–18m/s.

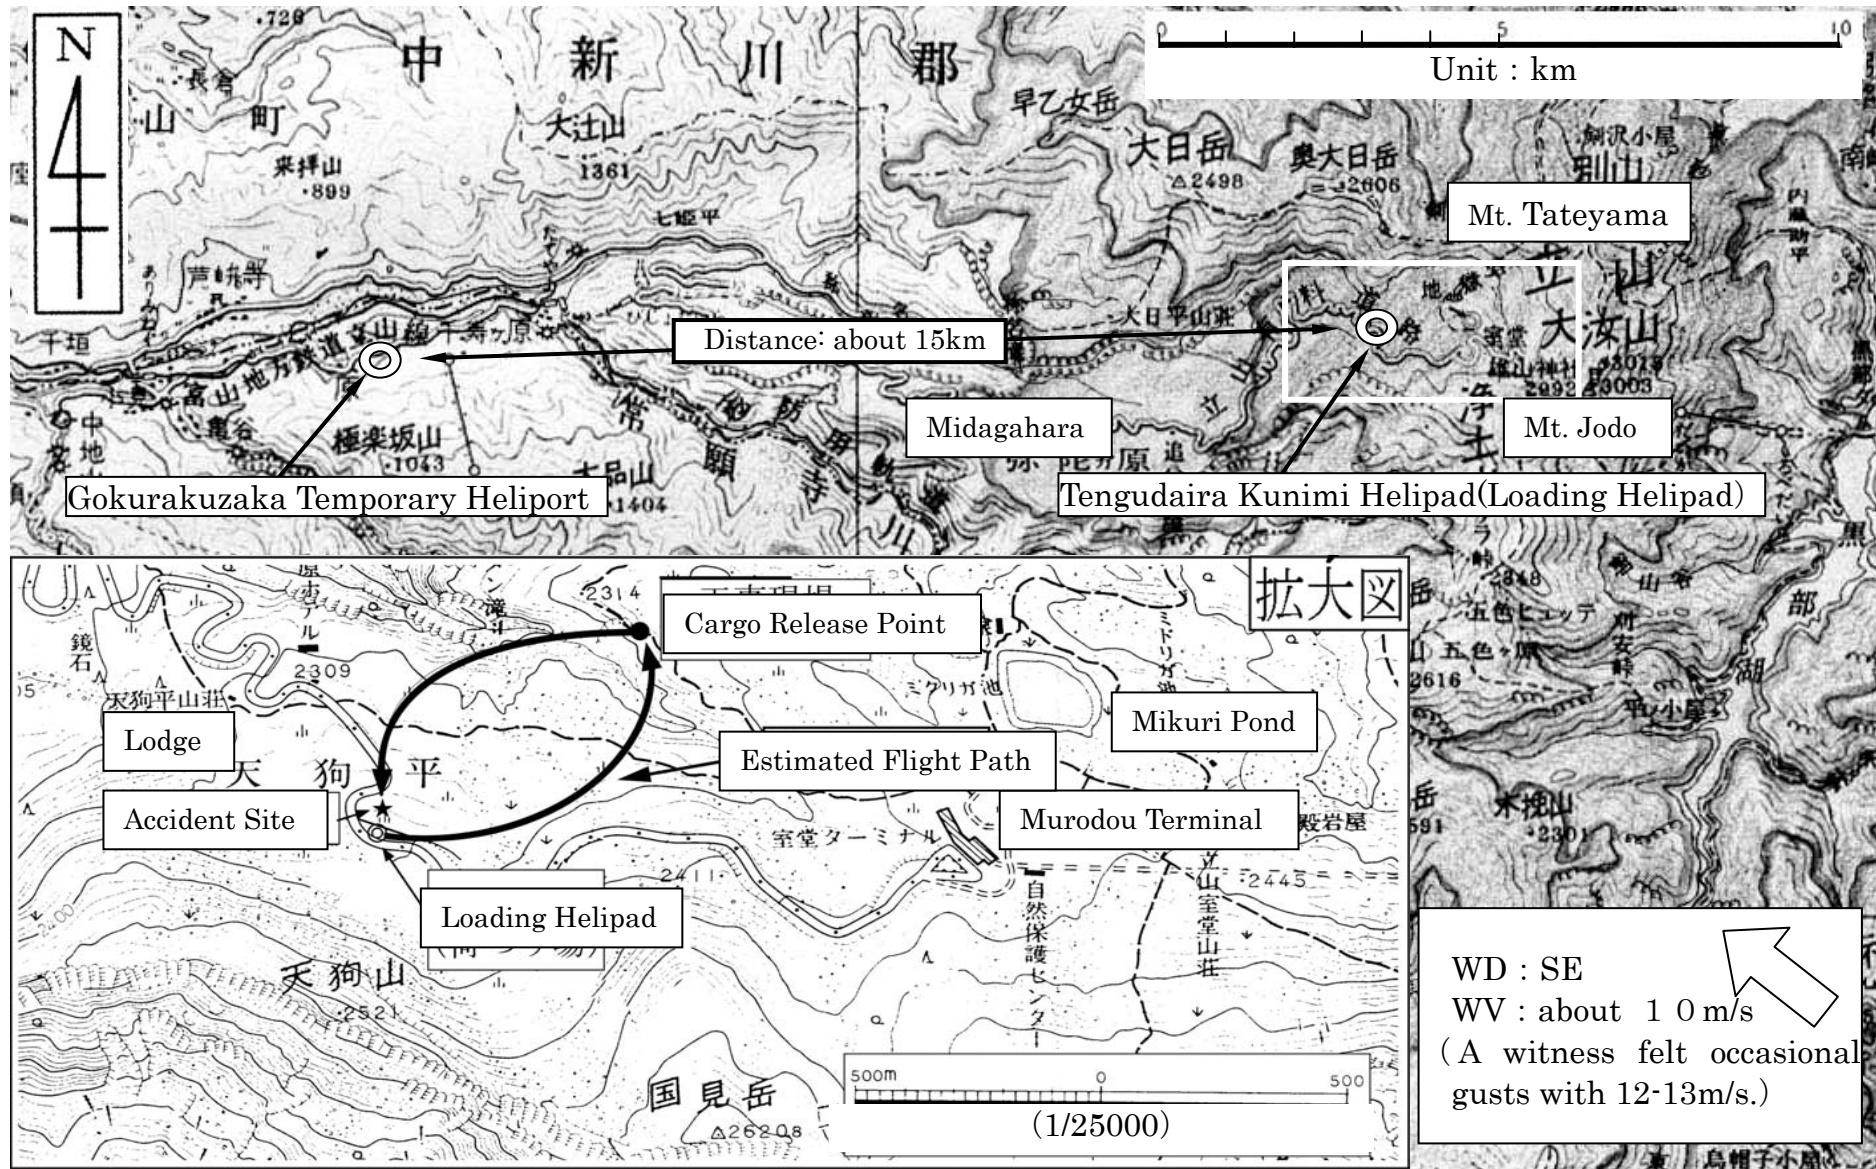
Figure 1 Accident Site and its vicinity & Estimated Flight Path

over as if it would roll over to the right, and fire came out of the lower side No. 2 engine.”  
(See Figures 1, 2 and Photographs 1, 2.)

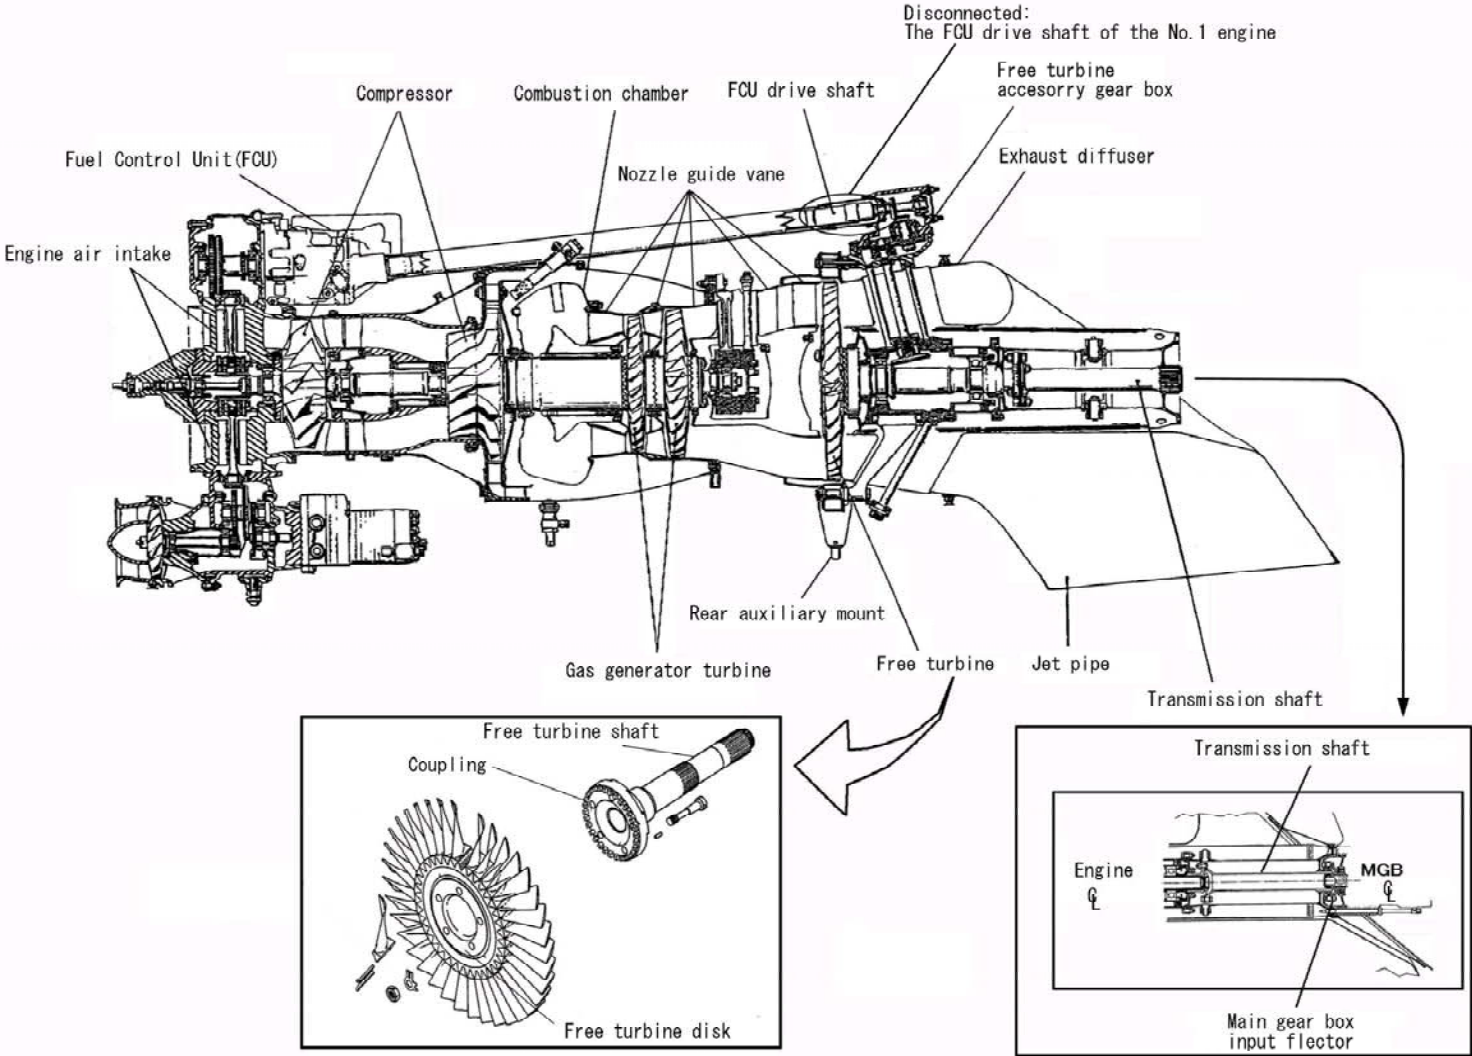
Figure 6 Cut Away View of TURMO IV C Engine

- ③ Based on the fact that no damage was found to the No. 2 engine, it is considered that this engine was operating normally until the time of the accident.  
(See Figure 6 and Photographs 4, 5)
