**AIRCRAFT ACCIDENT
INVESTIGATION REPORT**

Japan Coast Guard

J A 6 7 1 3

**JAPAN COAST GUARD
BELL - 412 (ROTORCRAFT), JA6713
ON THE SEA ABOUT 8km EAST-NORTHEAST OFF IKEMA
ISLAND LIGHTHOUSE, MIYAKOJIMA CITY, OKINAWA
PREFECTURE, JAPAN
AT ABOUT 19:41 JST, DECEMBER 1, 2008**

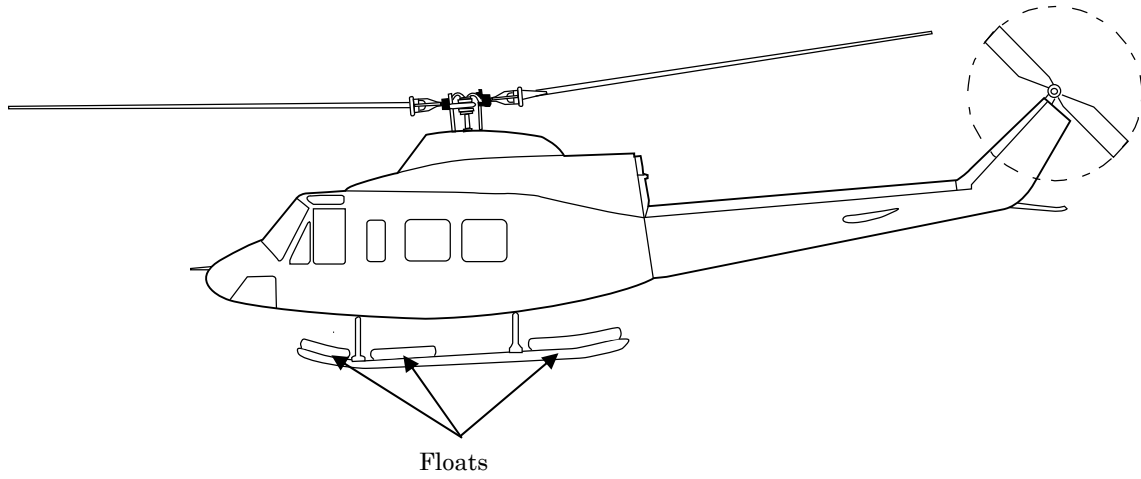
Figure 3 Floats Equipped Location

Judging from the statements in 2.1, it is considered highly probable that with the floats inflated when the Aircraft ditched, it was almost stably floating on the sea until the floats ruptured.

As stated in 2.1 and described in 2.7.2, it is considered highly probable that the Aircraft suffered damage at ditching and the pieces of its damaged parts were floating around it. Therefore, it is considered probable that contacts with these fragments punctured holes in the floats.
