**AIRCRAFT ACCIDENT
INVESTIGATION REPORT**

**PRIVATELY OWNED
JA77AR**

PRIVATELY OWNED ROBINSON R66 (ROTORCRAFT), JA77AR

AT ABOUT 15:33 JST, DECEMBER 30, 2020

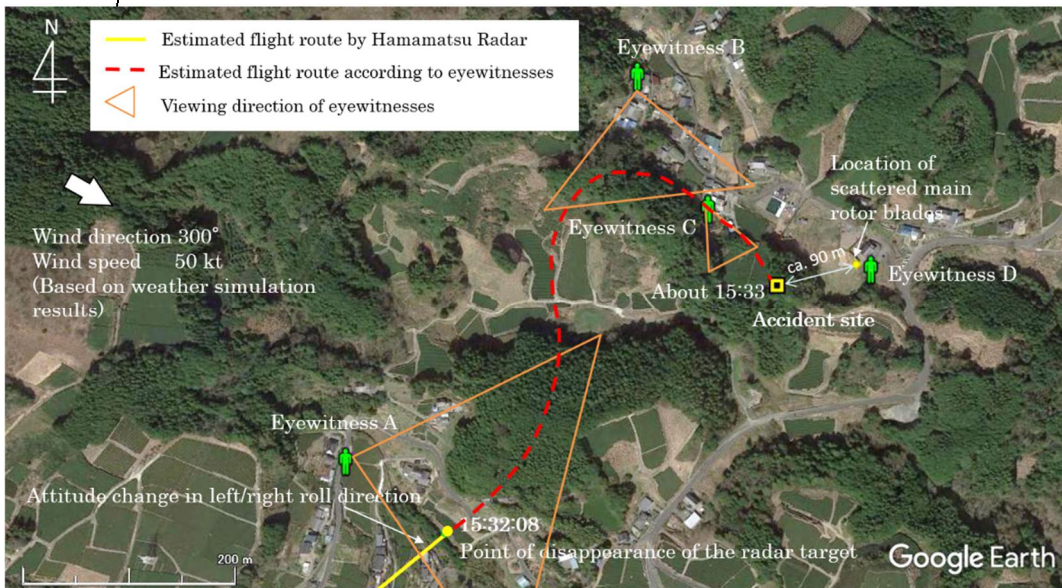
Figure 2: The Helicopter's Estimated Flight Route Immediately before the Crash

As shown in Figure 2, the flight route from the point where the radar target of the helicopter disappeared to the crash point was about 900 m, and the helicopter flew for one minute, in addition, according to the recording on the Engine Monitoring Unit, from around 15:32:25, the torque suddenly increased, and the helicopter was more likely flying at a low speed of about 30 kt. According to the statements of eyewitnesses, the helicopter was swinging its tail right and left, and immediately before the crash, therefore, it was flying while largely tilting to the right with a large nose down, the helicopter most likely continued flying in a difficult flight control condition. Besides, if the main rotor drive shaft had been bent during the flight, the imbalance of the main rotor would rapidly result in complete separation of the entire main rotor gearbox, and the airframe will disintegrate in midair. Therefore, it is likely that the main rotor drive shaft was bent after the crash, not during the flight.

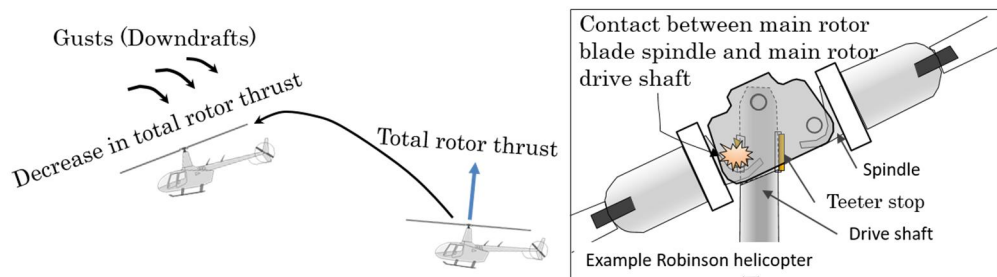
Figure 14: Mast Bumping

Mast bumping is a phenomenon where the main rotor blade spindle (or hub for Bell Helicopter type) strongly contacts or bumps the main rotor drive shaft, when a helicopter (usually often for two-bladed helicopter) having semi-rigid rotor systems*⁶ enters a low-G condition out of the normal condition of 1G and the attitude is not properly controlled. The excessive flapping may result in the damage to the main rotor drive shaft and the control system, making it difficult to control. Besides, as a characteristic of the occurrence of the mast bumping occurs during flight, contact marks are often left on both sides of the main rotor shaft.

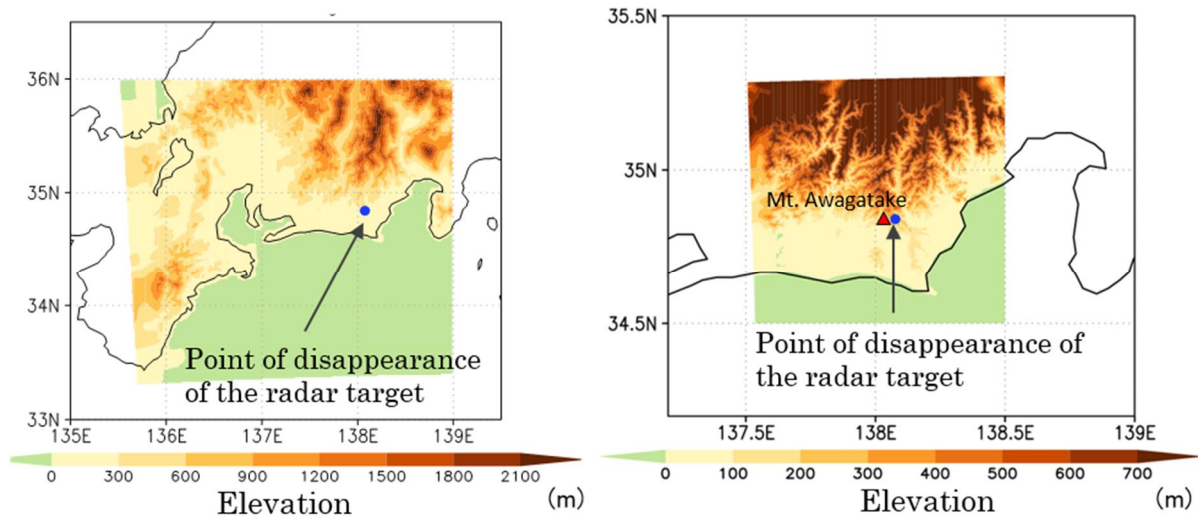
**Figure 15: Computational Region of Numerical Analysis A Model Terrain (Left)
Computational Region of Numerical Analysis B Model Terrain (Right)**

Computational region: For analysis A and B, respectively, within a 400-km (Left, Figure 15) and an 80-km (Right, Figure 15) radius centered on the point where the helicopter experienced a sudden change in attitude, and 21.1 km in vertical direction for both.

As shown in Figure 15 (Right), topographic features in the vicinity of the estimated flight route of the helicopter were mountainous in the north and plain in the south. Around an altitude of about 600 m (about 2,000 ft) where the helicopter was flying, as shown in Figure 16 (Left), on the southwest side, the horizontal wind was blowing from an angle of 300° at about 25 m/s (50 kt), which is indicated mainly in yellow color, and the northeast side, the horizontal wind was blowing at about 15 m/s (30 kt), which is indicated in dark blue. In addition, as shown in Figure 8: Meteorological Satellite Imagery (Visible), in the Tokai region, there are three streaky cloud lines running through the northwest to the southeast, and one of these lines is located near the accident site, and as shown in Figure 9, at Shizuoka Airport, the strong wind had continued blowing until 17:00. The horizontal wind velocity and the vertical flow in Figure 16 (Right) show
