**AIRCRAFT SERIOUS INCIDENT
INVESTIGATION REPORT**

ALL NIPPON AIRWAYS CO., LTD.

J A 8 0 4 A

**EMERGENCY EVACUATION USING SLIDES
ALL NIPPON AIRWAYS CO., LTD.
BOEING 787-8, JA804A
TAKAMATSU AIRPORT
AT 08:49 JST, JANUARY 16, 2013**

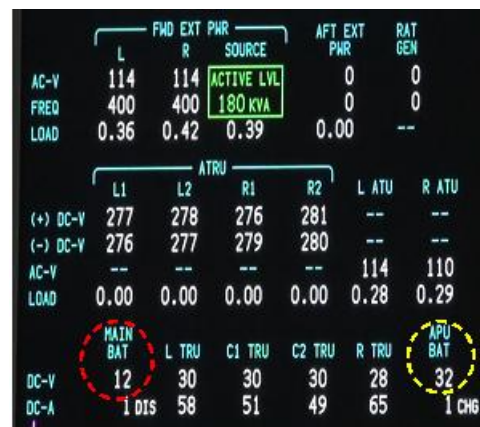
Fig. 2.11.1-2: APU Battery Sneak Voltage

With this circuit card installed, under voltage equilibrium between the APU battery and main battery, electric currents do not flow. However, with the absence of the main battery or lower voltage than that of the APU battery, the card circuitry allows the currents to flow from the APU battery to the main battery circuit even if the TOWING POWER switch is in OFF position and wingtip lights and fuselage-end light are illuminated.

In order to confirm this phenomenon on the airplane, the card was reinstalled and the main battery was removed. We confirmed the illumination of wingtip lights and fuselage end light, and the multi-function display (MFD) screen in the cockpit showed the main battery voltage of 12 V as shown in Fig. 2.11.1-2.

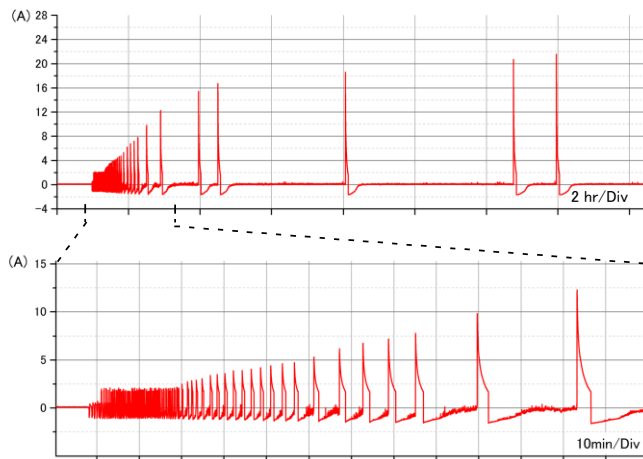
Fig. 2.11.3-2: Charging/Discharging at Short Cycle

charging/discharging in short cycle at the last portion of CV charging was observed as Fig. 2.11.3-2 illustrates when the CC charging shifted to CV charging.

Thales interpreted this phenomenon that it is out of design scope, but has

nothing to do with cell heat generation. It only shortens the cell life.

Boeing and GYT interpreted the phenomenon likewise that it has nothing to do with cell's thermal generation and it only shortens the cell life.

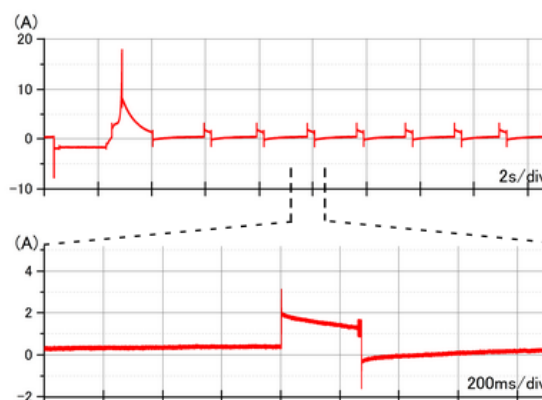
Fig. 2.11.6.1-1: Fluctuation of Charging Current

- a. Oscillating phenomenon of charging currents fluctuating from +3 A to -2 A was observed at the end of battery charging. This was identical to what observed during the battery-BCU integration test (see section 2.11.6.1).

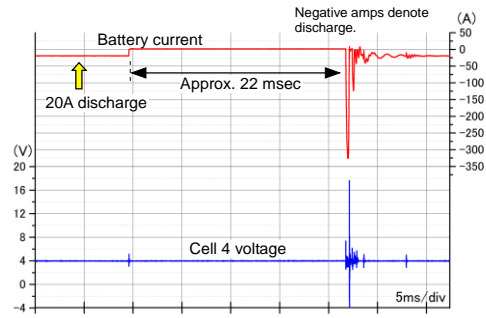
Fig. 2.11.6.1-2: High Transient Voltage

A current interruption of approximately 22 msec approximately 1 sec after the fulfillment of the contactor BIT criteria (see 2.6.5.3) was observed during a nominal APU start with engine-run conditions using the Boston event APU BCU.

Boeing comment on the phenomenon was: “The contactor opened as part of BIT operation resulting in a transient. As this test simulated an APU start under engine-run conditions and the battery BIT on actual airplane is conducted upon airplane powered up. Therefore, an actual airplane does not experience this phenomenon.”

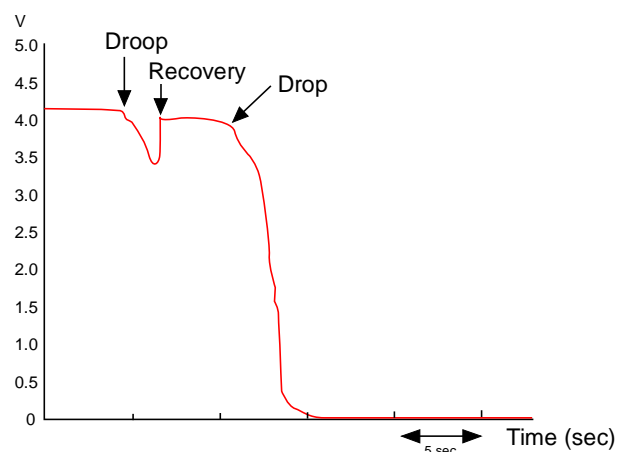
Fig. 2.11.6.3: Voltage Drop When a Cell Vented

Following the test above, this test was done to prove the theory that a short circuit from the case to the ground can cause a short circuit. 20 V was applied to cell 6 negative terminal and its case was grounded. The cell vented 40 hr later. The cell voltage data showed that the voltage dropped by 0.5 V from 4.2 V, recovered to approximately 4.0 V, then dropped to 0 V.

The voltage drop and subsequent recovery was later understood to be caused by an internal short circuit within one of the three windings within the cell, followed by fusing of the cathode current collectors on the affected winding. The final voltage drop to 0V was

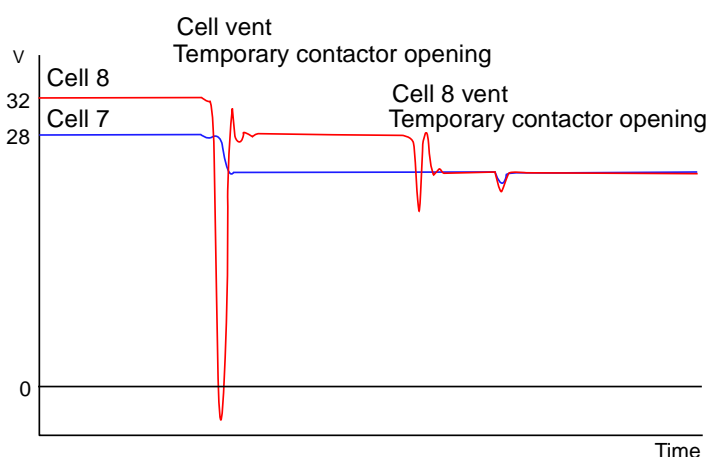
Fig. 2.11.6.5: Battery Voltage Fluctuation
(First test)

In the first test, cell 7 was heated with a heater blanket for forced venting. After the venting of the cell 7, temporal opening and closing of the contactor which was observed in the serious incident was also observed. When cell 8 vented, the contactor behaved the same way. When cell 8 physically contacted the battery box, J3 negative current exceeded 1,000 A, and the battery voltage dropped from 24 V to 5 V in approximately 4 sec.

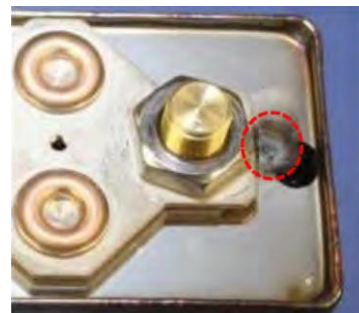
Fig. 2.11.6.9-1: Distinctive Hole

- a. Short circuit between cell case and battery box

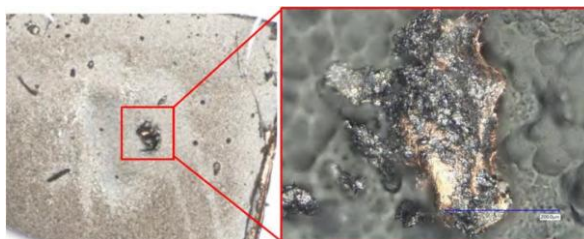
Fig. 2.11.6.9-2: Copper Particle Discovered on Separator

The copper current collector had a small copper piece penetrating through some layers of the separator. This feature was likely introduced during cell manufacturing and did not have an immediate effect on cell characteristics or performance. Over time, this feature could have penetrated additional layers of separators and created an internal short.

Over time, this feature could have penetrated additional layers of separators and created an internal short.

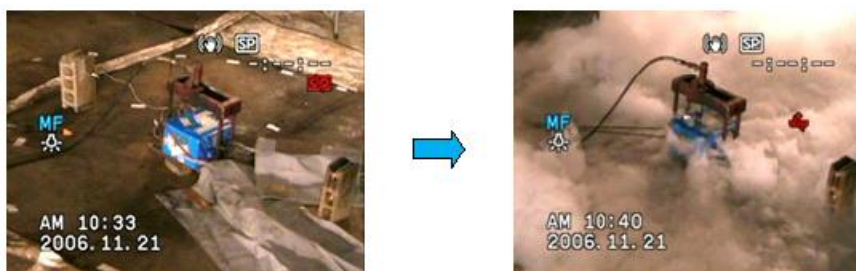
Fig. 2.12.7.1: Observed Smoke

In 2006, with consultations with Thales and Boeing, GYT conducted one of several battery nail penetration tests to assess the impact of an internal short circuit. The test configuration was: nail penetration to cell 2, without connecting wire to the BCU for charging/discharging, and without battery box ground wire, under non-controlled ambient temperature. The penetrated cell vented with smoke without generating smoke. No other cells vented.

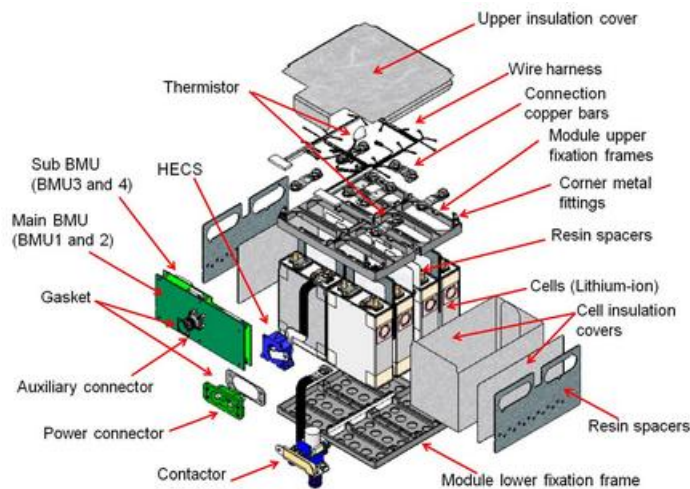
Fig. 2.13.1.2: Battery Assembly

Fig. 2.13.1.2 illustrates internal parts used for a battery construction. All assembly is done manually. Lower fixation frames are placed on the battery box floor. Cells are placed on them facing each safety valve oriented to the box side wall. Spacers are inserted between the cells. Top fixation frames are placed on the cells and bolted to the brace bar. Busbars, thermo-sensors are connected to the cells. The BMU, contactor, and HECS are installed in the box to finalize the battery construction. The battery goes through AC/DC resistance check and ATP.

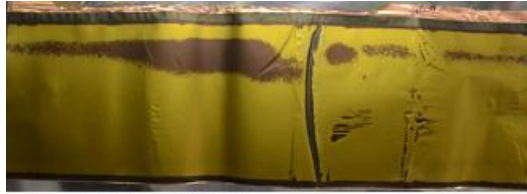
Fig. 2.13.2-1: Wrinkles of Anode Graphite during Narita Event Investigation

In the investigation lead by the Civil Aviation Bureau of Japan (JCAB), remaining cells were dismantled under 100% SOC condition. The examination revealed wrinkles on anode graphite.

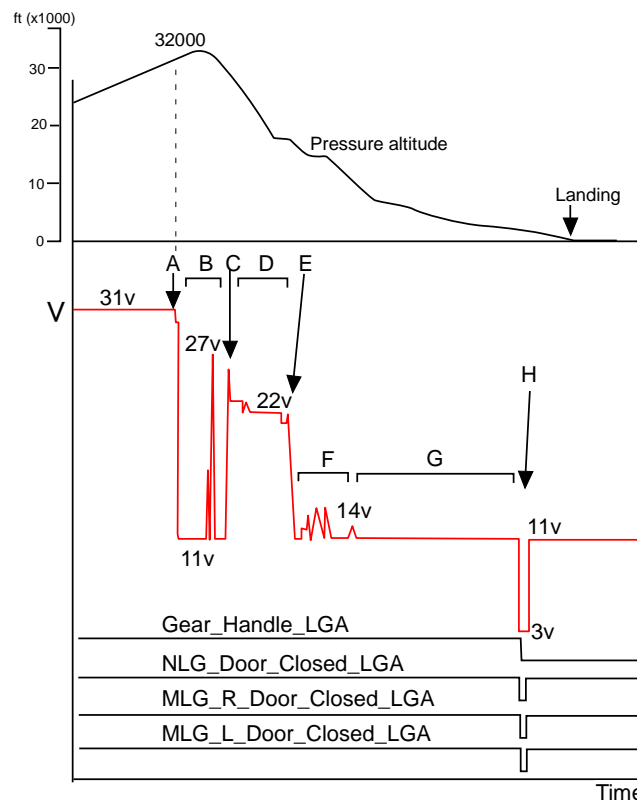
Fig. 3.8.3-1: Battery Voltage Fluctuation during Takamatsu Event

Main battery voltage dropped from 31 V to 30 V. It is very likely that a cell experienced an internal short circuit (see section 3.10) which resulted in rapid cell heating and case swelling and subsequent venting during this drop. As described in section 3.8.1 b., cell 6 was the very likely cell as the initiator. Plastic insertions around cell 6 melted due to cell heat generation.

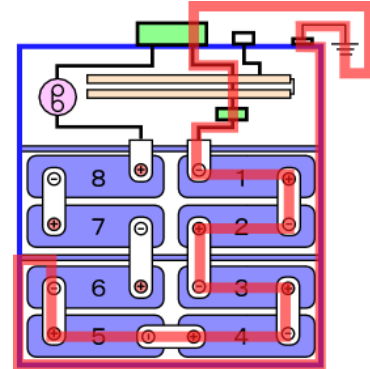
Fig. 3.8.3-2: Short Circuit Path

Recorded 26 V implies possibility of contactor closing and a short circuit of the second cell. The voltage drop to 23 V suggests the possibility of the venting of the second cell. Cell 5 was not vented as described in section 2.8.3 e and Kakuda testing demonstrated that the second venting cell was the cell located next to the S1 or S3 of the venting cell. In light of these facts, the second vented cell was probably cell 7.

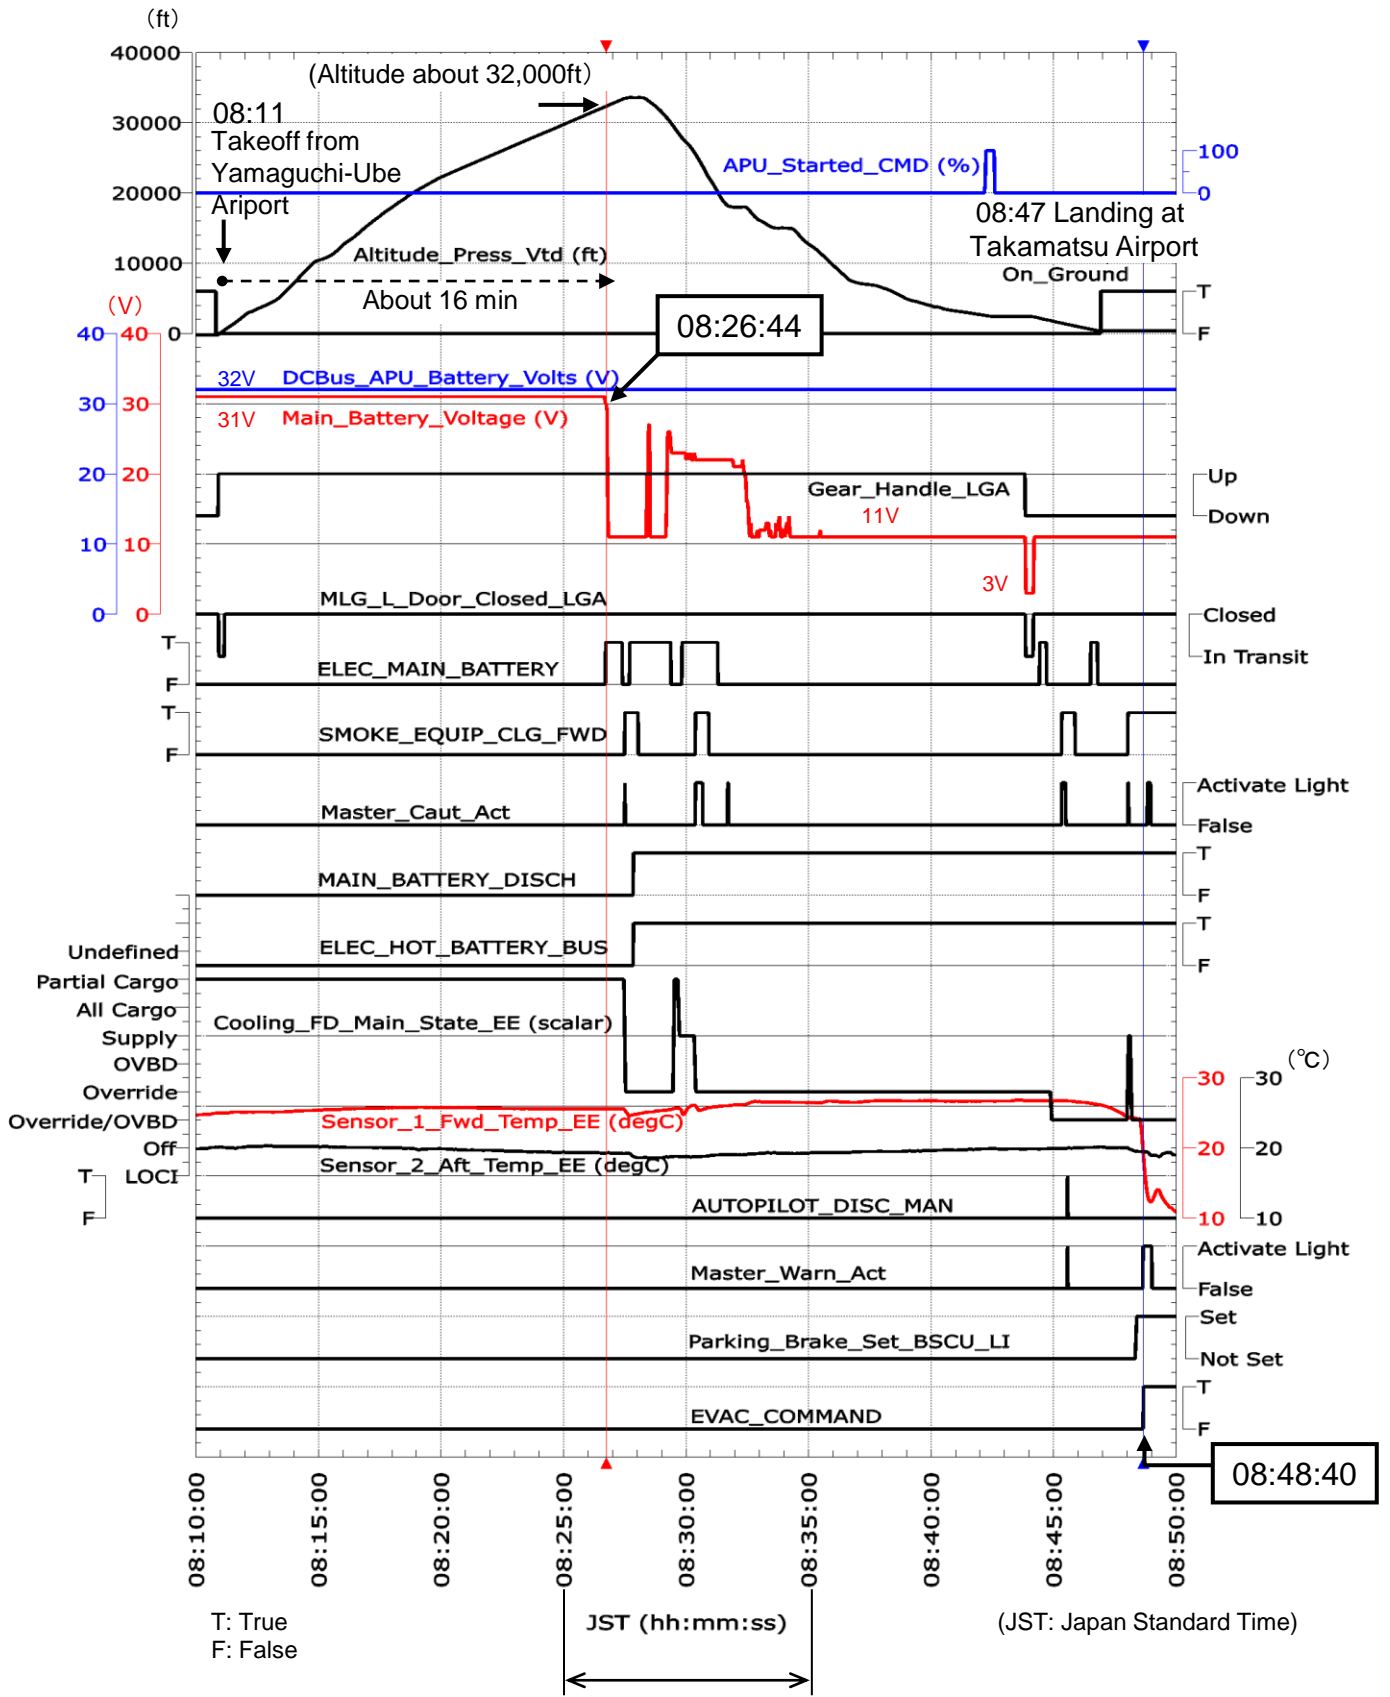
Figure 2: FDR Records

As shown in Figure 2: FDR records, the smoke ventilation system started to function after the main battery voltage dropped. It is highly probable that the system operated as designed. The smoke was extracted overboard through the override valve and forward outflow valve, but part of it was sucked in from the cabin air compression inlet, forwarded to the cockpit and cabin to be sensed.

Over-discharging accompanies voltage decrease; however, the FDR records in Figure 2 showed no main battery voltage decrease. This fact demonstrates the absence of over-discharging at battery level.

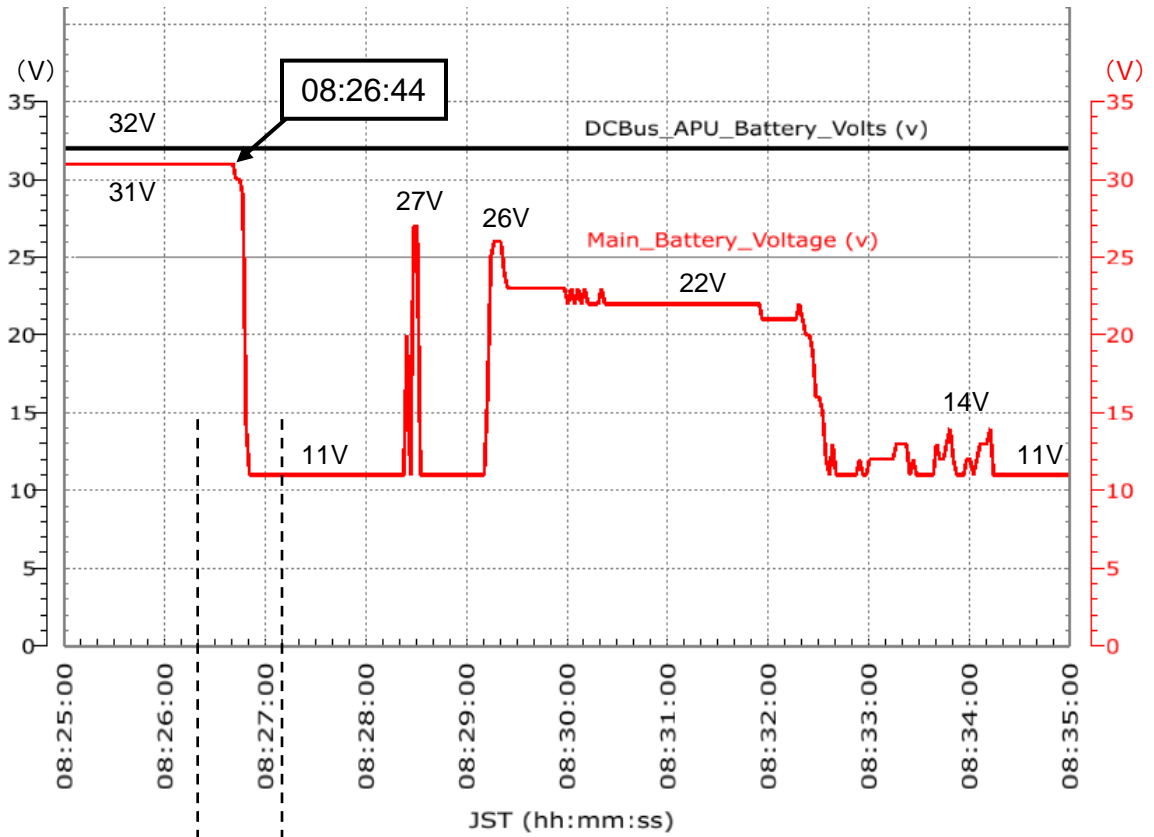
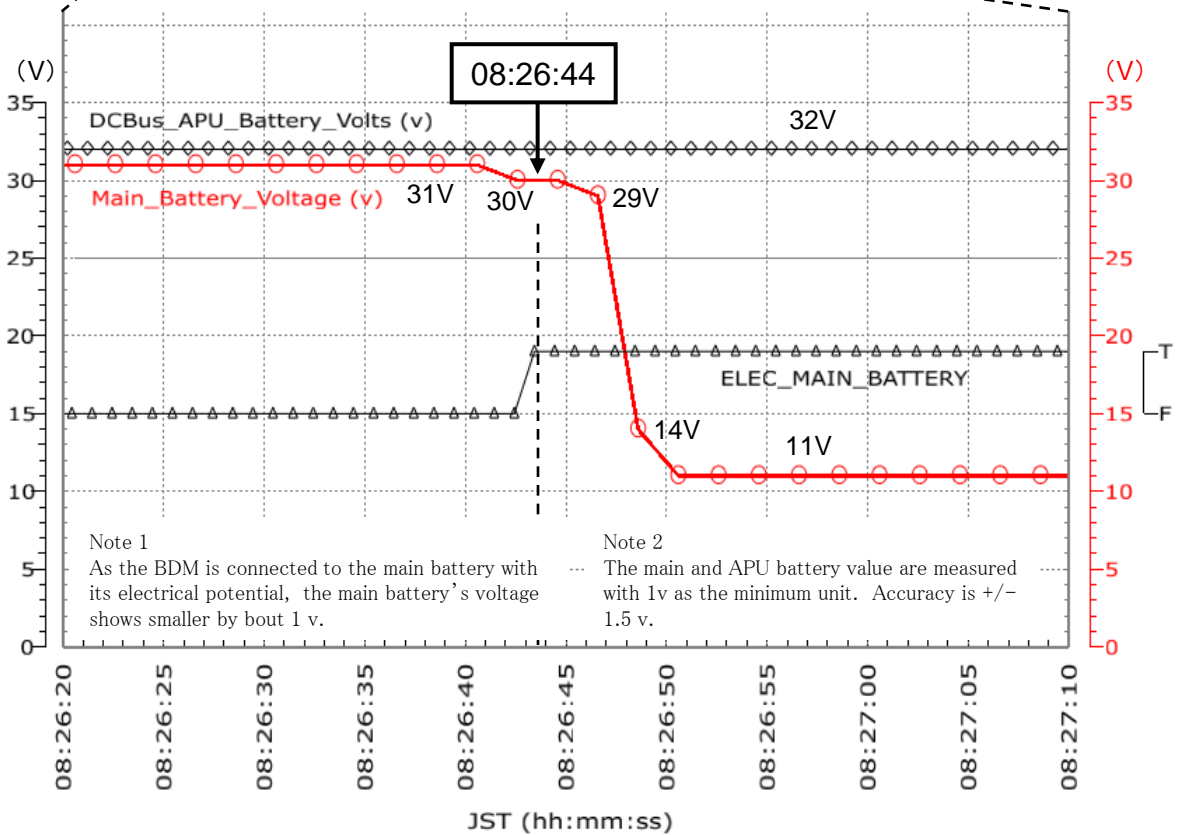
Figure 3: Battery Voltage Fluctuation

The FDR battery voltage fluctuation depicted in Figure 3 illustrates that the voltage dropped from 29 V to 14 V in 2 sec, followed by another drop to 11 V in 2 sec. The actual main battery voltage at the time when FDR recorded main battery voltage as 11 V was very likely less than 11 V as described in section 3.6. The possible causes for voltage drop are as follows:

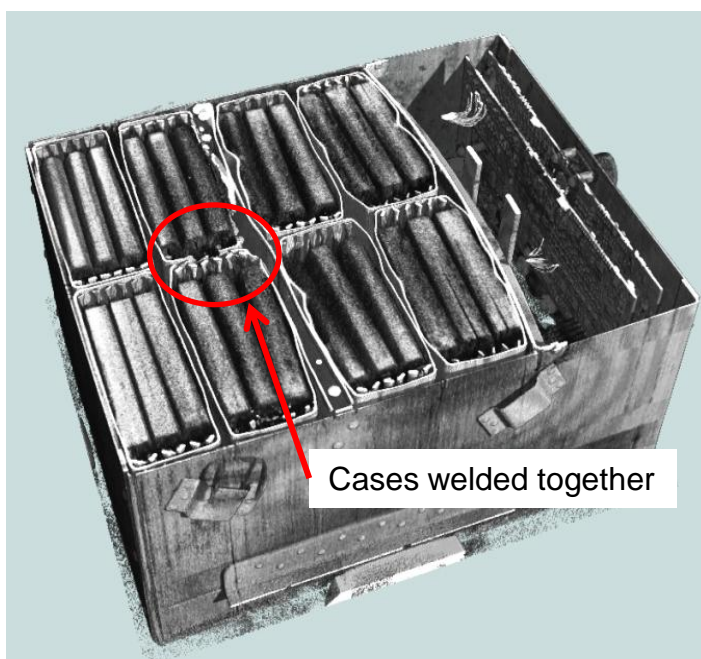
Figure 8: CT Scan Image

CT-scanning of cells except cell 6 revealed that the amount of cell electrolyte differed from cell to cell.

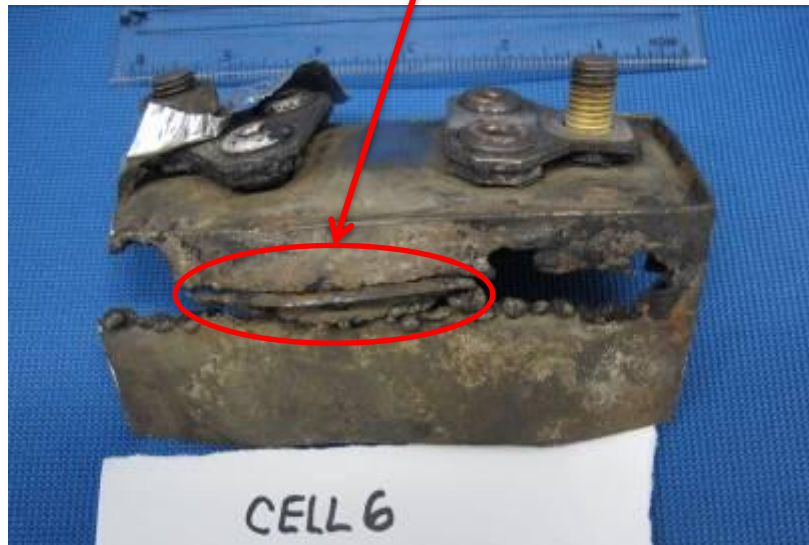
Part of this portion was welded to the cell case.

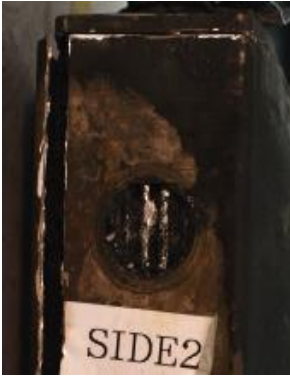
Cell 1: Open

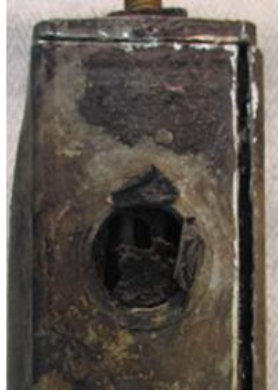
Cell 2: Open

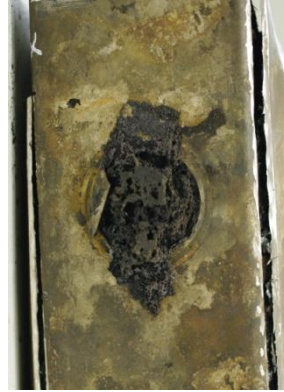
Cell 3: Open

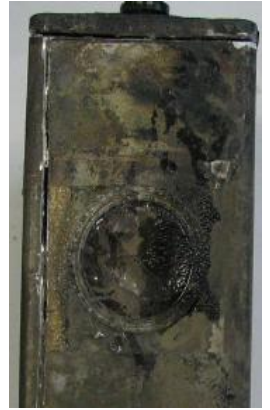
Cell 4: Close

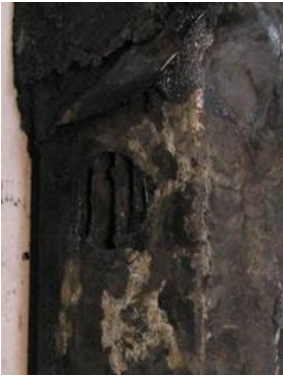
Cell 8: Open

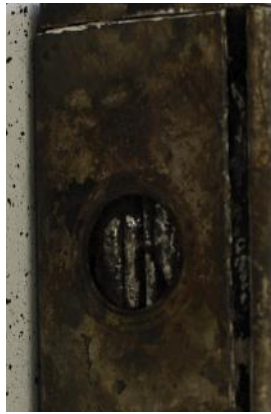
Cell 7: Open

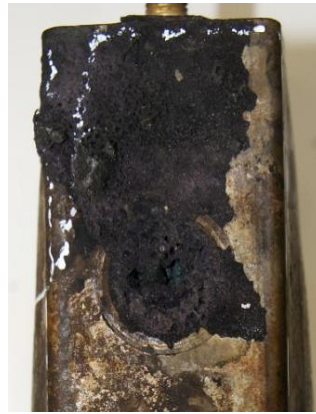
Cell 6: Open

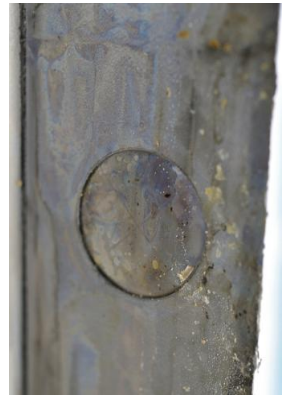
Cell 5: Close

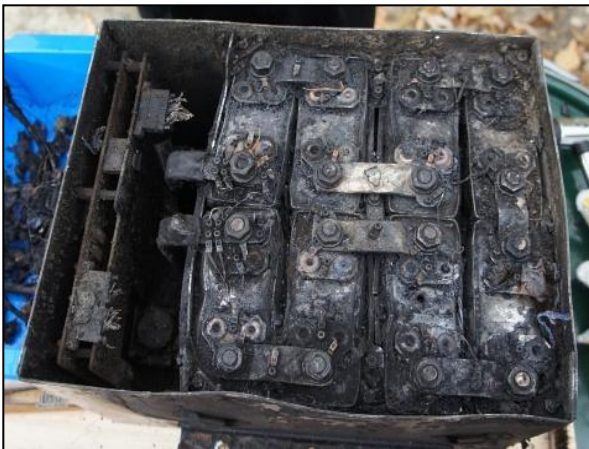
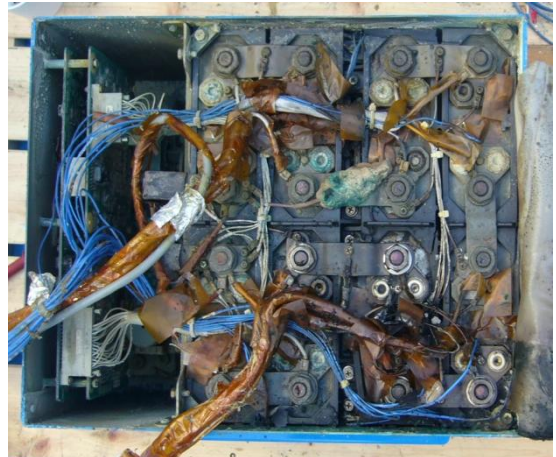
Figure 7: Damage to Current Collectors

Config. 2

Config. 3

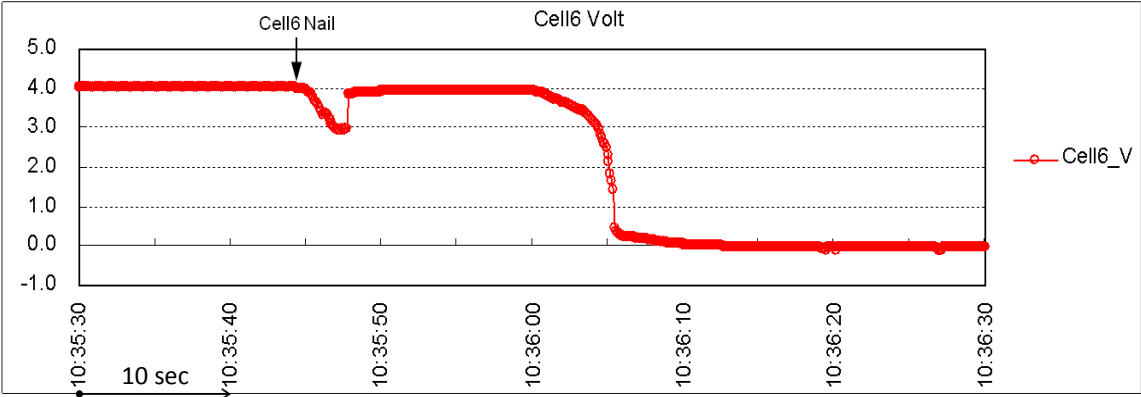
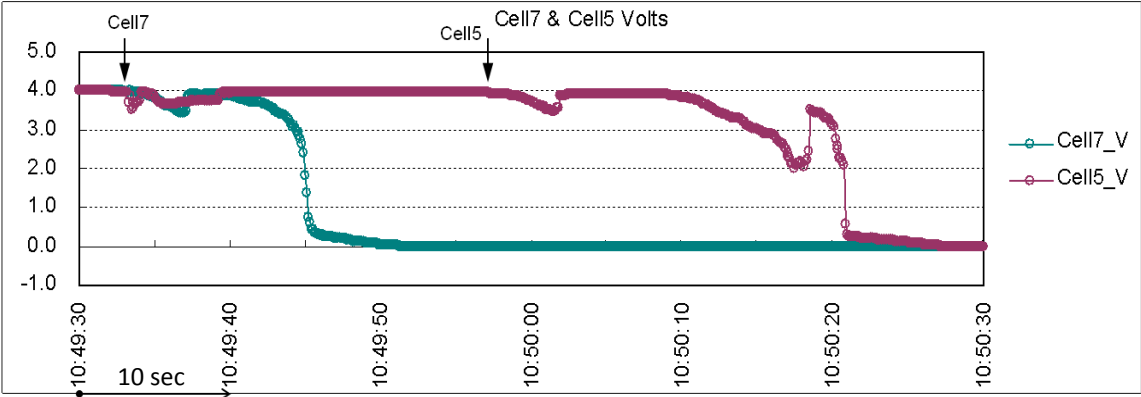
Figure 11-1: Fluctuations of Cell Voltage and Ground Wire Current (Configuration 2)

As described in section 2.11.5.b, and the records in Figure 11-1: Detailed cell voltage drop (Configuration 2), Appendix 2 illustrates, cell internal pressure increased and it vented right after the internal short circuit occurred. The cell voltage temporally dropped by approximately 1 V, recovered to 4 V and finally dropped to 0 V.

As described in the section 2.11.5 b. and the Figure 11-1: “Fluctuations of Cell Voltage and Ground Wire Current” in Appendix 2, approximately 1,000 A of ground wire currents were recorded approximately 30 sec after the cell 6 venting. This indicates that the concurrent physical contact between the swollen cell 6 and the brace bar. At this stage, it is very likely that the failed cell itself was transformed into a combined conductor which contains all the shorted windings and melted resin sheets wrapping each winding, as described in section 3.7.1. The short circuit with the battery box very likely caused both terminals of cell 6 to have equal electric potential with the ground; however, no battery voltage drop is recorded in the test. As described in the section 2.11.6.5, the battery voltage drop during ground wire high currents was observed in the battery vent test performed by Boeing. It was very likely caused by the mechanism in which shorted point to the battery box became the ground voltage potential.

As described in the section 2.11.5 b. and the Figure 11-1: Fluctuations of Cell Voltage and Ground Wire Current” in the Appendix 2, it is very likely that around the time when cell 7 vented, internal short circuit in the cell, caused by heat propagation from cell 6, increased its internal pressure causing the case to swell. Swollen cell 7 very likely pushed the brace bar towards cell 6, reestablishing short circuit path allowing high currents to run through the ground wire. The timing of the contact coincided with 1,630 A of currents through the wire just after cell 7 venting. The next high current jump to 1,010 A coincided with bursts of flames preceded by sputtering sound. This demonstrates that the ground wire fused at the timing of the second current jump.
