AIRCRAFT SERIOUS INCIDENT INVESTIGATION REPORT

JAPAN AIRLINES INTERNATIONAL CO., LTD.

BOEING 747-400, JA8072

MAY 8, 2005

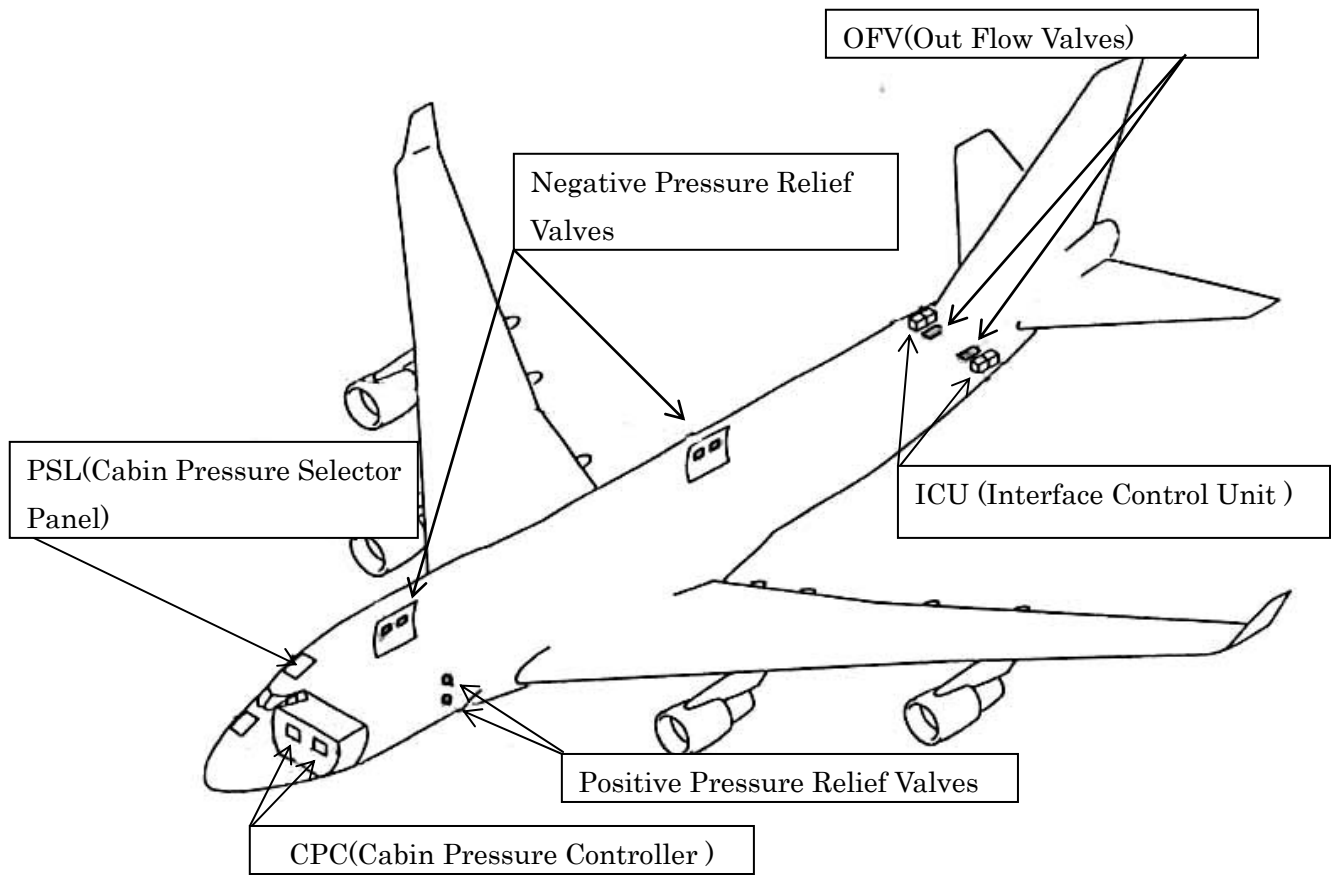
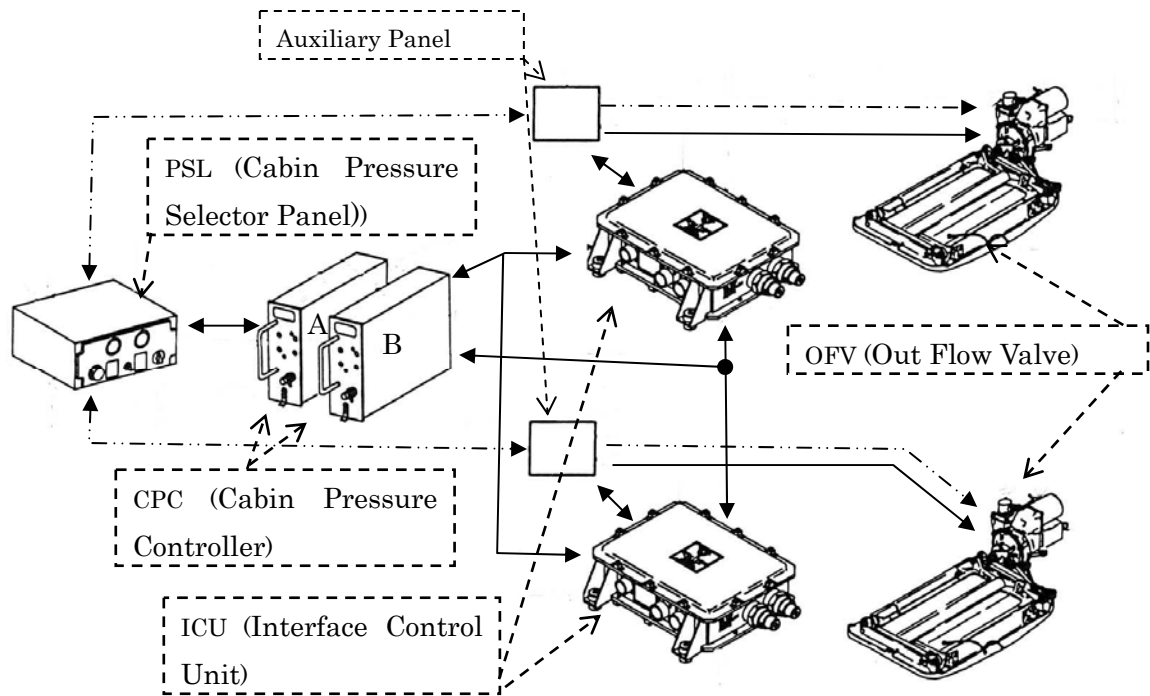
Figure 4 Cabin Pressure System Outline

Pillows were found on the wire meshed cover for the LH OFV under the floor in the aft fuselage. A passenger’s small bag was found between the RH outer skin of the fuselage and the inner lining.

(See Figure 4 and Photo 4.)
