AA2023-7

**AIRCRAFT ACCIDENT
INVESTIGATION REPORT**

**Solaseed Air Inc.
J A 8 0 7 X**

CABIN CREW MEMBER INJURY BY SHAKING OF THE AIRCRAFT SOLASEED AIR INC. BOEING 737-800, JA807X AT AROUND FL260 OVER ABOUT 120 KM SOUTHWEST OF NAHA AIRPORT AT ABOUT 08:37 JST, JULY 16, 2022

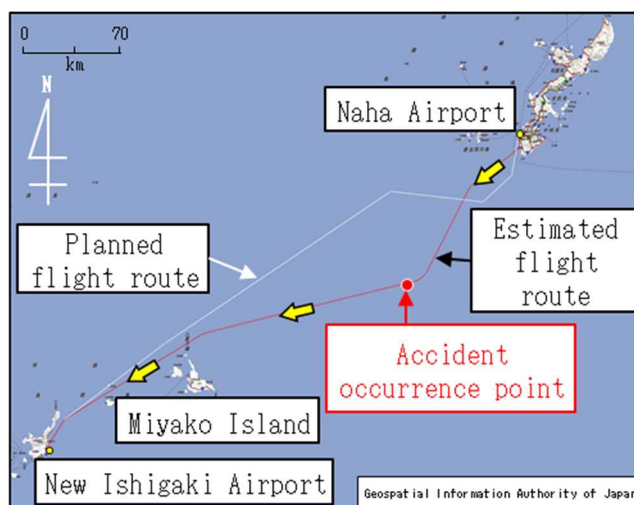
Figure 1 Estimated Flight Route

As visually recognizing developing clouds on its flight path after the take-off, the PIC changed the heading from 240° to 215° with a clearance from the ATC, and continued to climb. At about 08:30, the PIC confirmed the weather conditions visually as well as by using the airborne radar, and found that there was neither developing cloud on the flight path nor turbulence, therefore turned off the seat belt sign.

In order to head for the flight route on the original flight plan, the aircraft changed the heading with a clearance from the ATC at 08:35:28. At 08:35:50, the aircraft reached the cruising altitude of FL260. After changing the heading, despite of the ongoing unshaking conditions, the PIC thought that there was no cumulonimbus ahead and a clear sky was seen, but the clouds, which had been visually recognized approx. 2,000 ft below, were flat at the apex, neither like cumulonimbus clouds in shape nor seemingly going to develop, but seemed to be close enough to be sensible. Therefore, the PIC thought of going to secure sufficient altitude difference by climbing from FL260 to FL280 in order to ensure the safety. The aircraft commenced climbing with a clearance from the ATC at 08:36:25, but the clouds, which had seen below just moments before, were developing on the flight route when the aircraft started climbing, and looming directly below the aircraft. At 08:36:41, the moment the aircraft passed over the developing clouds at close range, the shaking as if to hold his body down occurred.

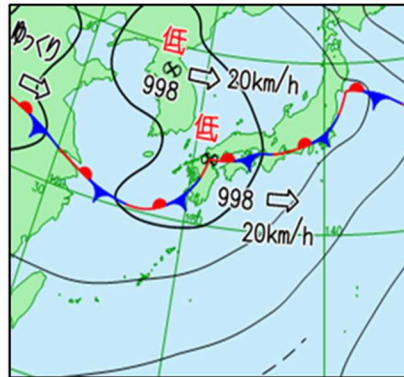
Figure 4: Preliminary weather chart at 09:00 on July 16, 2022 (Excerpt)

2.6 Meteorological Information	<p>(1) Weather Conditions in Airspace the Accident Occurred</p> <p>According to the preliminary weather chart (Figure 4) as of 09:00 on July 16, 2022, there was a low pressure in the north part of the Kyushu region, a stationary front was extending to the East China Sea. Developed convection cloud *5 zones were scattering near the Nansei Islands located on the south side of the front. And the Domestic Significant Weather Analysis Chart valid at 06:00 on July 16, 2022 (Figure 5) showed that the cumulonimbus clouds with a cloud top altitude reaching the vicinity of FL 430 were moving toward the east-northeast over the sea southeast of Miyako Island.</p> <p>According to the Domestic Significant Weather Prognostic Chart at 09:00 on July 16, 2022 which the PIC had confirmed in the pre-flight briefing (Figure 6), significant weather was not forecast in the relevant airspace.</p> <p>According to the meteorological satellite image (visible) as of 08:35 (Figure 7), the vicinity of the accident occurrence point is located on the northeast of the developed convection cloud zone. Based on the echo top height of radar echo composite chart, the cloud top height in the vicinity of the accident occurrence point changed at 08:30 from a dark green color indicating 5 to 6 km (FL164 to FL197) (Figure 8), at 08:35 to a yellow green color indicating 8 to 9 km (FL262 to FL295) (Figure 9), and at 08:40 after the aircraft had passed to a yellow color indicating 9 to 10 km (FL295 to FL328) which partially changed up to a pink color indicating 11 to 12 km (FL361 to FL394) (Figure 10). In addition, according to the radar echo</p>
