**AIRCRAFT ACCIDENT
INVESTIGATION REPORT**

**ORIENTAL AIR BRIDGE CO., LTD.
J A 8 4 5 A**

August 25, 2022

**DAMAGE TO AIRFRAME FROM TAIL STRIKE
ORIENTAL AIR BRIDGE CO., LTD.
BOMBARDIER DHC-8-402, JA845A
FUKUE AIRPORT, NAGASAKI PREFECTURE, JAPAN
AT 09:24:32, OCTOBER 23, 2020**

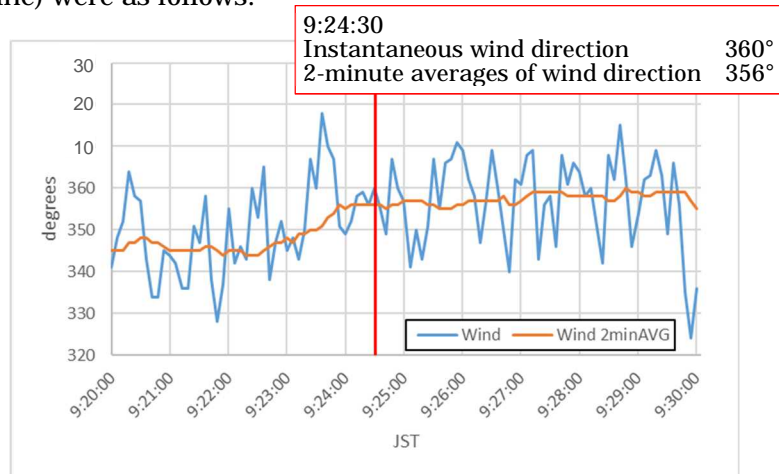
Figure 2 Wind direction

Wind direction and velocity around the time of the accident occurrence observed (at 6-second intervals) by the wind vane/anemometer installed near the aiming point marking on Runway 03 (about 320 m from the inside of the runway threshold, about 70 m east-southeast of the runway centerline) were as follows:
