AIRCRAFT ACCIDENT
INVESTIGATION REPORT

JAPAN AIRLINES FLIGHT 706
McDONNELL DOUGLAS MD-11, JA8580
OVER SHIMA PENINSULA, JAPAN
JUNE 8, 1997

December 17, 1999

AIRCRAFT ACCIDENT INVESTIGATION COMMISSION

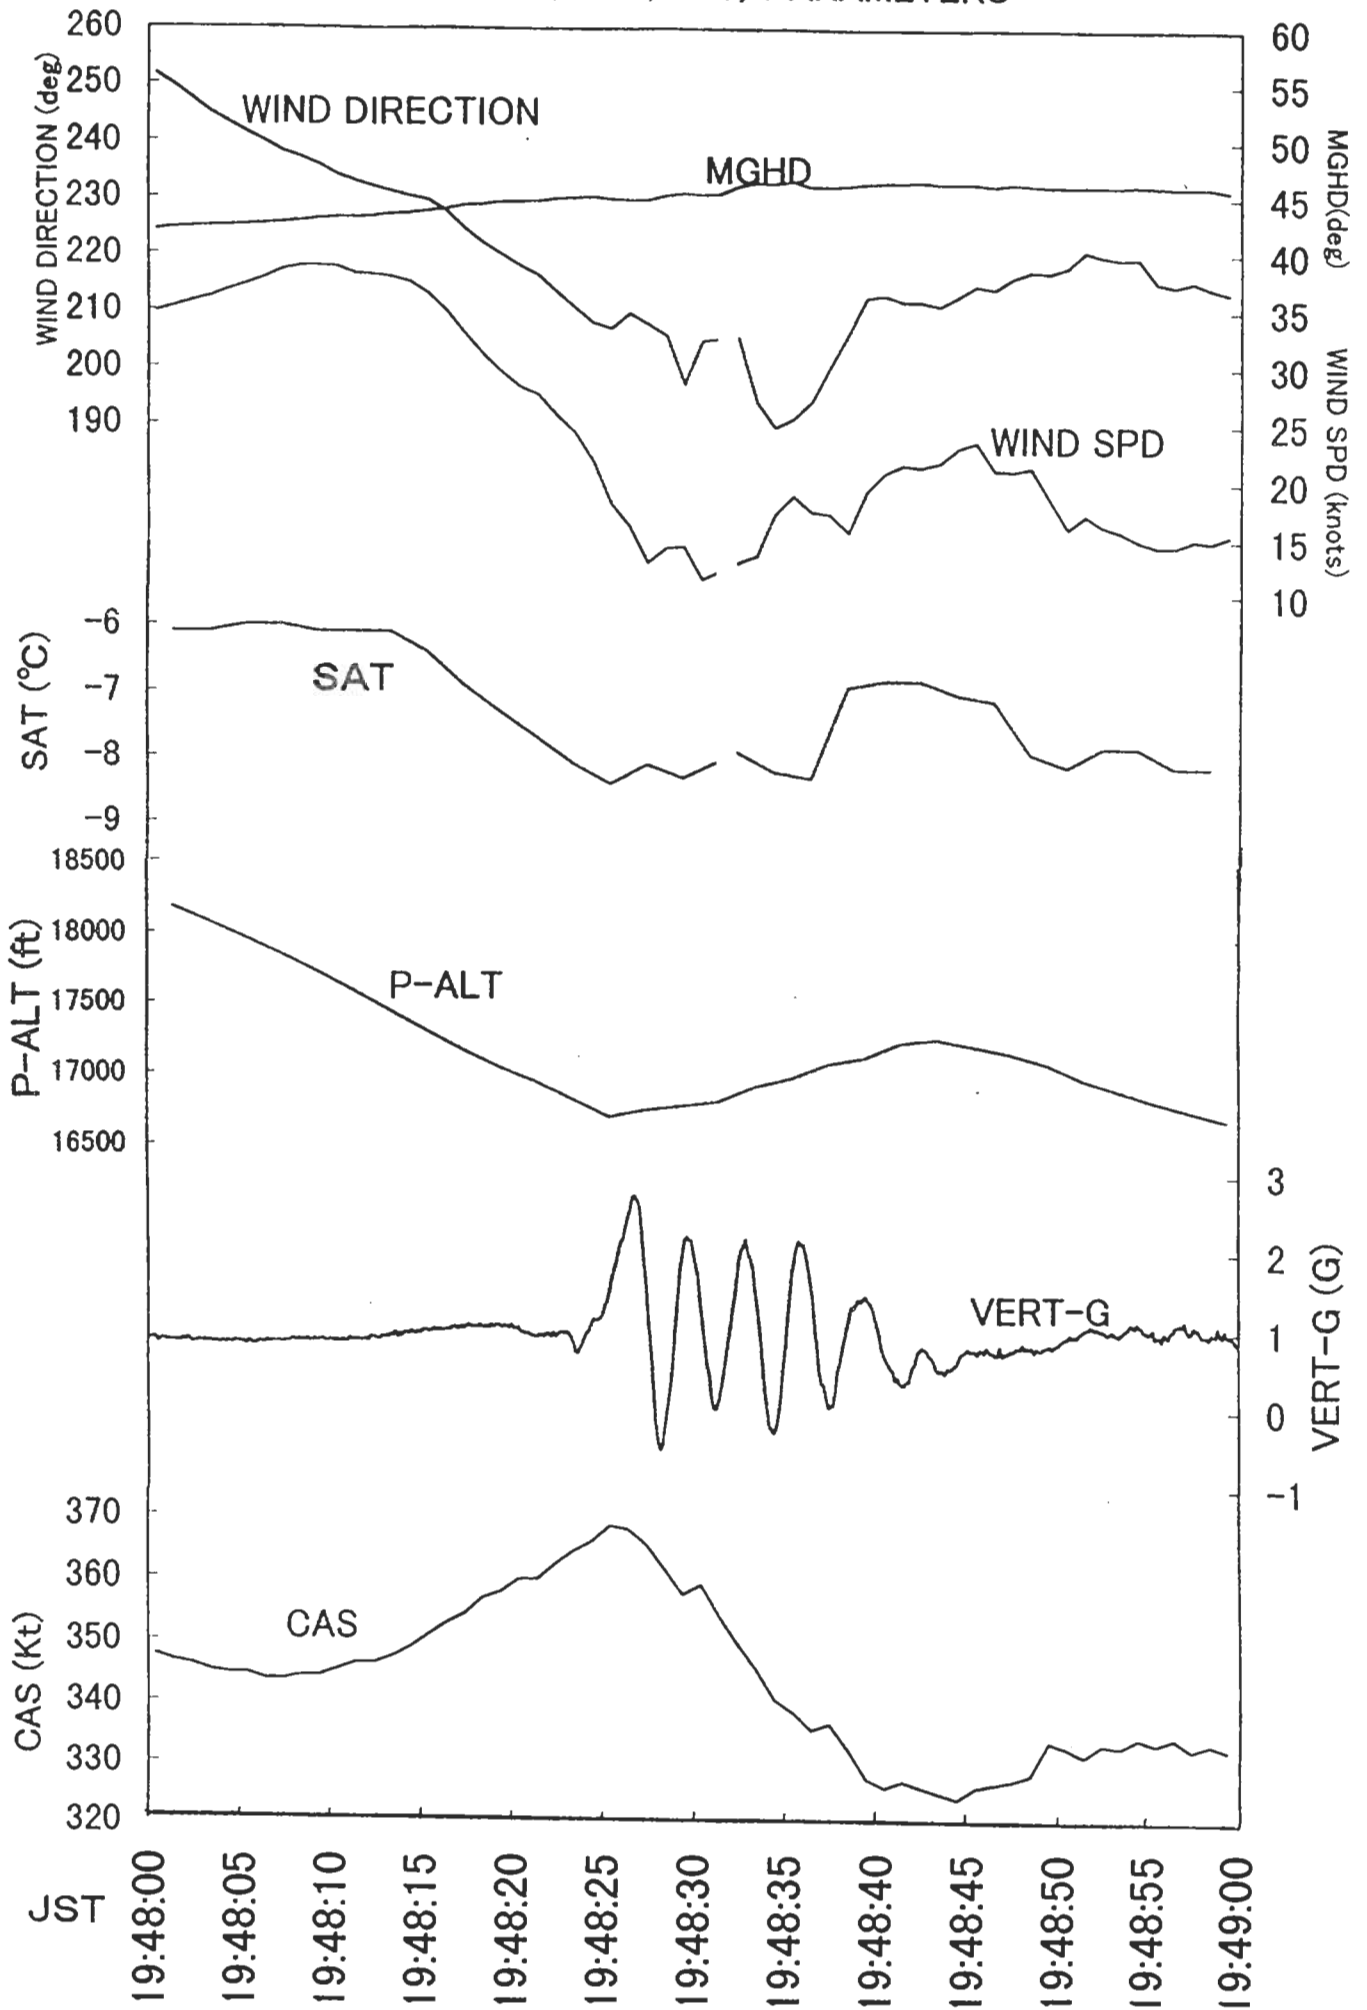
DFDR & ADAS (WIND, SAT) PARAMETERS

The Figure shows that the tail wind once increased and then decreased rapidly, which equals to the fact that the head winds increased against the aircraft. The rate of variations in the wind speed reached approximately 1.7~2.8 knots/sec. It is estimated that the rapid changes in the wind speed resulted in the abrupt increase in the CAS.
