**AIRCRAFT ACCIDENT
INVESTIGATION REPORT**

J A 9 6 3 5

**CRASH DURING CARGO TRANSPORT
WITH UNDERSLUNG EXTERNAL CARGO
INTO THE MOUNTAIN SLOPE
AERO ASAHI CORPORATION
AEROSPATIALE AS332L (ROTORCRAFT), JA9635
NEAR KIGENSUGI CEDAR TREE
YAKUSHIMA-TOWN, KUMAGE-GUN
KAGOSHIMA PREFECTURE
AT ABOUT 07:50 LOCAL TIME, SEPTEMBER 26, 2010**

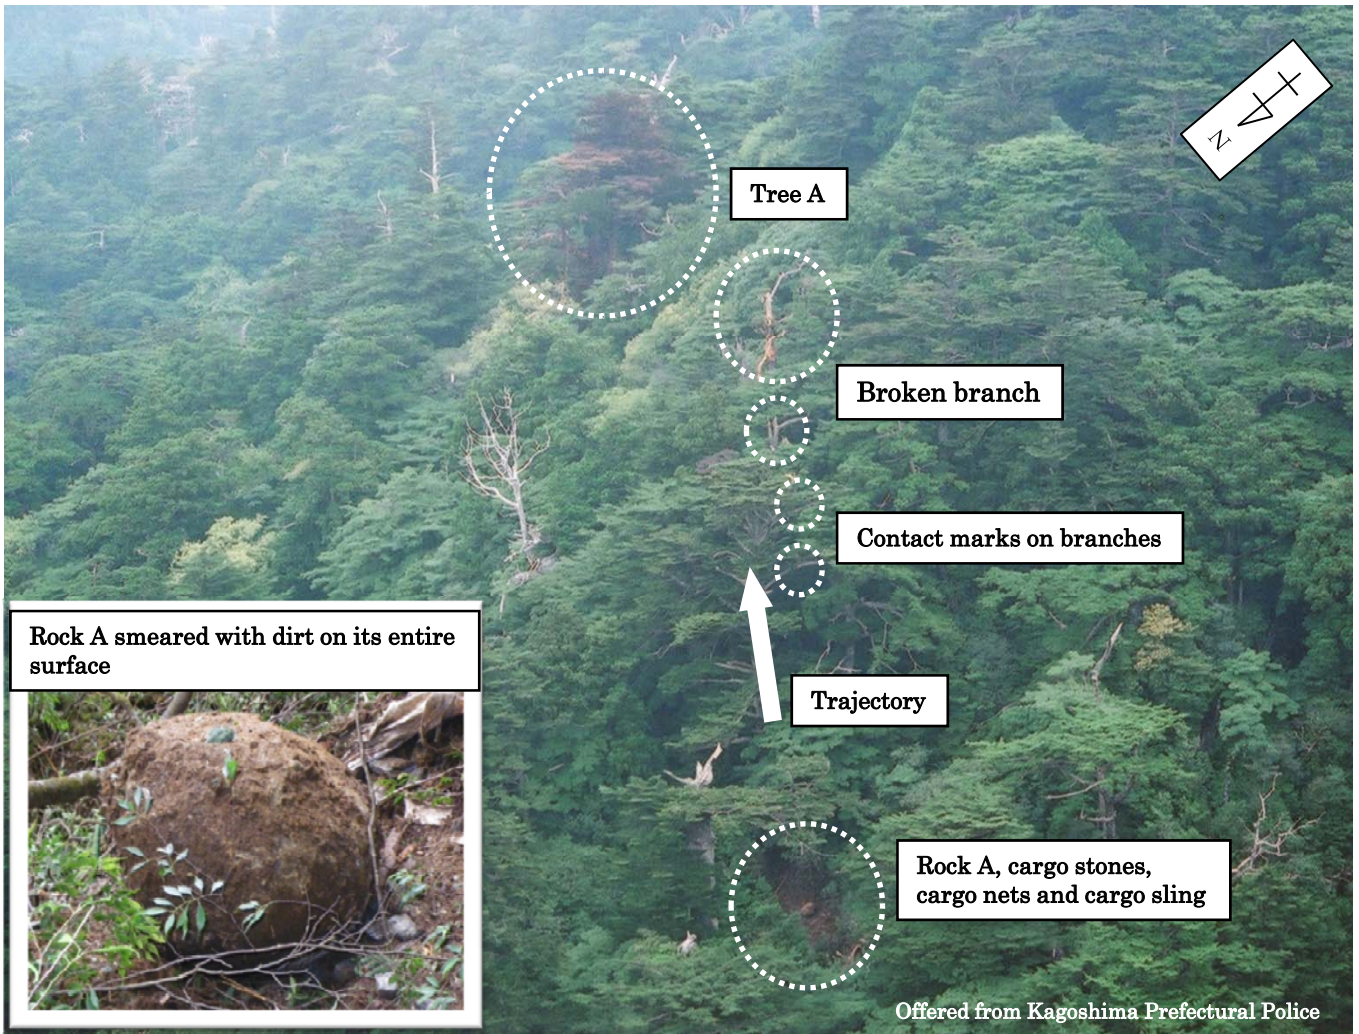
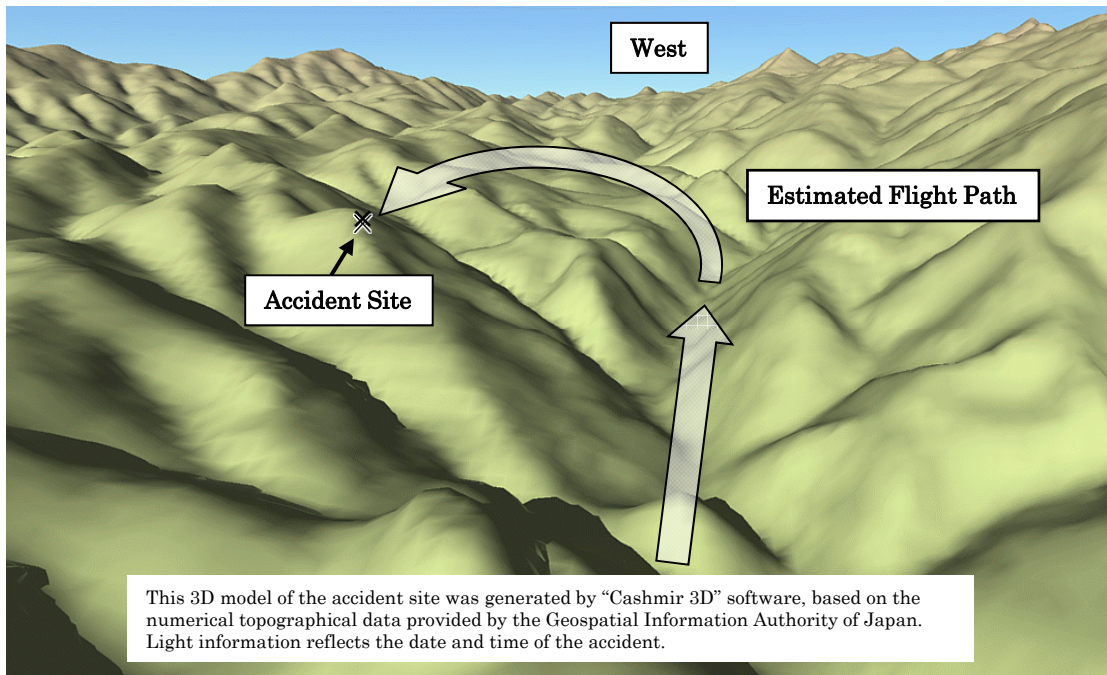
Figure 3: Aerial Photo of Accident Site and Terrain Features (3D Image)

※ Tall trees densely grow on the slope.

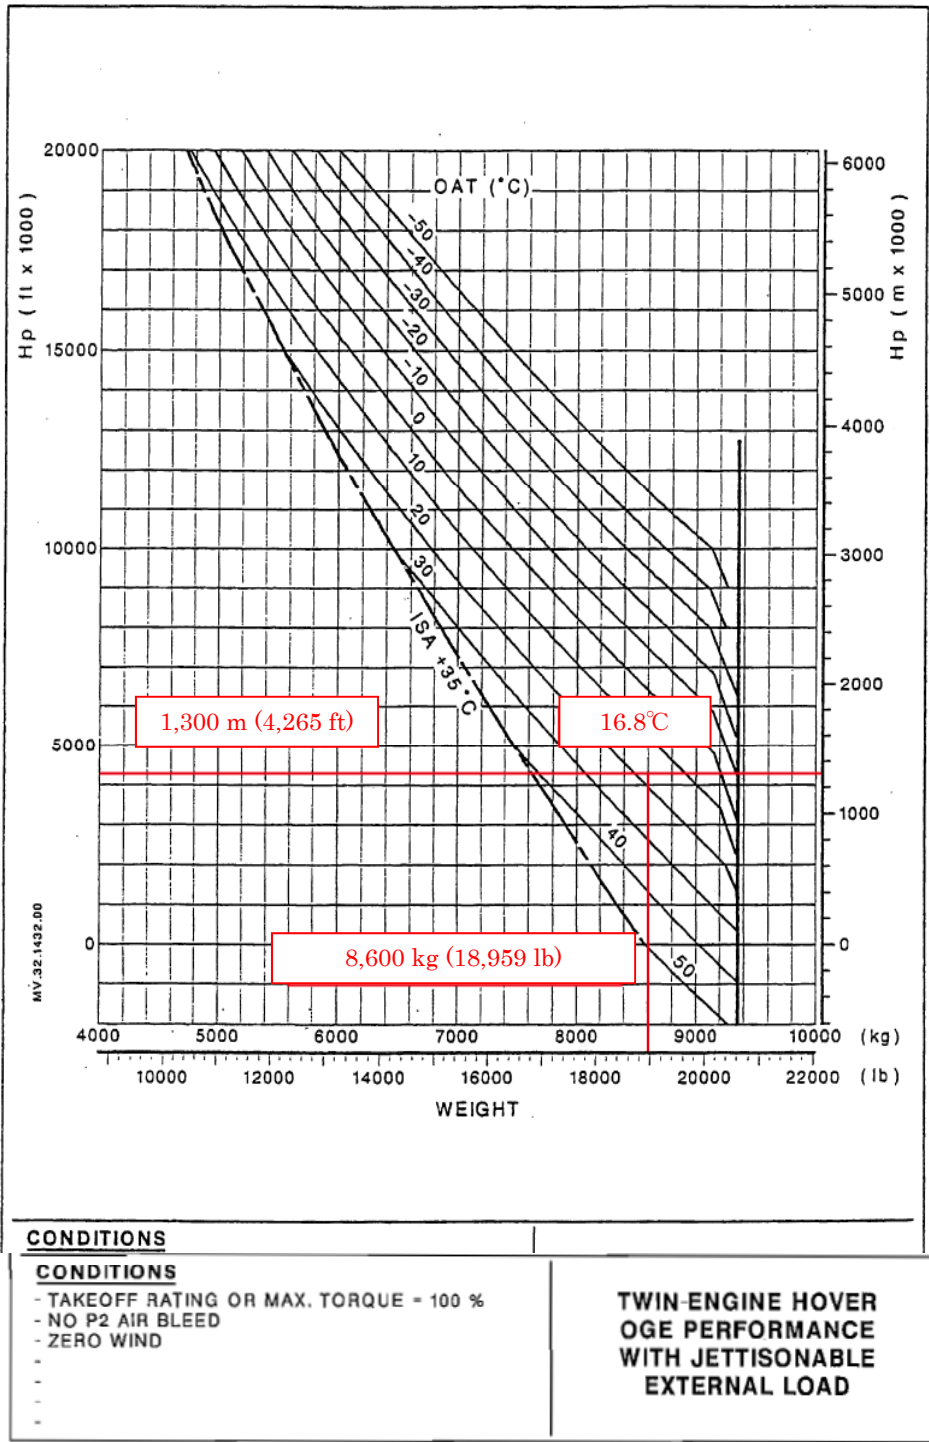
- Absolute maximum weight: 9,350 kilograms (20,610 pounds)*
- Modifications to the weight determined by altitudes and temperatures are given in SECTION 5.1 and in Figure 2 of the present supplement.*

TRANSPORT OF EXTERNAL LOADS
4,500 kg (9,920 lb)
