AI2012-4

**AIRCRAFT SERIOUS INCIDENT
INVESTIGATION REPORT**

**EVERGREEN INTERNATIONAL AIRLINES, INC.
N 4 8 2 E V**

**EVERGREEN INTERNATIONAL AIRLINES, INC.
BOEING 747-200 (CONVERTED FREIGHTER MODEL), N482EV
ABOUT 4 NM SOUTHWEST OF
CHUBU CENTRAIR INTERNATIONAL AIRPORT, JAPAN
AROUND 06:03 JST, NOVEMBER 28, 2010**

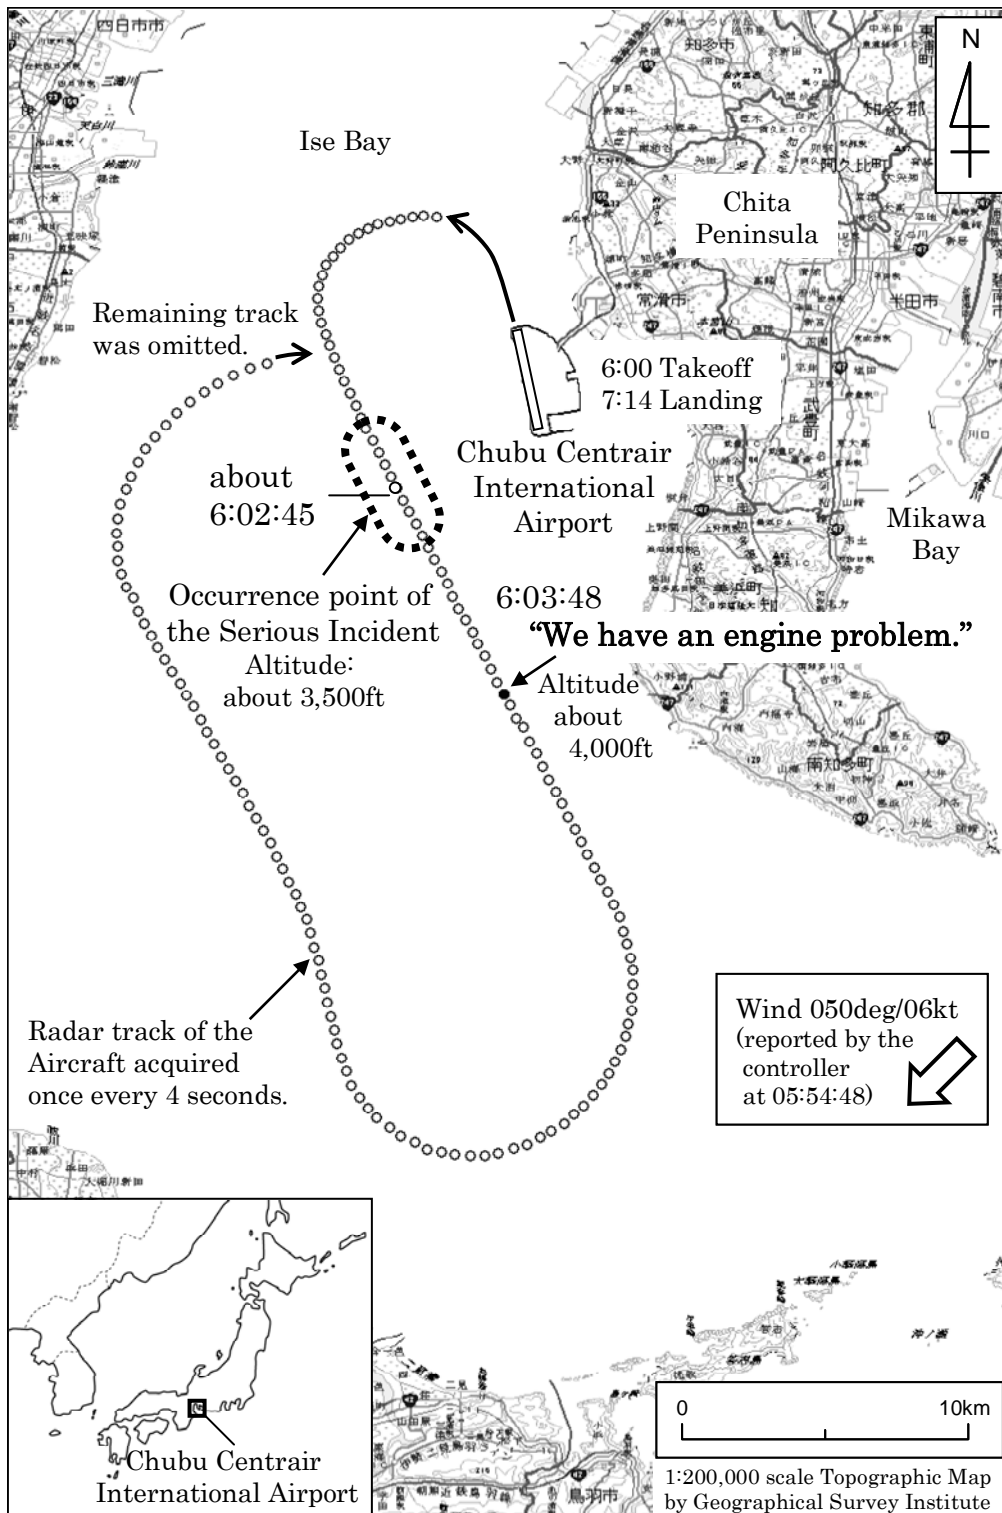
Figure 1 Estimated Flight Route

This serious incident occurred around 06:03 at an altitude of about 3,500 ft about four nautical miles southwest of the Airport (about 34°49' N and 136°45' E). (See Figure 1 Estimated Flight Route, Figure 2 Estimated Aircraft Altitude derived from Radar Tracking Records, Photo 1 Serious Incident Aircraft, Photo 3 Damage to the Aircraft, Photo 4 Damage viewed from Engine Exhaust, Attachment ATC Communications)

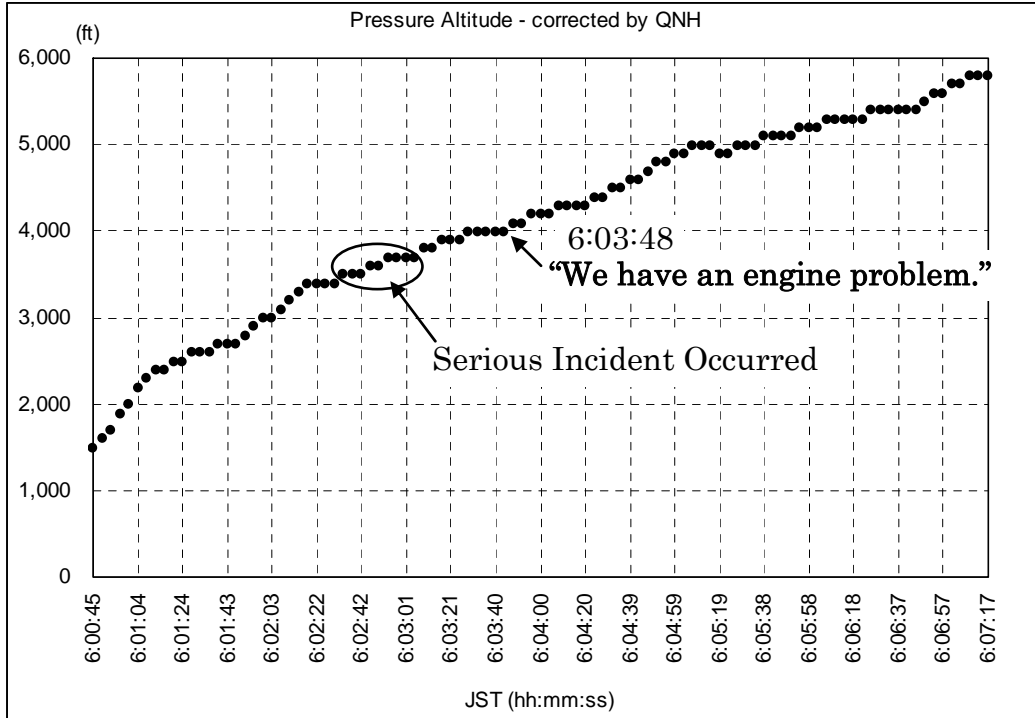
Figure 2 Estimated Aircraft Altitude
derived from Radar Tracking Records

The data of pressure altitude based on a Secondary Surveillance Radar was corrected by QNH.
