**AIRCRAFT ACCIDENT  
INVESTIGATION REPORT**

**PRIVATELY OWNED  
N 7 0 2 A V**

## CRASH DUE TO LOSS OF CONTROL DURING FLIGHT PRIVATELY OWNED SOCATA TBM700, N702AV IN YAMAZOE VILLAGE, YAMABE-GUN, NARA PREFECTURE AT AROUND 12:15 JST, AUGUST 14, 2017

June 14, 2019

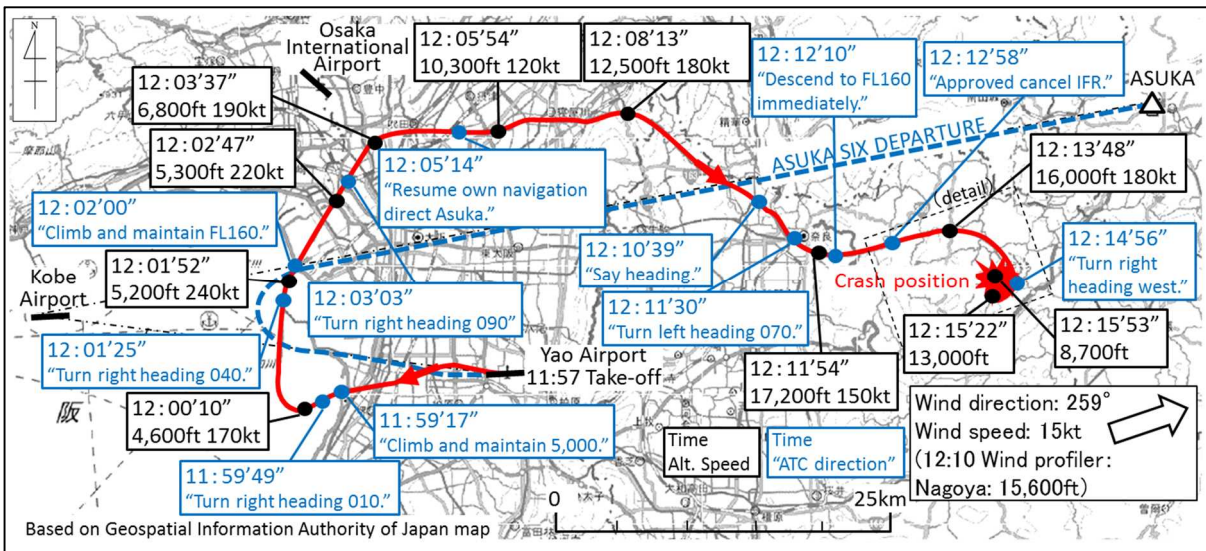
Figure 1: estimated flight route

According to the radar track records for air traffic control at Kansai Aerodrome control tower, the estimated flight route of the Aircraft after the take-off until the crash is as shown in Figure 1.

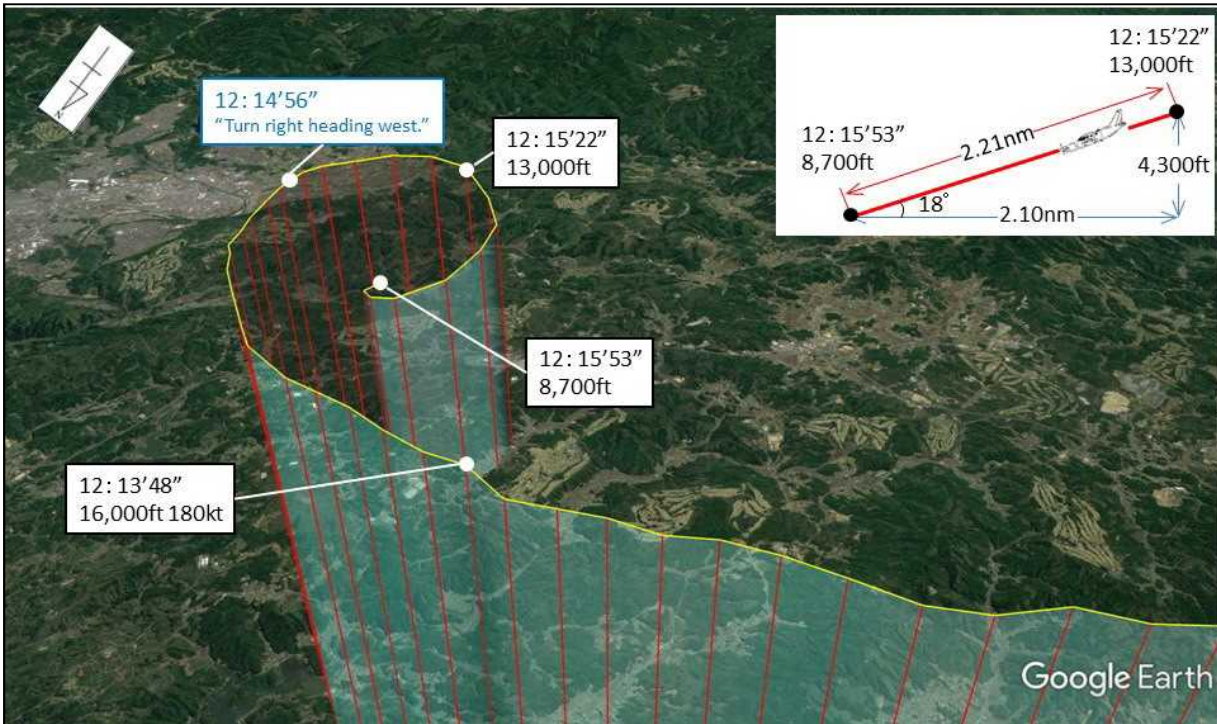
Figure 3: estimated flight route (detailed)

- 12:14:56 Kansai TCA instructed the Aircraft to turn right heading to the west, but after that, the Aircraft did not respond to the calls from Kansai TCA.
- 12:15:22 The Aircraft nosedived while turning right near the crash site, passing an altitude of 13,000 ft.
- 12:15:53 The Aircraft disappeared from the radar after being confirmed last at 8,700 ft above around the crash site.

The flight route from 12:15:22 to 12:15:53 was about 2.21 nm in distance along the route and about 18° in descent angle. (See Figure 3.)

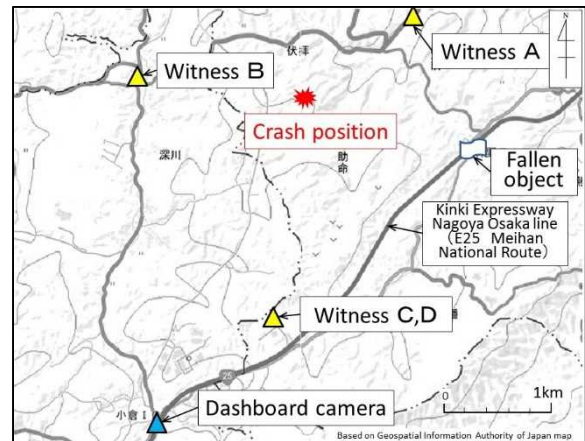
Figure 4: positions of eye witnesses

looked up at the sky. Eyewitness A saw the Aircraft falling almost vertically into the mountain, with one wing catching on fire and nearly half of the airframe enveloped in flames. The Aircraft was hidden behind the mountain, and after a moment, Eyewitness A heard a big bang like a rumbling of the earth.

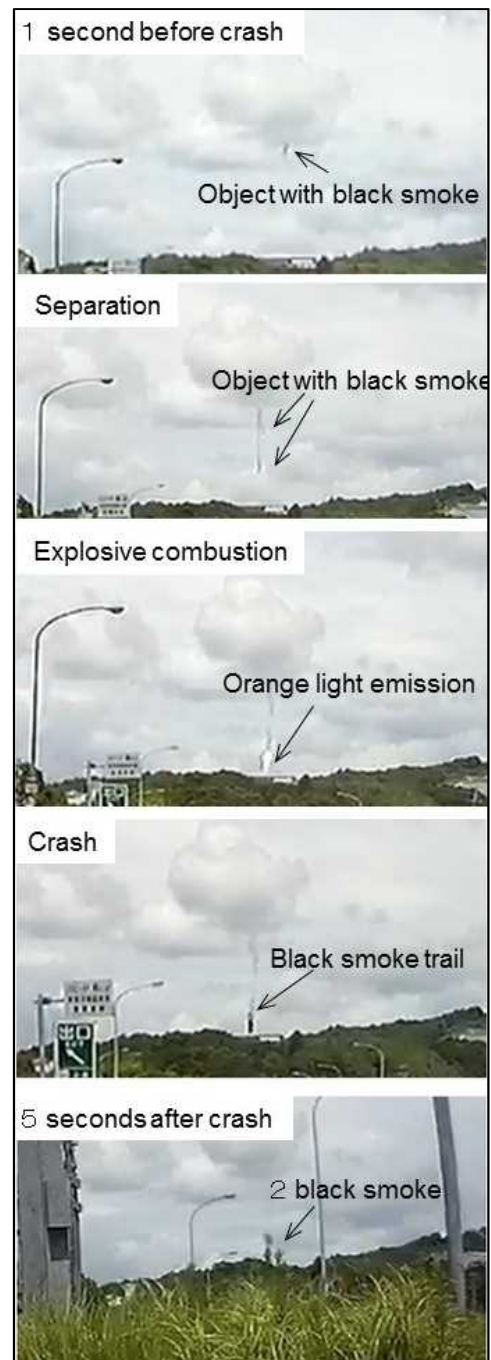
Figure 5: continuous photos of the dashboard camera

One second before the crash, an object that seemed to be the Aircraft emerged from the low cumulus layer trailing black smoke, and went falling down. Subsequently, an object separated from the object falling first came out trailing black smoke. The first emerged object burned explosively emitting orange light before impacting the ground. After the two objects had reached the ground, the trailing black smoke disappeared gradually. Five seconds after the crash, two columns of black smoke trailed from the vicinity of the crash site.

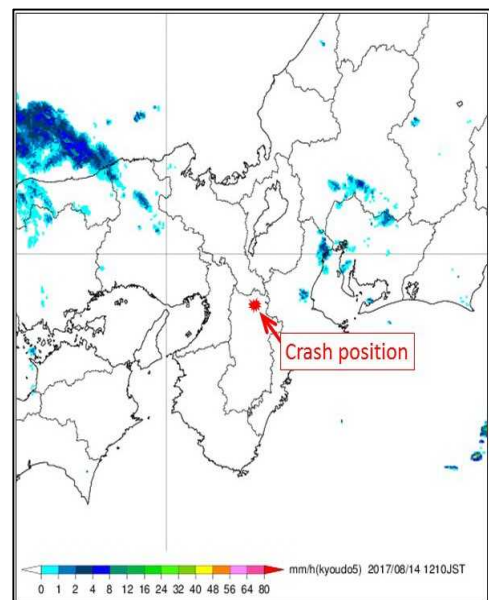
Figure 6: radar image (12:10)

The echo status of the weather radar (reflection intensity) near the accident site was as shown in Figure 6, and no noticeable echo was confirmed near the Aircraft's crash position.

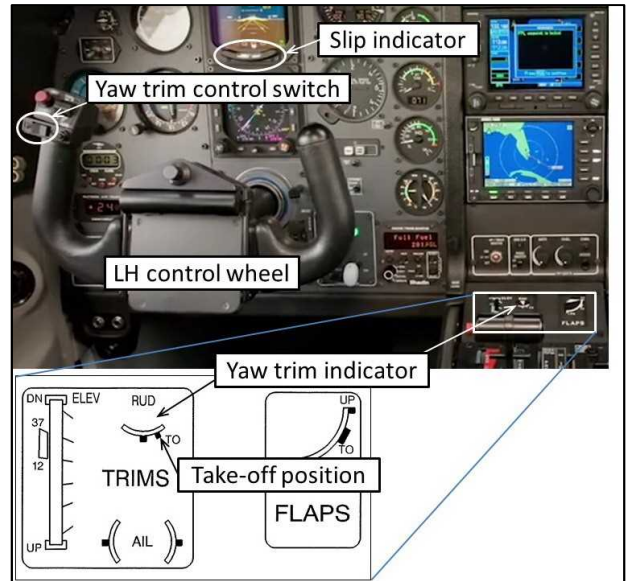
Figure 18: yaw trim control

As being equipped with a single engine with high power output, the Aircraft is very more likely to yaw to the left at take-off, when the yaw trim be set at the take-off position. The Aircraft would yaw to the right to the travelling direction and its speed would slow gradually when the Aircraft is shifted to cruise flight without returning the yaw trim position from the take-off position. At this time, the ball of the slip indicator (see Figure 18) is moving to the left, indicating the Aircraft is sideslipping, but it is difficult to notice it because the Aircraft is stable.

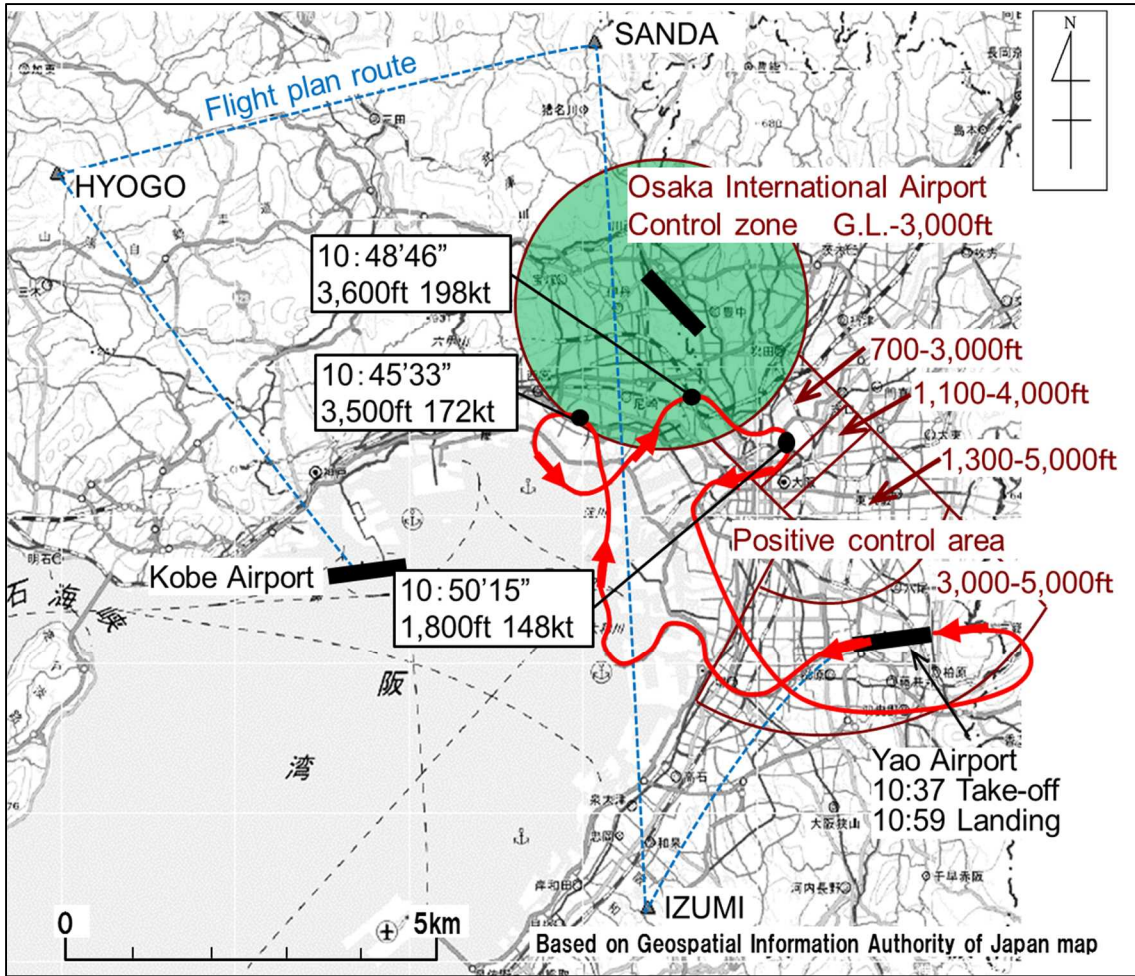
Figure 23: estimated flight route of the Aircraft in the morning on August 11

Based on the radar track records for air traffic control of the Kansai radar approach control, the estimated flight route of the Aircraft at that time was as shown in Figure 23. For the blue dashed flight-planned route, the Aircraft, while straying, followed such a route as could enter the Positive Control Area.
