**AIRCRAFT SERIOUS INCIDENT  
INVESTIGATION REPORT**

**POLAR AIR CARGO WORLDWIDE, INC.  
N 8 5 2 G T**

CASE EQUIVALENT TO RUNWAY OVERRUN  
(LIFT-OFF IN THE VICINITY OF  
THE END OF DEPARTURE RUNWAY)  
ON RUNWAY 16L AT NARITA INTERNATIONAL AIRPORT  
AT 22:41 JST, JULY 15, 2017

POLAR AIR CARGO WORLDWIDE, INC.  
BOEING 747-8F, N852GT

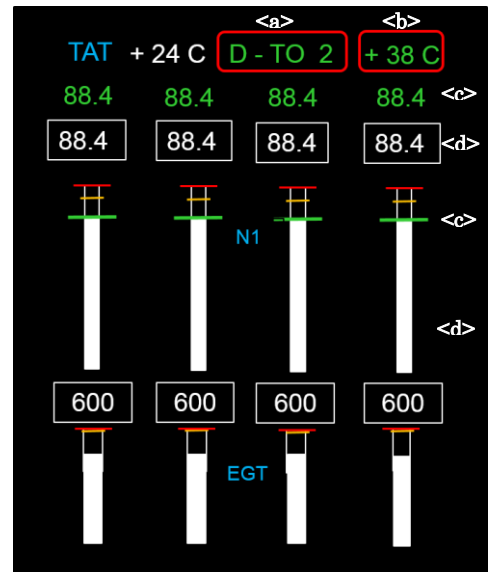
Figure 5 EICAS indication at the time of take-off (Image)

Figure 5 shows the EICAS indication at the time of take-off.

When commencing the take-off roll, it is probable that the Captain and the FO verified that the actual N1 values <d> would rise and reach to the N1 values <c> calculated by the FMC on the EICAS in Figure 5.

Based on the above, it is probable that the Captain and the FO did not see the N1 value, 89.1 % as abnormal, despite being under conditions that the Aircraft was required to take off from runway 16L, which was short in length, with its weight close to the maximum take-off weight.
