AI2018-7

**AIRCRAFT SERIOUS INCIDENT
INVESTIGATION REPORT**

PARTS DROPPED FROM AIRCRAFT COLLIDED WITH A VEHICLE ON THE GROUND AT OSAKA CITY, OSAKA, JAPAN AT AROUND 10:57 JST, SEPTEMBER 23, 2017

KLM ROYAL DUTCH AIRLINES BOEING 777-200, PH-BQC

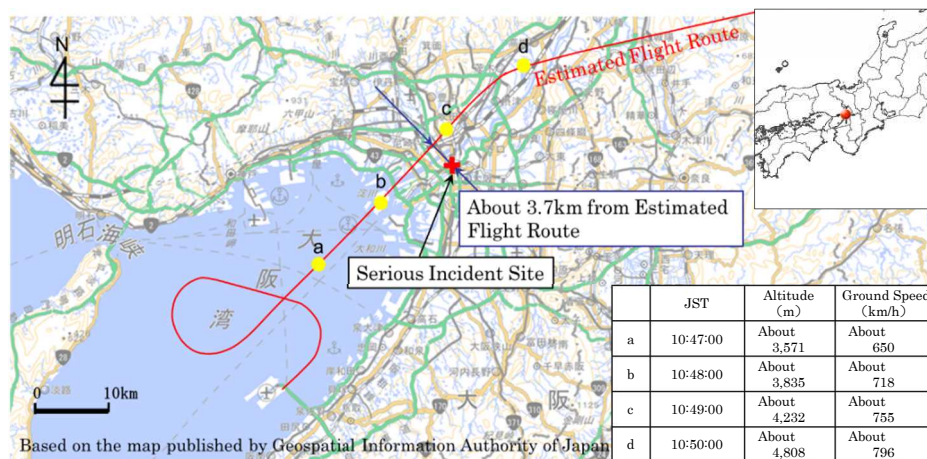
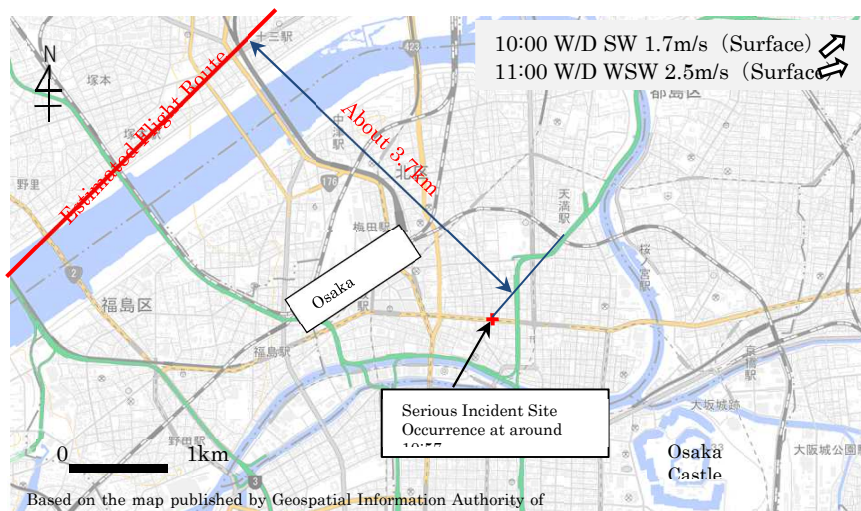
Figure 1 Estimated Flight Route & Serious Incident

Given that the Panel arrived at the impact site at around 10:57, it is probable that, from the relationship with the Aircraft's estimated flight route and times shown in Figure 1, the Panel likely departed from the Aircraft between points a and d and within a time period of about seven to ten minutes. Regarding the path the departed Panel took, this could not be clarified due to factors that include difficulty in estimating the precise point and time that the Panel departed from the Aircraft, the fact that the wind direction and wind speed were changing with the altitude along the Aircraft's estimated flight route, the fact that the Panel was a thin plate that is easily influenced by the wind, and, further, the possibility that the Panel was blown by the wake turbulence of the Aircraft after it departed.

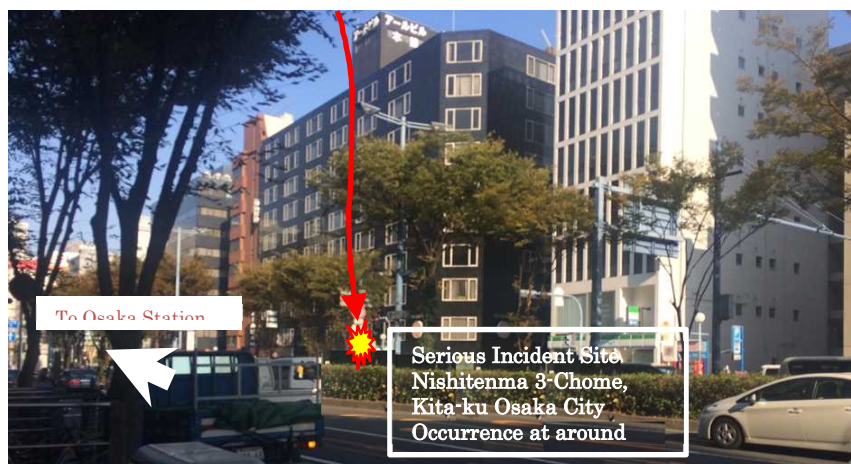
Figure 2 Location of the Serious Incident

This serious incident occurred around 10:57 on September 23, 2017, above National Route 1 in Nishitenma 3-chome, Kita-ku, Osaka City (Latitude 34° 41' 51" N, Longitude 135° 30' 27" E).
