MA2011-4

**MARINE ACCIDENT
INVESTIGATION REPORT**

MARINE ACCIDENT INVESTIGATION REPORT

Vessel Type and name: Container ship “KUO CHANG”
IMO number: 9172313
Gross tonnage: 15,095 tons

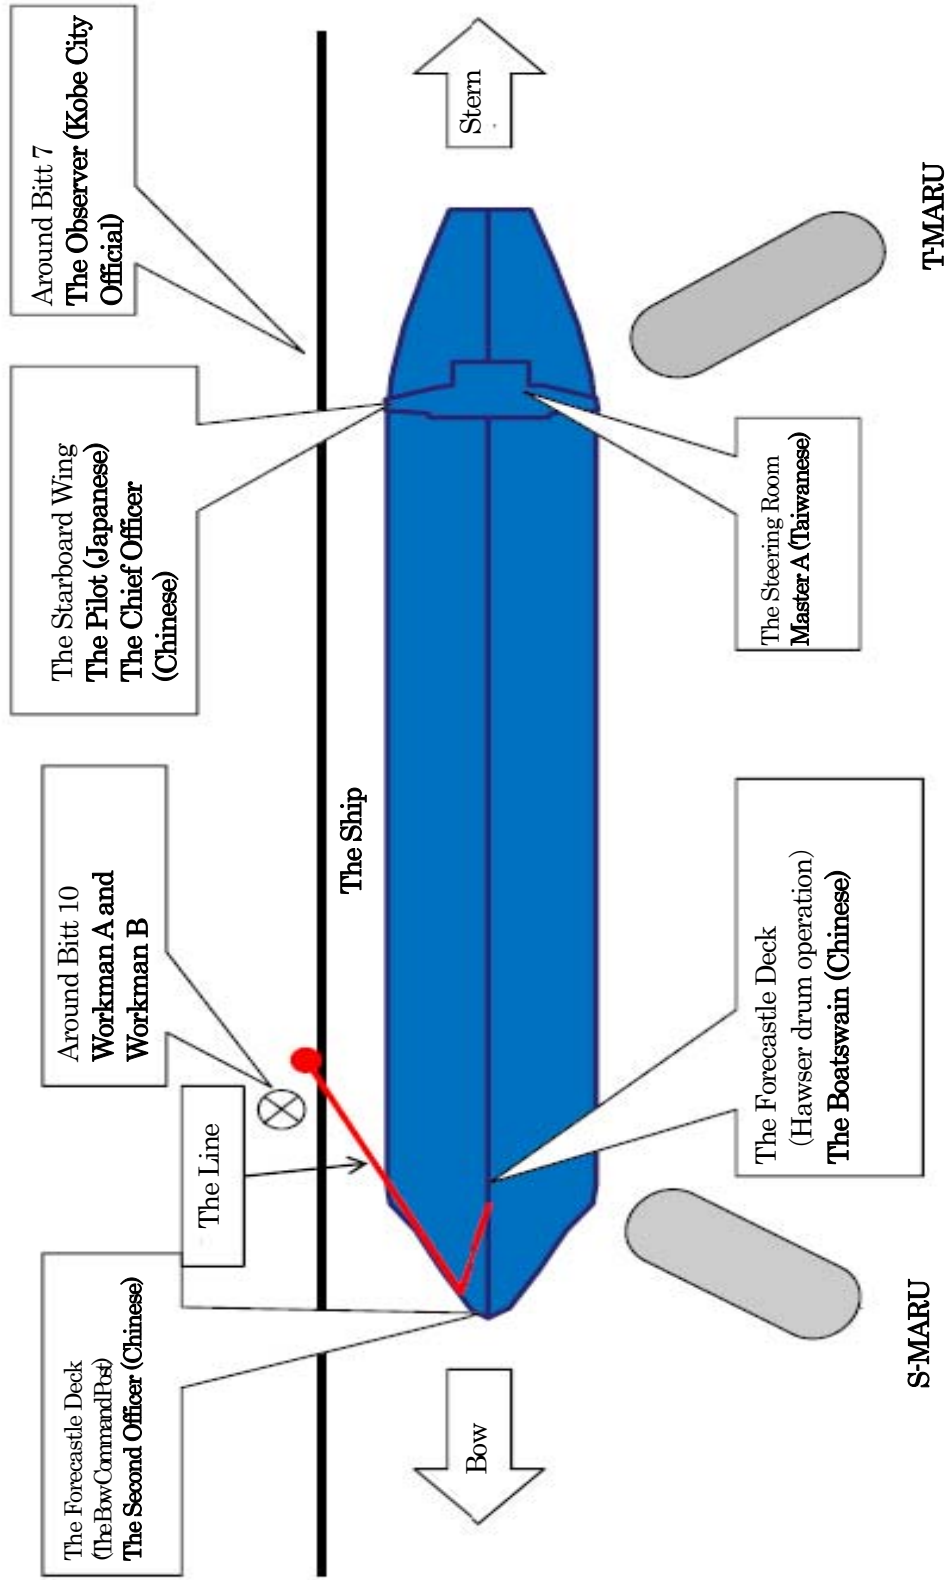
Attached Chart 4: Positions of the Parties Concerned at the Time of the Occurrence of the Accident

It is considered probable that the accident occurred because the Line broke, snapped back and hit Workman A and Workman B, who were working inside the hazardous zone of snap-back.

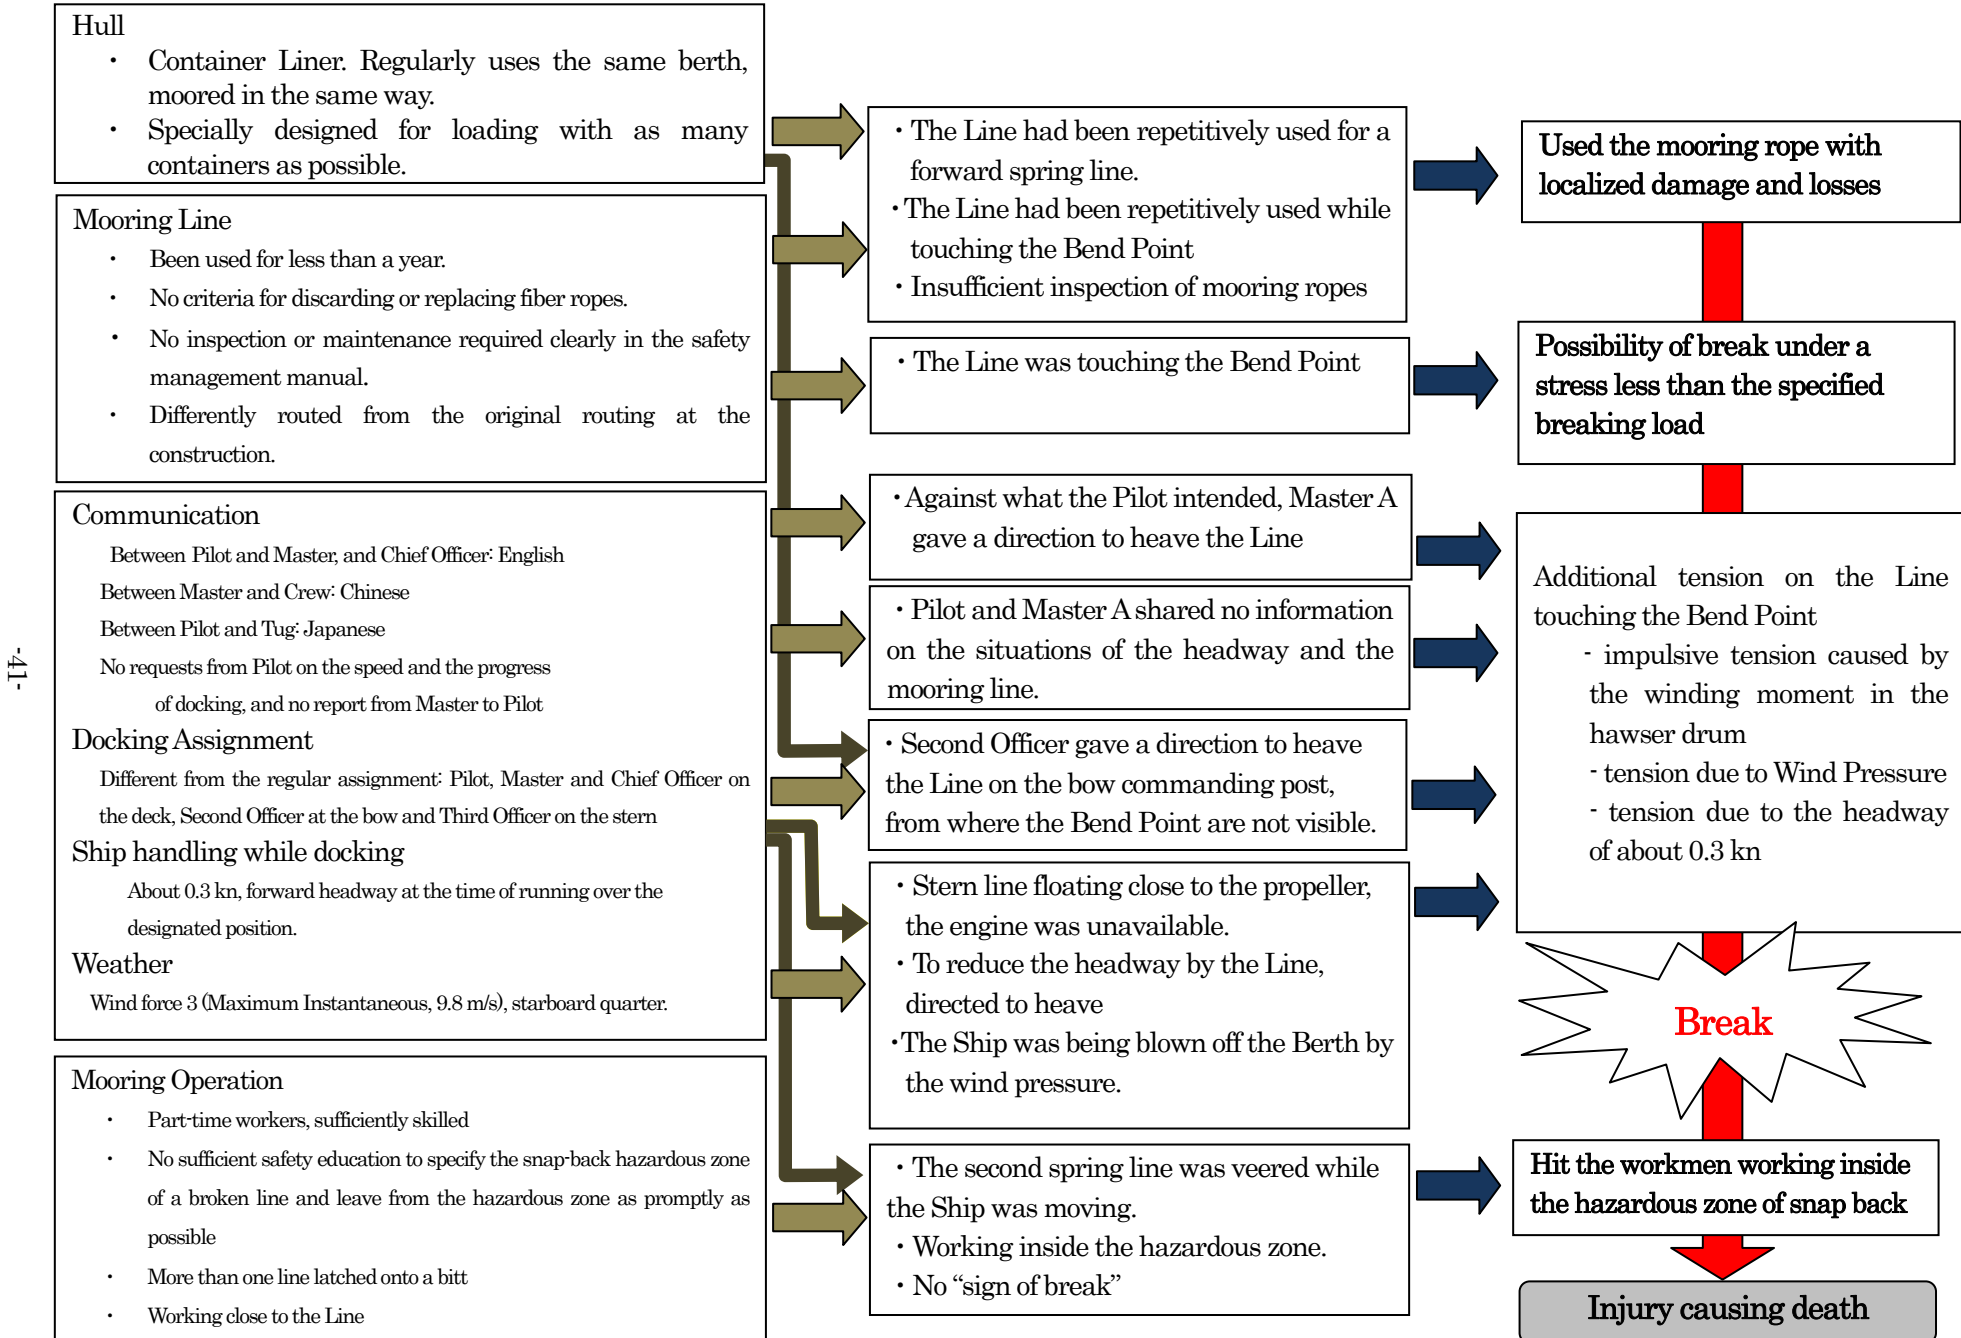
Attached Chart 10: Cause and Effect Relationship of Casual Factors

It is considered probable that the Line was broken due to the wear it had incurred and by the additional tensions on the Line touching the Bend Point: the impulsive tension due to the winding moment in the hawser drum; the tensions due to the forward headway of the Ship; and the Wind Pressure.
