**MARINE INCIDENT
INVESTIGATION REPORT**

MARINE INCIDENT INVESTIGATION REPORT

Vessel type and name: LNG Tanker, "LNG ARIES"
Vessel number (IMO number): 7390193
Gross tonnage: 95, 084 tons

Incident type: Loss of control (blackout)
Date and time: Around 12:37, December 3, 2012 (Local time, UTC+9 hours)
Location: Off the Southeast of the Toden-Ogishima LNG Berth in Section 2 of Kawasaki Quarter, Keihin Port
120° true, 100 meters from the Toden-Ogishima LNG Berth Light in Kawasaki City, Kanagawa Prefecture
(approximately 35° 28.2'N, 139° 44.4'E)

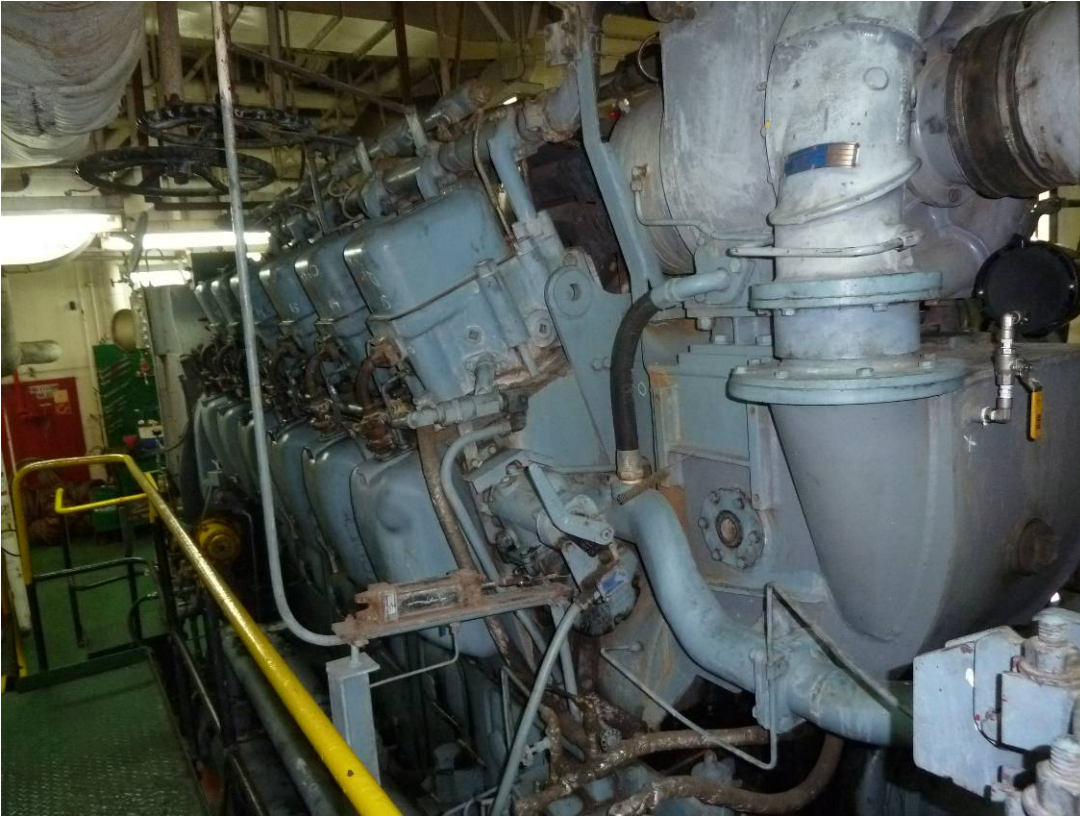
Photo 1: Stand-by Diesel Generator (the port side)

After the emergency diesel generator of the Vessel was urgently operated and the lighting restored, an attempt was made to operate the stand-by diesel generator and close the ACB for the generator. However, the voltage of the generator did not increase, and the ACB could not be closed. A crew member inspected the main switchboard and found that a diode on the electric circuit was loose. After the diode was fixed, the stand-by diesel generator started to operate, and then the voltage of the generator increased, and it became possible to close the ACB for the generator.

The operation of the stand-by diesel generator on the Vessel continued to restore the main boilers; however, it turned out that a load of around 380 kW caused the ACB to trip.

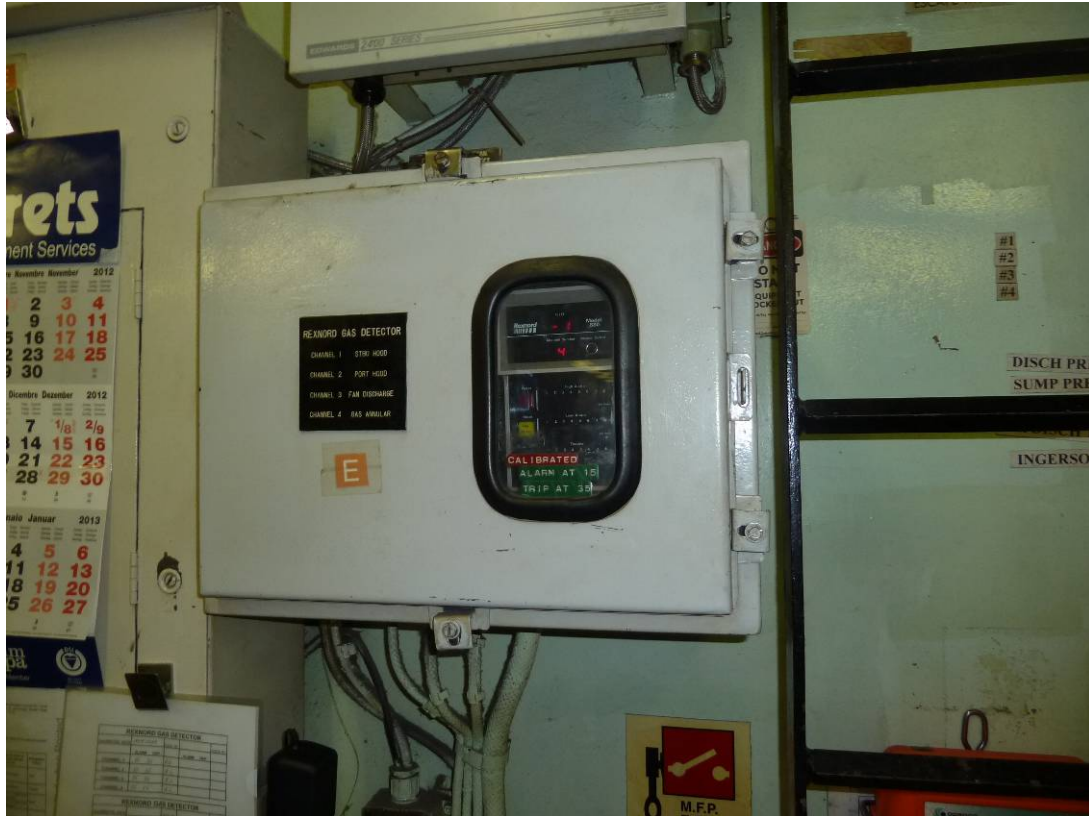
Photo 7: Gas Leakage Detector Monitoring Equipment

The inspection of the gas leakage detectors revealed that there was no damage to the fuel gas pipes. However, a failure was found at the base of the detection unit. An alarm error had activated the warning device (for the increase of gas concentration) and also stopped the burning of BOG in the main boilers to occur a flame failure.

- (2) The stand-by diesel generator of each vessel must periodically be operated under normal load and be subject to periodic maintenance.
- (3) The emergency diesel generator of each vessel must be operated, as is currently done, on a trial basis according to the manual.
- (4) The interval for performing the operation tests of the gas leakage detectors was changed from every four months to every two months.
