MA2012-12

**MARINE ACCIDENT
INVESTIGATION REPORT**

Vessel type and name: Chemical Tanker SEIYO
Vessel number: 137203
Gross tonnage: 499 tons

Accident type: Foundering
Date and time: Around 09:22 (Local time, UTC+9 hours), January 9, 2011,
Location: South-west off Sado Island, Sado City, Niigata Prefecture,
Around 216° true bearing, 16.0 km from Sawazakihana lighthouse
located at Sado City,
(approximately 37°42.5'N, 138°05.6'E)

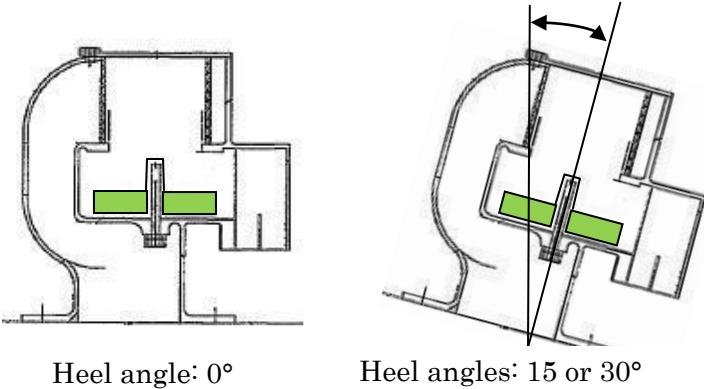
Figure 2-8 Heel Angles of Air Vent Pipe Head

2) A heel angle of air vent pipe head was 0°, and 15° & 30° with an opening turned downward.

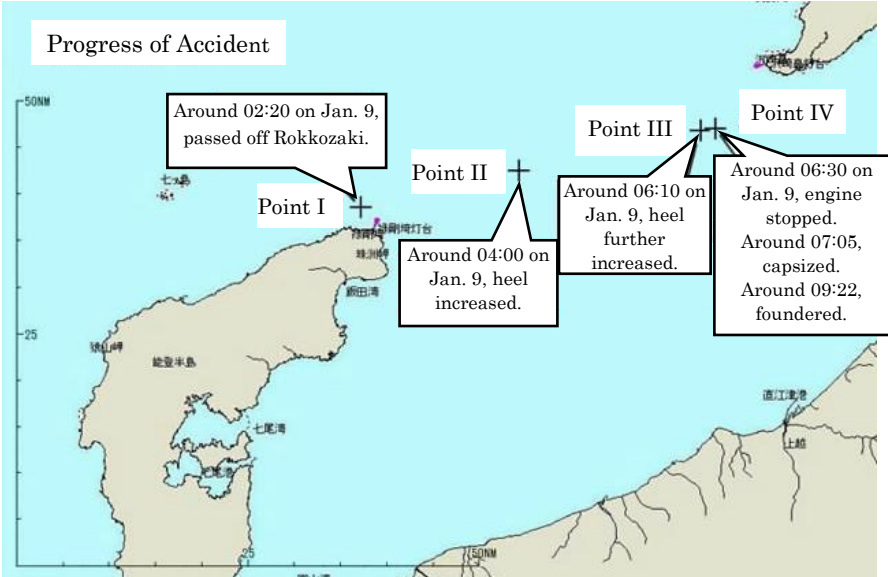
Figure 2-11 Points of Calculation

The oscillation of the Vessel affected by waves at the point where she passed off Rokkozaki at around 02:20 (hereinafter referred to as “Point I”), at the point where her heel increased at around 04:00 (hereinafter referred to as “Point II”), and at the point where she reported to JCG at around 06:10 (hereinafter referred to as “Point III”), were as follows:

In the simulation, under the conditions of the Vessel’s speed and waves at each Point, the calculations were made for the Vessel’s situation generating her rolling angle (the amount of water flowed into the ballast tanks and the amount of the sea water remaining on the expansion trunks) and at the same time the rolling period and the natural period were computed.

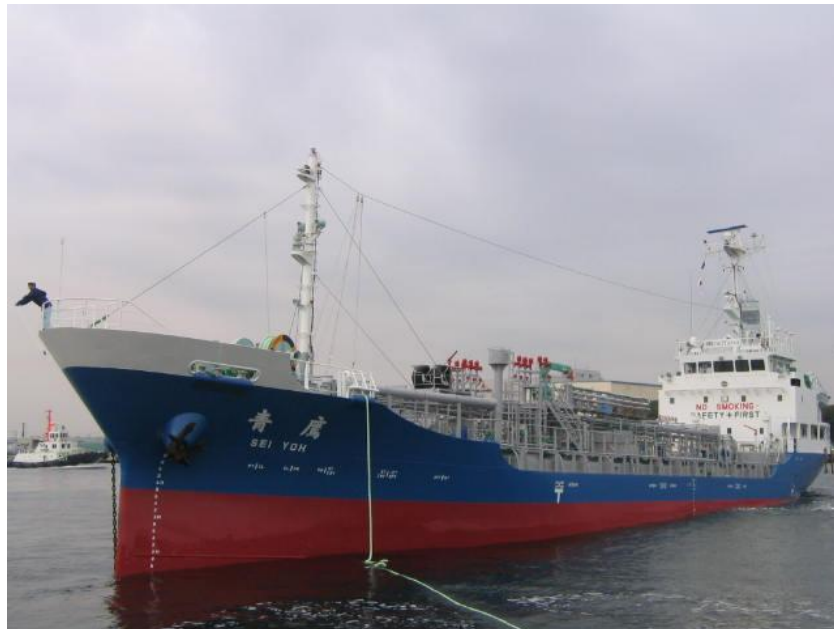
Photo 1 the Vessel

The date and time of occurrence of the accident was at around 09:22 on January 9, 2011, and the location was around 216°, 16.0 km from Sawazakihana lighthouse located at Sado City,
(Refer to Figure 1 Map, Photo 1 the Vessel)
