MA2014-8

**MARINE ACCIDENT
INVESTIGATION REPORT**

Vessel Type and Name: Cargo Ship YUSHO SEVEN

Accident Type: Fatality of a stevedore

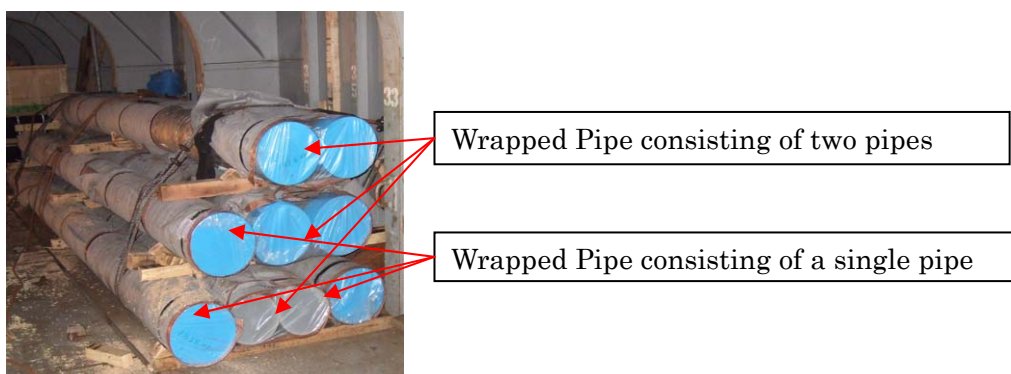
Photo 2.1-1 Wrapped Pipes

Operations Chief confirmed that several dozen small-diameter pipes bundled together (hereinafter, “Bundled Pipe”) and two stainless pipes wrapped in synthetic resin sheet and a stainless pipe wrapped in synthetic resin sheet (hereinafter, “Wrapped Pipe”) were placed on the quay.

There were two kinds of Wrapped Pipes: one was 6.0 m in length, about 27 cm in diameter, and about 366 kg in weight and the other was 6.0 m in length, about 33 cm in diameter, and about 448 kg in weight.

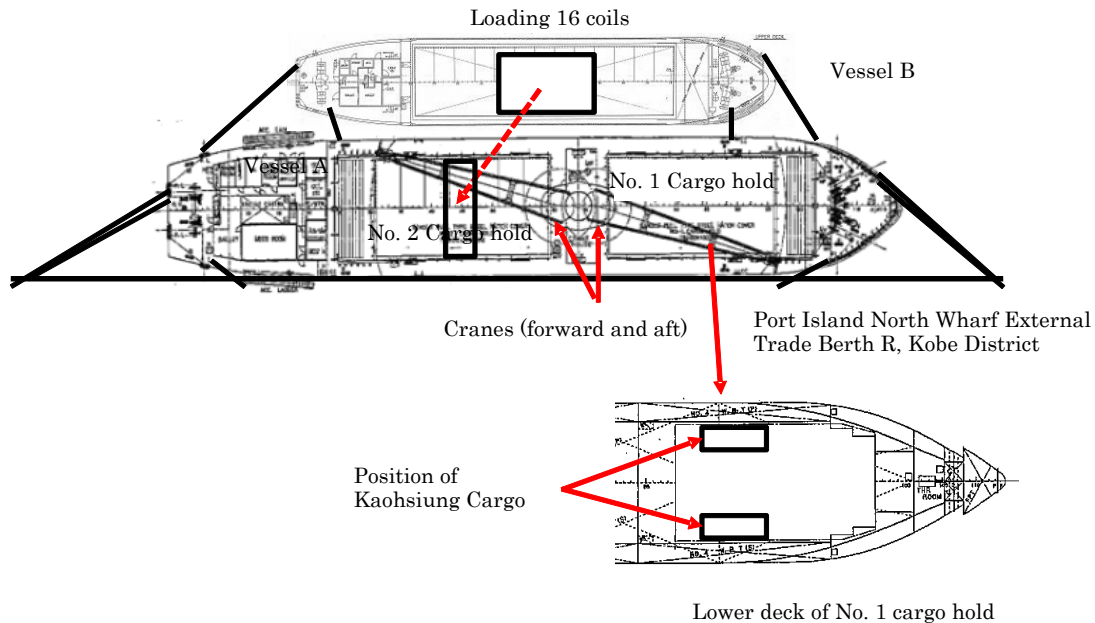
Figure 2.1-1 Loading Cargo into the Cargo Hold

After the barge moved away from the port side, Vessel B moored alongside the port side of Vessel A and 16 coils were hoisted one by one using the aft crane of Vessel A, loaded and stowed in No. 2 cargo hold.

When the coils were hoisted, Master B noticed that Vessel A listed to port.

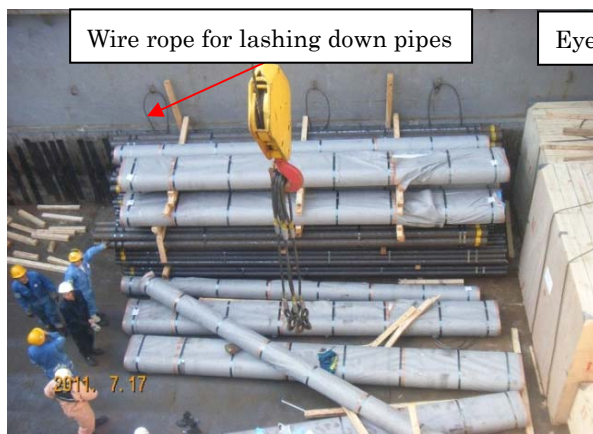
Photo 2.1-4 Wire Rope for Lashing down Pipes

Lasher E1 passed wire rope to lash the stacked pipes through the eye plates welded to the sidewalls. He planned to climb up onto the pipes and pull out the wire rope to lash down the pipes after they had been stacked to several tiers.

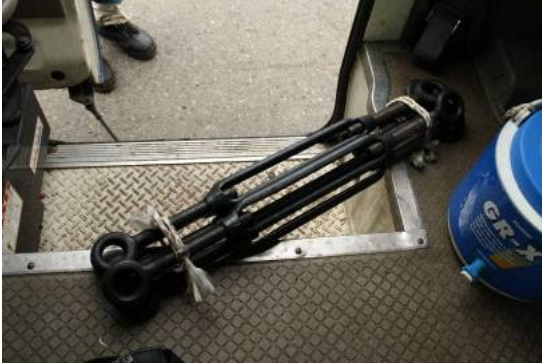
Photo 2.1-6 Turnbuckles of the Same Type

When the pipes on the port side had been stacked to six tiers, three lashers pulled out the wire rope that hung through the eye plates on the port sidewall, tied all the pipes together at three locations, and tightened the wire rope using turnbuckles.

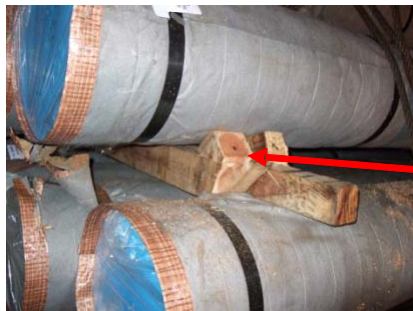
Photo 2.1-7 Wedge

Then, in accordance with instructions from No. 1 cargo hold supervisor, Lasher E₂ hewed square timbers to make wedges to the fore of No. 1 cargo hold.

(Hewn timber with one pointed end and one thick end)

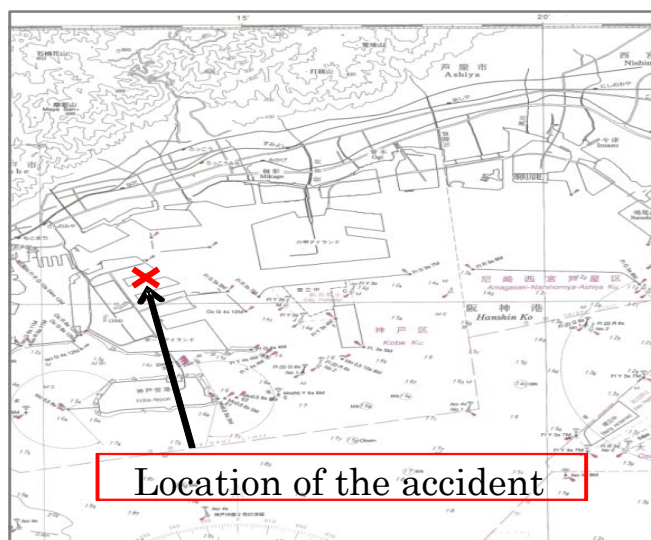
Figure 2.1-4 Location of the accident

This accident occurred at around 15:45 on July 17, 2011, at the Berth in Kobe District, Hanshin Port (in No. 1 cargo hold of Vessel A moored at the Berth).

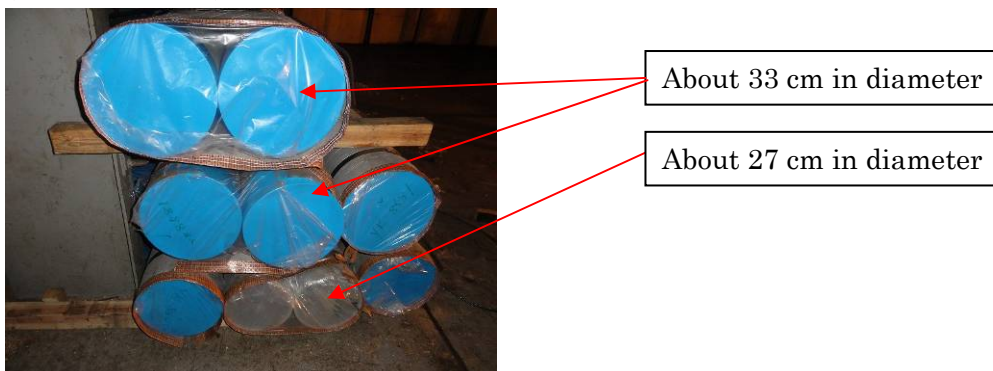
Photo 2.6-2 Wrapped Pipes

consisting of a single pipe) were on the sixth tier, and two bundles of Wrapped pipes consisting of two pipes were on the seventh tier. The total weight was about 1.790 tons. (See Photo 2.6-2)
