MA2014-6

**MARINE ACCIDENT
INVESTIGATION REPORT**

Vessel type and name: Bulk Carrier NIKKEI TIGER
IMO number: 9159438
Gross tonnage: 25,074 tons

Vessel type and name: Fishing Vessel HORIEI-MARU
Fishing vessel registration number: ME1-937
Gross tonnage: 119 tons

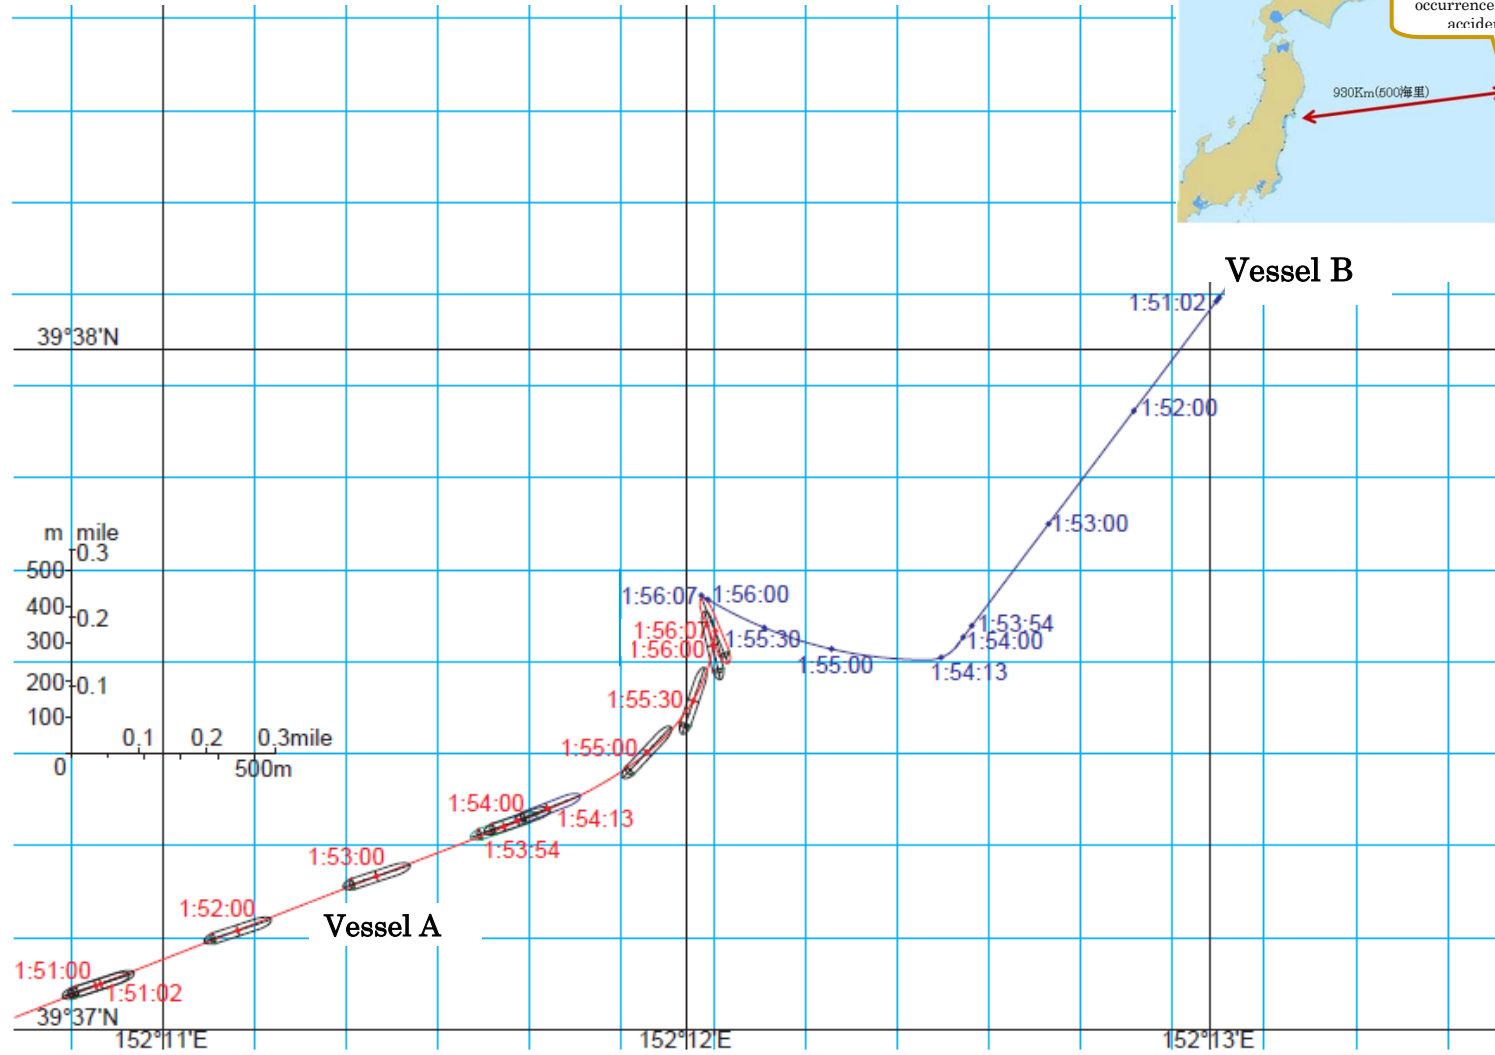
Appendix Figure 2: Estimated Vessel Locations

- (iv) Vessel B, at a speed of about 12.5 kn, proceeded toward the collision site.
- (v) Vessel B's starboard turn was a mild turn by a relatively small rudder angle.
- (vi) Tracks of Vessel A and Vessel B are shown in Appendix Figure 2.

- (ii) It is highly probable that at 01:51:01 on September 24, Vessel A was proceeding at around $39^{\circ} 37.06' N$ $152^{\circ} 10.83' E$ with a heading of 071.9° and at a speed of 12.68 kn. It is highly probable that Vessel A's trace after that until around 01:56 was as shown in Appendix Figure 2.

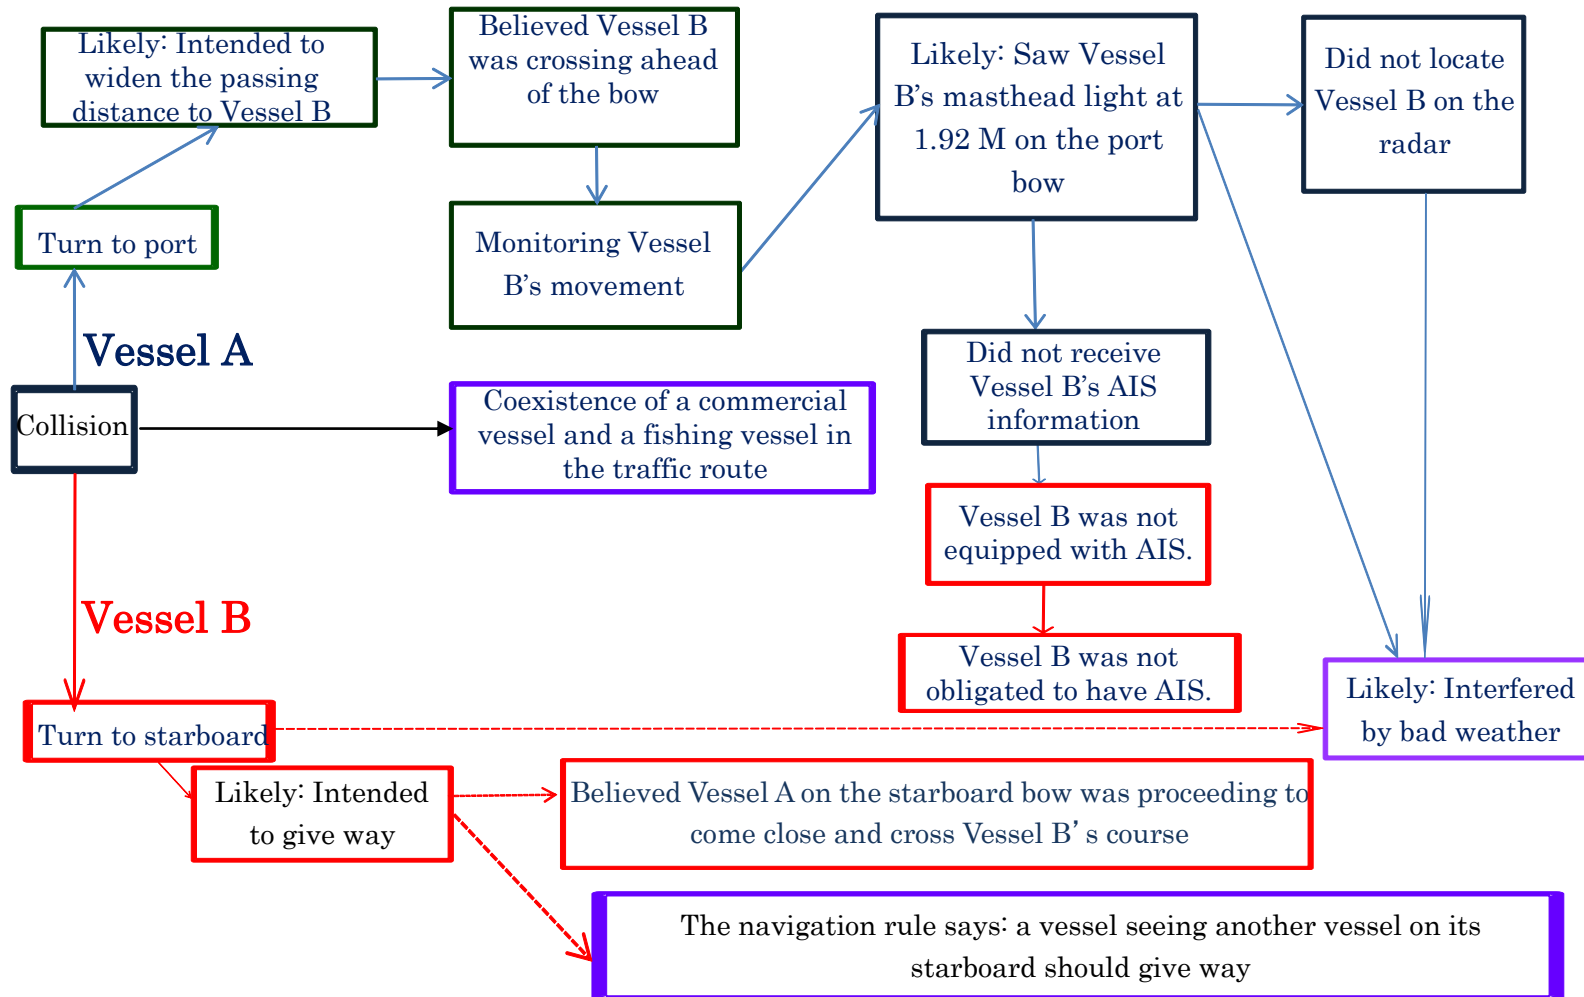
- (iv) It is probable that, when Chief Fisherman B during his radio conversations with Chief Fisherman C sensed shocks of collision, Vessel B collided with Vessel A.
(See Appendix Figure 3: "Why Tree" (Fault Tree Analysis) and Appendix Figure 4: VTA Analysis (Vessel A))
