**MARINE ACCIDENT
INVESTIGATION REPORT**

Vessel type and name: Chemical tanker Nisshomaru

Accident Type: Fatality and injury of crew

Date and time: Around 11:27, June 28, 2011

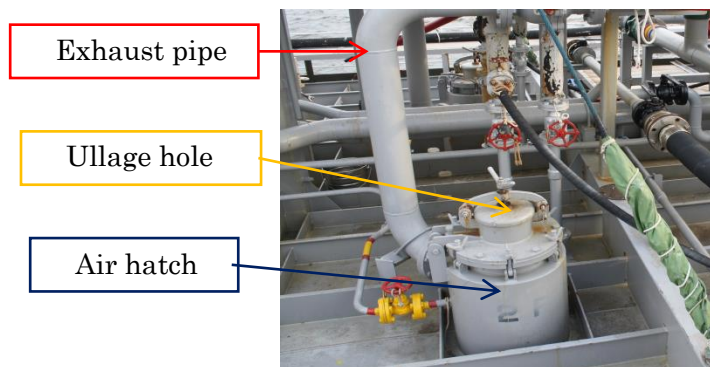
(Photo 2.5-2 Air hatch)

There was an air hatch on the bow side of each cargo tank. An ullage hole*⁷ was installed on the lid of the same hatch, and an exhaust pipe*⁸ was connected to the side of the air hatch.

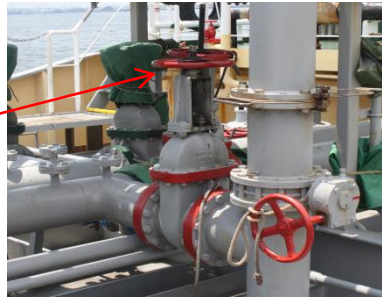
(Photo 2.5-5 Bypass valve operation handle)

Bypass valve operation handles for the second and fourth cargo oil bypass pipes were on the bow side of the manhole hatch for the No.4 cargo tank (port). These handles were operated to adjust the flow volume when cargo and tank wash water were transferred to slop tanks.

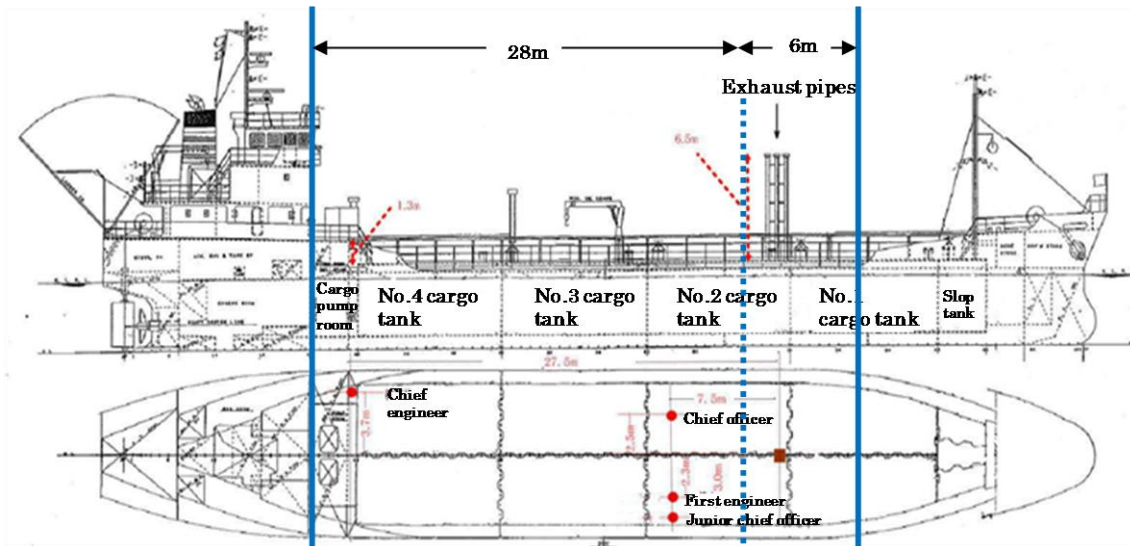
Figure 2.15-1 Calculation target range in the bow-stern direction (range indicated with solid blue lines)

The numerical simulation method used in this analysis targeted part of the Vessel, as shown in Figure 2.15-1. This included 6m toward the bow and 28m toward the stern from the slop tank exhaust pipe outlet in term of bow-stern direction, and 20m in the port-starboard direction, including the sea surface. Due to the fact that the draught at the time of this accident was approximately 1.25m at the bow and approximately 3.30m at the stern, we postulated the draught for the target range to be 2.3m and constant, and the range from the sea surface to 20m above it was included in the calculation target in terms of vertical direction. In order to simplify the calculation target, the equipment/appliances on the deck were ignored, and it was postulated to be a flat surface. However, one of the slop tank exhaust pipes, from which hydrogen sulfide gas leaked, was included in the calculation model. In addition, considering the part of the poop deck where the chief engineer was standing before this accident (1m toward the stern), we included only its height (1.3m) in the calculation model. The model of the calculation target used in this analysis is shown in Figure 2.15-2.

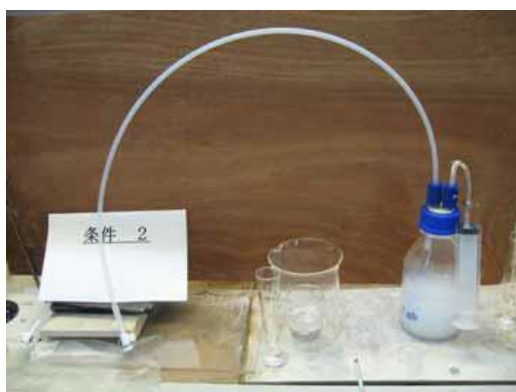
Attached Figure 1-1 Experiment equipment

We have conducted a confirmation experiment for the presumed produced substance and the concentration of the produced gas. However, due to the fact that we are unable to make the entire amount react in conditions in Appendix 1-1 to measure the concentration of the produced gas, we have reduced the mixed amount by approximately 1/20,000 to measure. The reduction scale and amount of liquid in each condition are shown in Appendix 1-2. Scenes from the experiment are shown in Attached Figure 1-1 and Attached Figure 1-2.

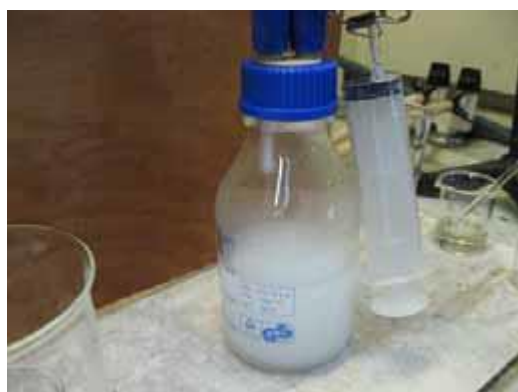
Attached Figure 1-2 Reactor bottle

Although sodium hydrogen sulfide wash water and acrylic acid wash water are both clear liquid, they react and become cloudy when mixed. (Refer to Attached Figure 1-2) The produced gas is clear and had an odor of rotten eggs. Gas started to be produced immediately after mixing. When we took a sample of the gas, the Gas Detector Tube changed its color, indicating that hydrogen sulfide gas had been produced. Attached Figure 1-4 shows the image.

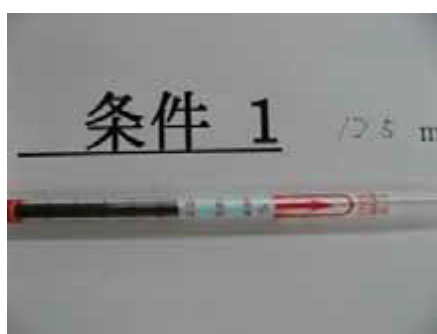
Attached Figure 1-4 Gas Detector Tube (Image of discoloration)

Condition	H ₂ S measured value (Collection amount: 12.5ml)(%)	H ₂ S measured value (Collection amount: 100ml calculation)(%)
Condition 1	2.8	22.4
Condition 2	3.0	24.0
Condition 3	3.2	25.6
Condition 4	2.7	21.6

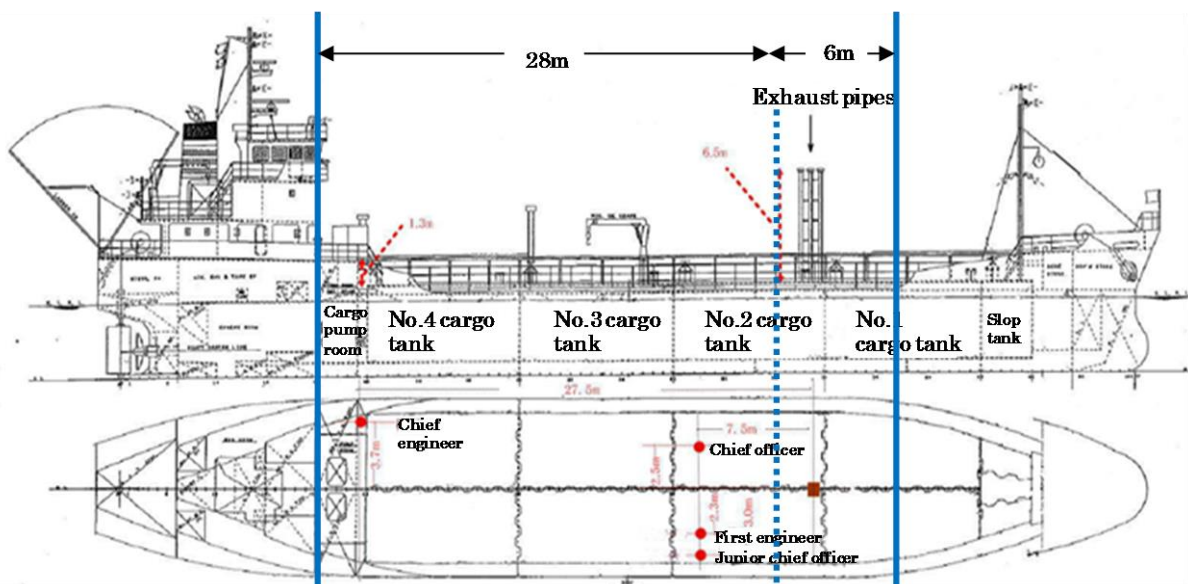
Attached Figure 2-1 Calculation target range in the bow-stern direction (range indicated with solid blue lines)

Due to the fact that the numerical simulation method used in this analysis generally has a heavy computation load, we targeted part of the hull, which is shown in Attached Figure 2-1, rather than targeting the overall vessel as well as the surrounding area of water. This included 6m toward the bow and 28m toward the stern from the slop tank exhaust pipe outlet in term of bow-stern direction, and 20m in the port-starboard direction, including the sea surface. Due to the fact that the draught at the time of this accident was approximately 1.25m at the bow and approximately 3.30m at the stern, we postulated the draught for the target range to be 2.3m and constant, and the range from the sea surface to 20m above it was included in the calculation target in terms of vertical direction. In order to simplify the calculation target, the equipment/appliances, etc. on the deck were ignored, and it was postulated to be a flat surface. However, one of the slop tank exhaust pipes, from which hydrogen sulfide gas leaked, was included in the calculation model. In addition, considering the part of the poop deck where the chief engineer was standing before this accident (1m toward the stern), we included only its height (1.3m) in the calculation model. The model of the calculation target used in this analysis is shown in Attached Figure 2-2.
