MA2015-7

**MARINE ACCIDENT
INVESTIGATION REPORT**

Accident type	Fatality of a crew member
Date and time	Between 03:45 to 03:55 on December 17th, 2013 (local time, UTC-8 hours)
Location	On the Pier of the Morro Redondo Port in the Cedros Island, Baja California State, United States of Mexico (approximately 28° 02.6'N, 115° 10.7'W)
Summary of the Accident	While the Cargo ship ONOE with twenty crew, including the Master and the second officer, was under the cargo handling load of the sea salt at the pier of the Morro Redondo Port in the Cedros Island, Baja California State, United States of Mexico on December 17th, 2013, and between 03:45 and 03:55, the second officer fell from the gangway of the land boarding facility to the pier underneath, which is about 5 to 6 meters in height, and died.
Process and Progress of the Investigation	<p>(1) Setup of the Investigation The Japan Transport Safety Board appointed an investigator to investigate this accident on February 17th, 2014.</p> <p>(2) Collection of Evidence Collection of questionnaire on February 18, 26, and 27; March 7, 11, and 25; July 10; August 14; September 3, 8, 11, 16, 24, and 29, 2014.</p> <p>(3) Comments from Parties Rele

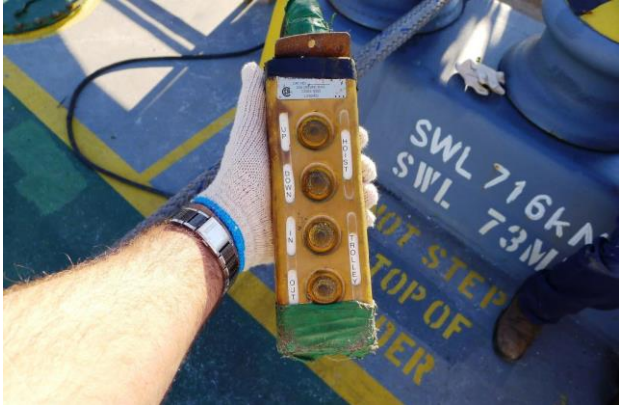
<p>Photo 1: Control box (Provided by Company A)</p>
<p>Crew Information</p>	<p>Master (Nationality: The Philippines), male, 58 years old Endorsement attesting the recognition of certificate as master under STCW regulation I/10 (issued by Japanese government), Date of issue: August 24th, 2012 (valid until August 23th, 2017) Boarded as master on this vessel since October 2013.</p> <p>Second officer (Nationality: The Philippines), male, 52 years old Endorsement attesting the recognition of certificate as master under STCW regulation I/10 (issued by Japanese government), Date of issue: December 14th, 2010 (valid until December 13th, 2015) Boarded as an officer on a container ship and a bulk carrier ^{*1} since March, 1994, and then as second officer on this vessel since November 2013.</p> <p>Able seaman (Nationality: The Philippines), male, 27 years old Boarded as able seaman on this vessel since February 2013.</p> <p>Ordinary seaman A (Nationality: The Philippines), male, 25 years old Boarded as able seaman on this vessel since September 2013.</p>
