MA2016-8

**MARINE ACCIDENT
INVESTIGATION REPORT**

MARINE ACCIDENT INVESTIGATION REPORT

Vessel type and name: Cargo Ship MING GUANG
IMO number: 8513456
Gross tonnage: 1,915 tons

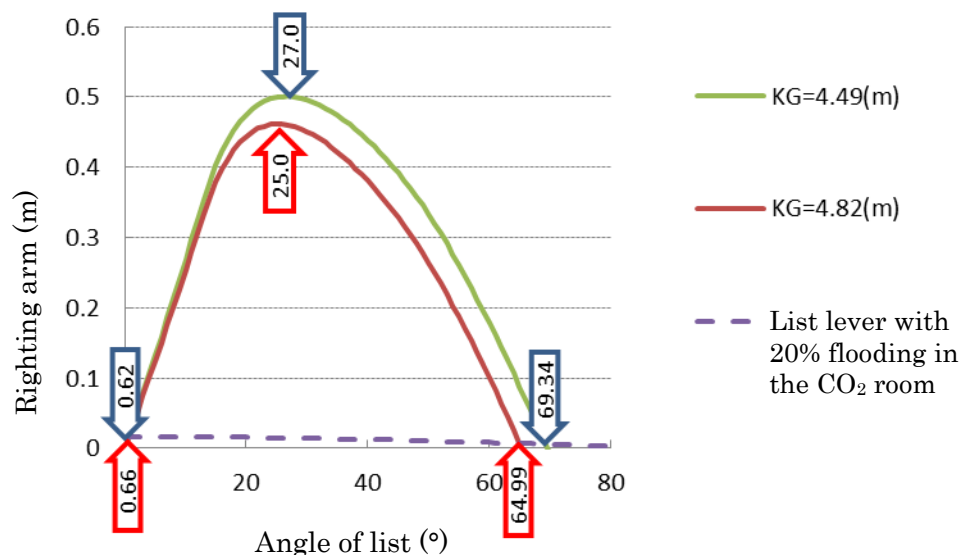
Figure 2 Stability Curves (CO₂ Room Flooding of 20%)

Light-condition height of center of gravity (m) (KGLC)	4.49	4.82
Fore draft (m)	5.25	
Aft draft (m)	5.28	
Mean draft (m)	5.27	
Displacement (t)	4420.65	
Height of center of gravity (m)	3.71	3.80
Metacentric height (m)	1.51	1.42
Angle of list (°)	0.62	0.66
Listing moment lever (m)	0.02	0.02

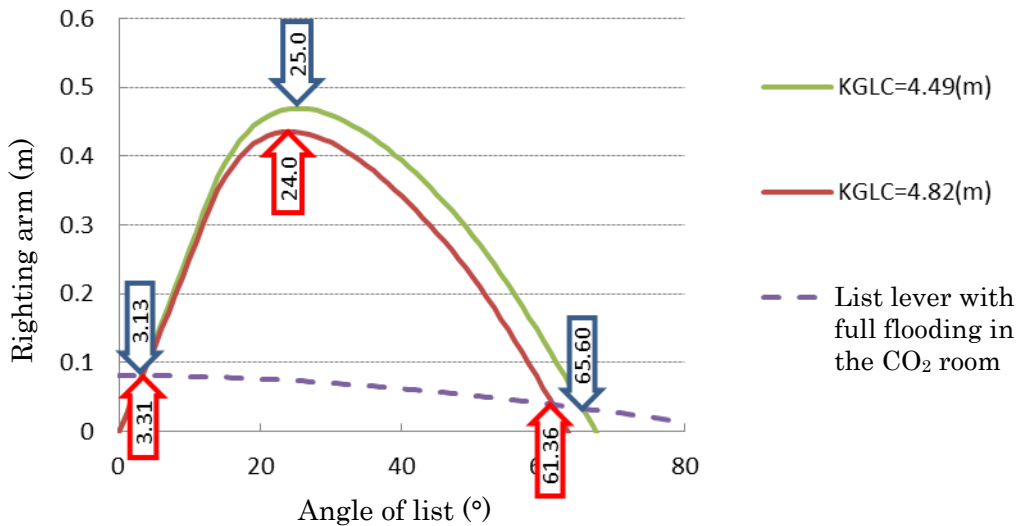
Figure 3 Stability Curves when CO₂ Room is Fully Flooded

Table 6 Situational Data when CO₂ Room is Fully Flooded

Light-condition height of center of gravity (m) (KGLC)	4.49	4.82
Fore draft (m)	5.46	
Aft draft (m)	5.18	
Mean draft (m)	5.32	
Displacement (t)	4471.72	
Height of center of gravity (m)	3.74	3.82
Metacentric height (m)	1.48	1.40
Angle of list (°)	3.13	3.31
Listing moment lever (m)	0.08	0.08

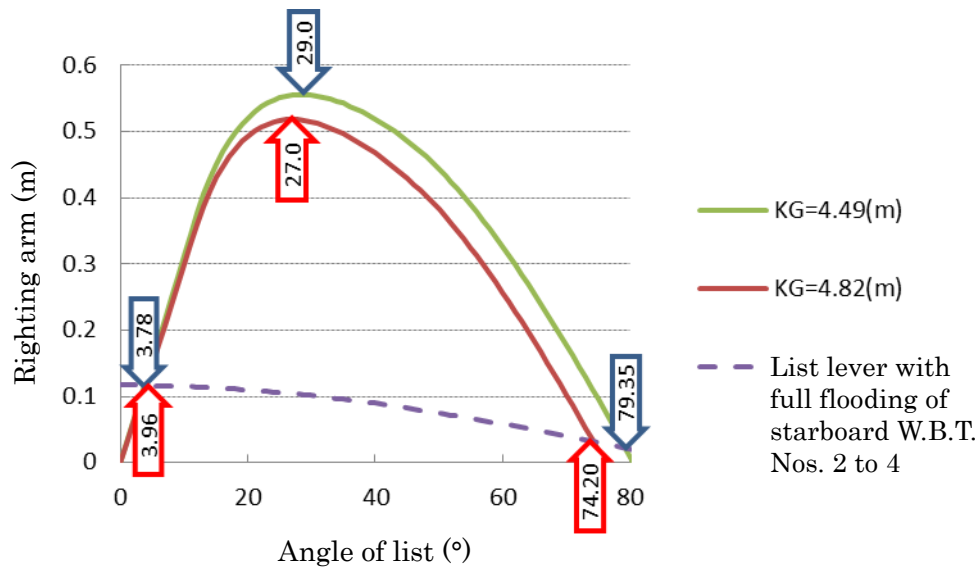
Figure 4 Stability Curves (Full Flooding of Starboard W.B.T. Nos. 2 to 4)

In the first case, we estimated stability when there is no flooding of the CO₂ room and full flooding of starboard W.B.T. Nos. 2 to 4 (tank weight: 60.3 t, 58.4 t, and 84.2 t, respectively.) The Vessel's situation in this state is shown in Table 7 and the stability curves are shown in Figure 4. The angles of list are approximately 3.8° at KGLC = 4.49 (m) and approximately 4.0° at KGLC = 4.82 (m), which roughly match with the Vessel's angle of list (4 to 5°) identified in the JTSB Investigation.

Light-condition height of center of gravity (m) (KGLC)	4.49	4.82
Fore draft (m)	5.37	
Aft draft (m)	5.46	
Mean draft (m)	5.42	
Displacement (t)	4569.72	
Height of center of gravity (m)	3.60	3.68
Metacentric height (m)	1.76	1.68
Angle of list (°)	3.78	3.96
Listing moment lever (m)	0.12	0.12

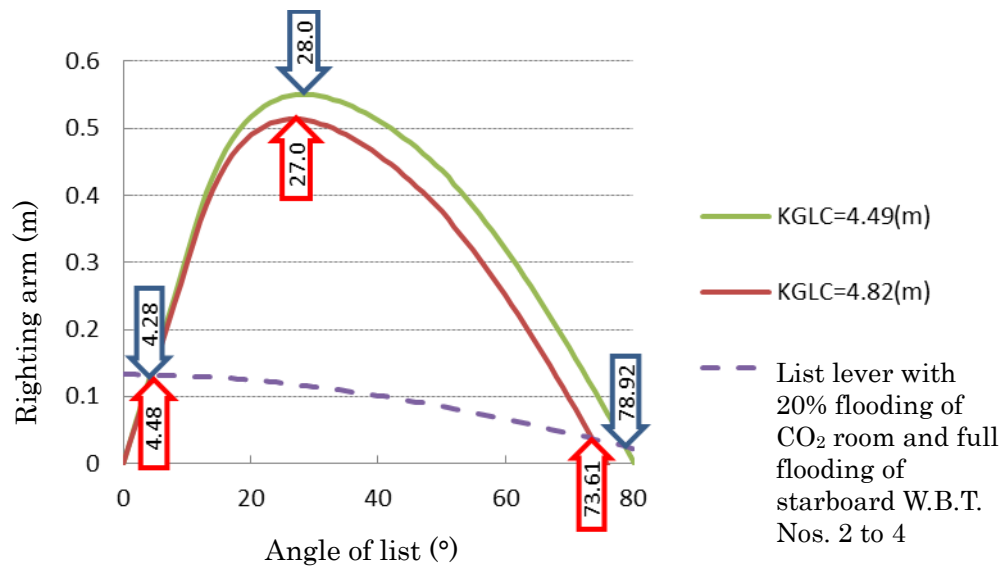
Figure 5 Stability Curves (20% Flooding of CO₂ Room and Full Flooding of Starboard W.B.T. Nos. 2 to 4)

Table 8 shows the Vessel's situation and Figure 5 shows the stability curves when the CO₂ room is 20% flooded and starboard W.B.T. Nos. 2 to 4 are fully flooded. The angles of list are approximately 4.3° at KGLC = 4.49 (m) and approximately 4.5° at KGLC = 4.82 (m), which roughly match with the Vessel's angle of list (4 to 5°) identified in the JTSB Investigation.

Light-condition height of center of gravity (m) (KGLC)	4.49	4.82
Fore draft (m)	5.42	
Aft draft (m)	5.44	
Mean draft (m)	5.43	
Displacement (t)	4582.49	
Height of center of gravity (m)	3.60	3.68
Metacentric height (m)	1.76	1.38
Angle of list (°)	4.28	4.48
Listing moment lever (m)	0.13	0.13

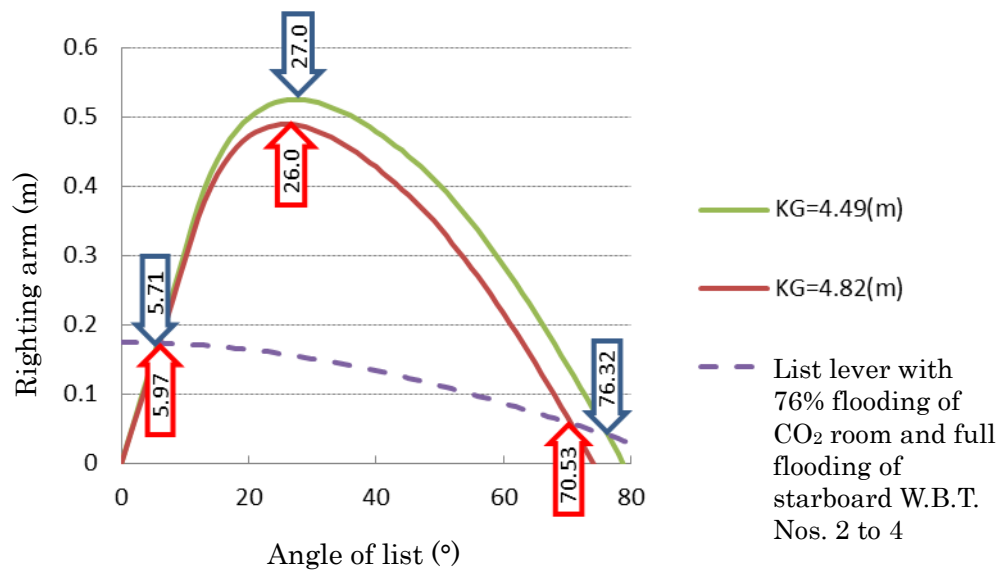
Figure 6 Stability Curves (76% Flooding of CO₂ Room and Full Flooding of Starboard W.B.T. Nos. 2 to 4)

According to the JTSB Investigation, flooding up to 50 cm from the CO₂ room's ceiling was confirmed. Flooding at such state is equivalent to 76% of the CO₂ room's capacity. Table 9 shows the Vessel's situation and Figure 6 shows the stability curves when the CO₂ room is 76% flooded (50.1 t) and starboard W.B.T. Nos. 2 to 4 are fully flooded. The angles of list are approximately 5.7° at KGLC = 4.49 (m) and approximately 6.0° at KGLC = 4.82 (m).

Light-condition height of center of gravity (m) (KGLC)	4.49	4.82
Fore draft (m)	5.57	
Aft draft (m)	5.38	
Mean draft (m)	5.48	
Displacement (t)	4620.19	
Height of center of gravity (m)	3.62	3.70
Metacentric height (m)	1.74	1.66
Angle of list (°)	5.71	5.97
Listing moment lever (m)	0.17	0.17

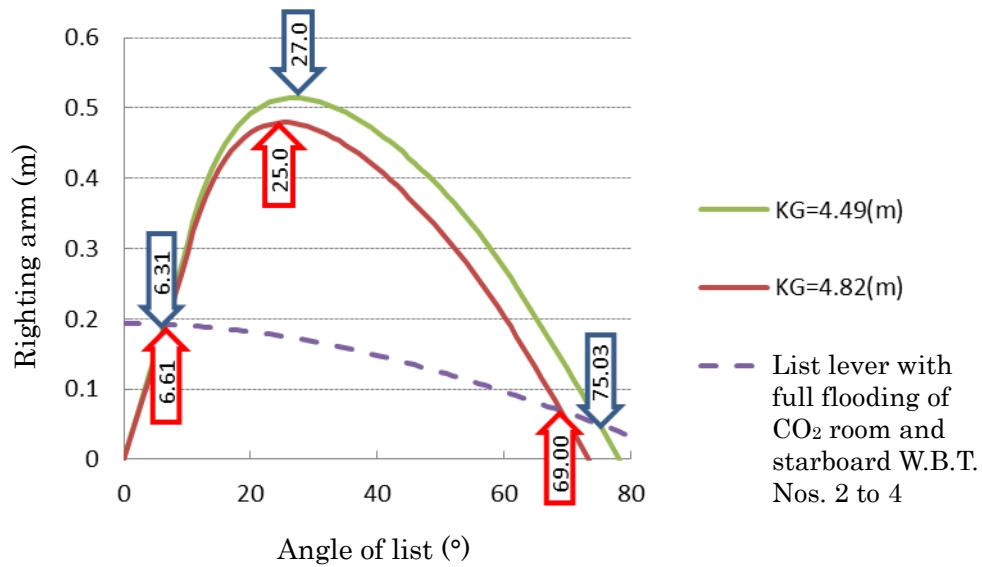
Figure 7 Stability Curves (Full Flooding of CO₂ Room and Starboard W.B.T. Nos. 2 to 4)

Table 10 shows the Vessel's situation and Figure 7 shows the stability curves when the CO₂ room is fully flooded (65.9 t) and starboard W.B.T. Nos. 2 to 4 are fully flooded. The angles of list are approximately 6.3° at KGLC = 4.49 (m) and approximately 6.6° at KGLC = 4.82 (m).

Light-condition height of center of gravity (m) (KGLC)	4.49	4.82
Fore draft (m)	5.64	
Aft draft (m)	5.35	
Mean draft (m)	5.49	
Displacement (t)	4635.70	
Height of center of gravity (m)	3.63	3.71
Metacentric height (m)	1.73	1.65
Angle of list (°)	6.31	6.61
Listing moment lever (m)	0.19	0.19

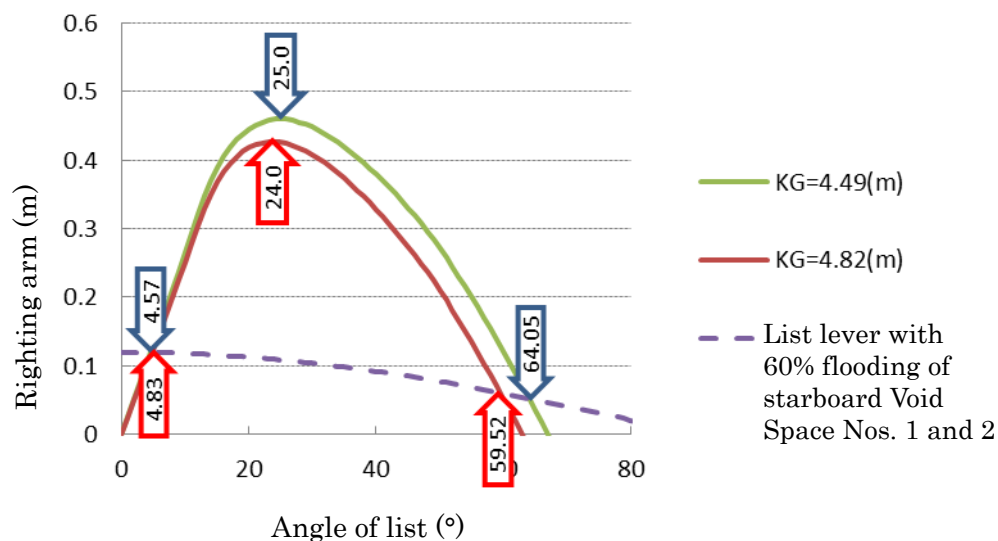
Figure 8 Stability Curves (60% Flooding of Starboard Void Space Nos. 1 and 2)

We estimated the Vessel's situation and residual stability based on the assumption that there was no flooding in the CO₂ room but 60% flooding in each of Void Space No. 1, which was adjacent to the CO₂ room, and Void Space No. 2, which was adjacent to Void Space No. 1. The amount of water when each of these void spaces is 60% flooded is 43.8 t in the case of Void Space No. 1 and 55.2 t in the case of Void Space No. 2. The Vessel's situation in this state is shown in Table 11 and the stability curves are shown in Figure 8. The angles of list are approximately 4.6° at KGLC = 4.49 (m) and approximately 4.8° at KGLC = 4.82 (m), which roughly match with the Vessel's angle of list (4 to 5°) identified in the JTSB Investigation.

Light-condition height of center of gravity (m) (KGLC)	4.49	4.82
Fore draft (m)	5.34	
Aft draft (m)	5.37	
Mean draft (m)	5.35	
Displacement (t)	4504.85	
Height of center of gravity (m)	3.74	3.82
Metacentric height (m)	1.49	1.34
Angle of list (°)	4.57	4.83
Listing moment lever (m)	0.12	0.12

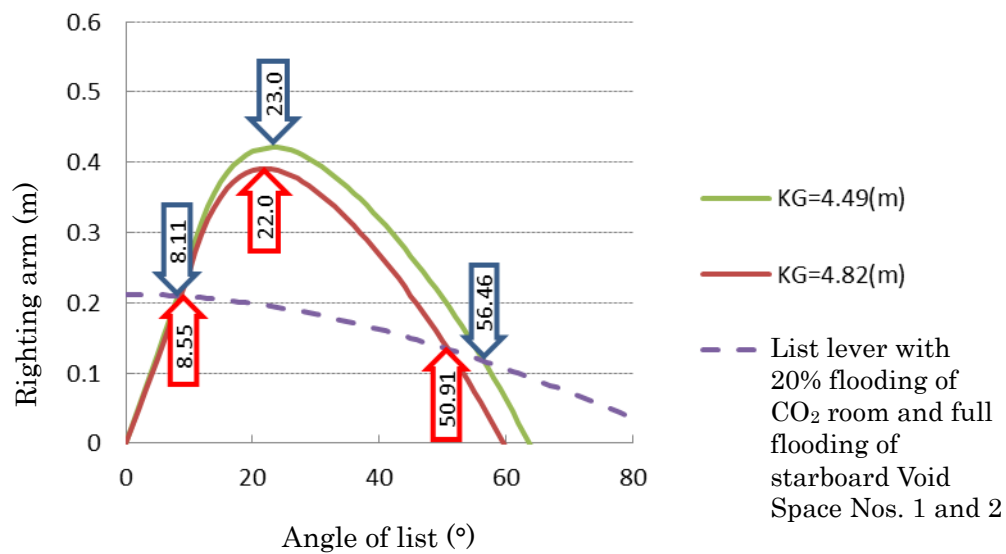
Figure 9 Stability Curves (20% Flooding of CO₂ Room and Full Flooding of Starboard Void Space Nos. 1 and 2)

We estimated the Vessel's situation and stability curves when the CO₂ room is 20% flooded (13.2 t) and starboard Void Space Nos. 1 and 2 are fully flooded. The amount of water when each of these void spaces is fully flooded is 72.9 t in the case of Void Space No. 1 and 92.0 t in the case of Void Space No. 2. The Vessel's situation in this state is shown in Table 12 and the stability curves are shown in Figure 9. The angles of list are approximately 8.1° at KGLC = 4.49 (m) and approximately 8.6° at KGLC = 4.82 (m), which roughly match with the Vessel's angle of list (7 to 10°) identified in the JTSB Investigation.

Light-condition height of center of gravity (m) (KGLC)	4.49	4.82
Fore draft (m)	5.48	
Aft draft (m)	5.39	
Mean draft (m)	5.43	
Displacement (t)	4582.24	
Height of center of gravity (m)	3.78	3.86
Metacentric height (m)	1.46	1.38
Angle of list (°)	8.11	8.55
Listing moment lever (m)	0.21	0.21

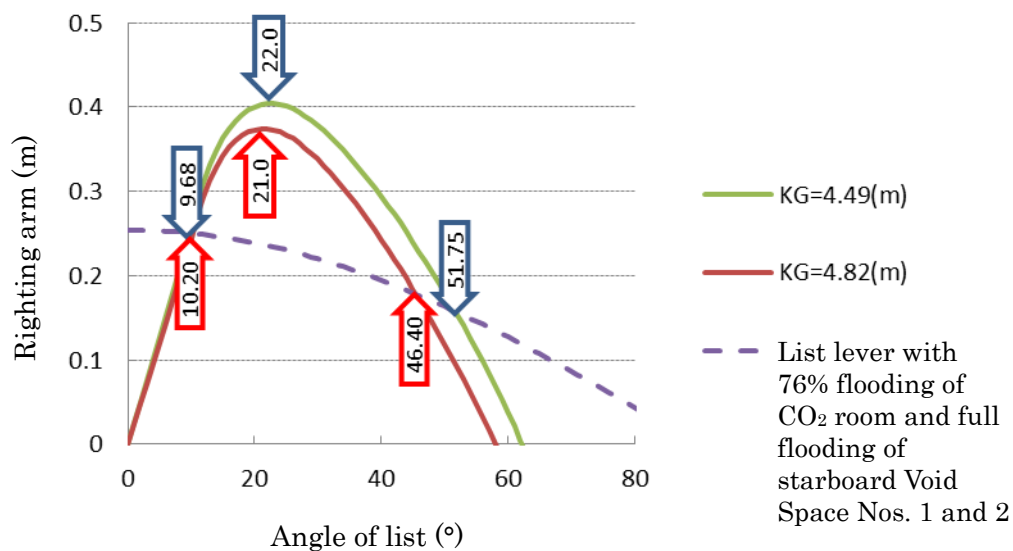
Figure 10 Stability Curves (76% Flooding of CO₂ Room and Full Flooding of Starboard Void Space Nos. 1 and 2)

According to the JTSB Investigation, flooding approached 50 cm from the CO₂ room's ceiling. Flooding up to 50 cm from the CO₂ room's ceiling is equivalent to approximately 76% of the room's capacity. Accordingly, we estimated the Vessel's situation and stability curves when the CO₂ room is 76% flooded (50.1 t) and starboard Void Space Nos. 1 and 2 are fully flooded (72.9 t and 92.0 t). The Vessel's situation in this state is shown in Table 13 and the stability curves are shown in Figure 10. The angles of list in this state are approximately 9.7° at KGLC = 4.49 (m) and approximately 10.2° at KGLC = 4.82 (m), which roughly match with the Vessel's angle of list (7 to 10°) identified in the JTSB Investigation.

Light-condition height of center of gravity (m) (KGLC)	4.49	4.82
Fore draft (m)	5.63	
Aft draft (m)	5.32	
Mean draft (m)	5.48	
Displacement (t)	4620.06	
Height of center of gravity (m)	3.79	3.87
Metacentric height (m)	1.45	1.37
Angle of list (°)	9.68	10.20
Listing moment lever (m)	0.25	0.25

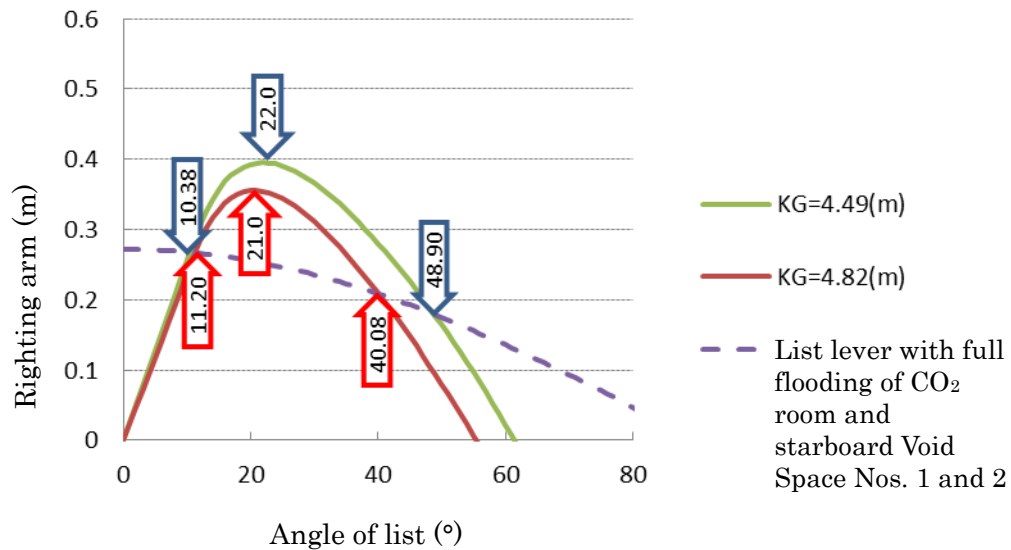
Figure 11 Stability Curves (Full Flooding of CO₂ Room and Starboard Void Space Nos. 1 and 2)

We estimated the Vessel's situation and stability curves when the CO₂ room is fully flooded (65.9 t) and starboard Void Space Nos. 1 and 2 are also fully flooded (72.9 t and 92.0 t). The Vessel's situation in this state is shown in Table 14 and the stability curves are shown in Figure 11. The angles of list in this state are 10.4° at KGLC = 4.49 (m) and 11.2° at KGLC = 4.82 (m), which roughly match with the Vessel's angle of list (7 to 10°) identified in the JTSB Investigation.

Light-condition height of center of gravity (m) (KGLC)	4.49	4.82
Fore draft (m)	5.70	
Aft draft (m)	5.29	
Mean draft (m)	5.50	
Displacement (t)	4635.58	
Height of center of gravity (m)	3.80	3.91
Metacentric height (m)	1.45	1.34
Angle of list (°)	10.38	11.20
Listing moment lever (m)	0.27	0.27

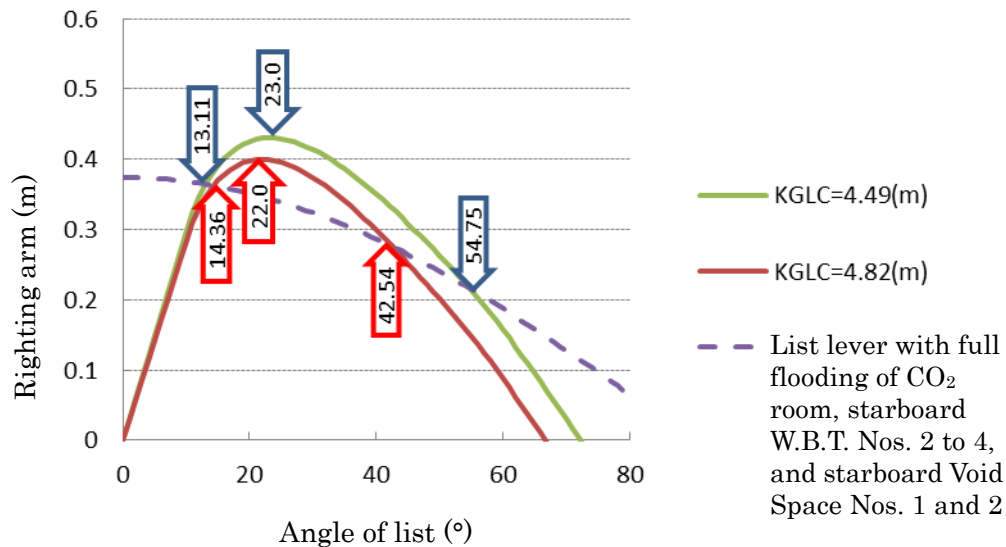
Figure 12 Stability Curves (Full Flooding of CO₂ Room, Starboard W.B.T. Nos. 2 to 4, and Starboard Void Space Nos. 1 and 2)

We estimated the Vessel's situation and stability curves when the CO₂ room (65.9 t), starboard W.B.T. Nos. 2 to 4 (flooding amounts: 60.3 t, 58.4 t, and 84.2 t, respectively), and starboard Void Space Nos. 1 and 2 (72.9 t and 92.0 t) are fully flooded. The Vessel's situation in this state is shown in Table 15 and the stability curves are shown in Figure 12. The angles of list in this state are 13.1° at KGLC = 4.49 (m) and 14.4° at KGLC = 4.82 (m). The residual stability lever at the angle of list when the righting arm is at maximum is equivalent to 0.09 m at KGLC = 4.49 (m) and 0.05 m at KGLC = 4.82 (m). From this it can be inferred that capsizing would occur with the action of even slight heeling moment.

Light-condition height of center of gravity (m) (KGLC)	4.49	4.82
Fore draft (m)	5.87	
Aft draft (m)	5.46	
Mean draft (m)	5.67	
Displacement (t)	4800.74	
Height of center of gravity (m)	3.69	3.77
Metacentric height (m)	1.70	1.62
Angle of list (°)	13.11	14.36
Listing moment lever (m)	0.36	0.36

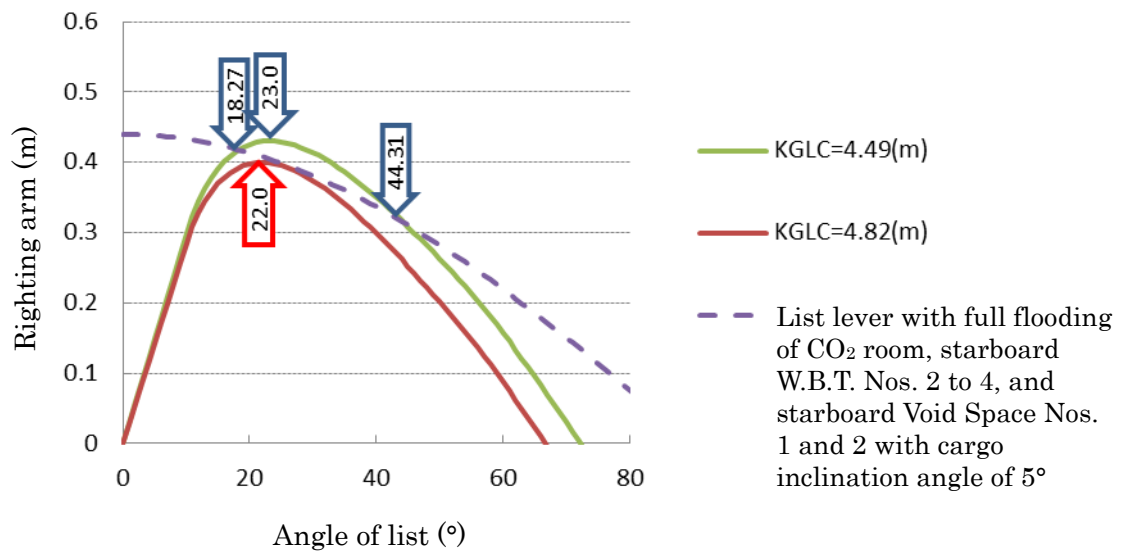
Figure 13 Stability Curves (Full Flooding of CO₂ Room, Starboard W.B.T. Nos. 2 to 4, and Starboard Void Space Nos. 1 and 2 with Cargo Inclination Angle of 5°
[Lateral Shift in Cargo's Center of Gravity of 0.35 m])

To reproduce the approximately 18° angle of list revealed by the JTSB Investigation, we estimated the Vessel's situation and residual stability in a state in which, in addition to the circumstances described in 3.4 above, the cargo moved to produce a cargo inclination angle of 5°. A cargo inclination angle of 5° corresponds to a lateral shift of 0.35 m in the cargo's center of gravity. The Vessel's situation in this state is shown in Table 16 and the stability curves are shown in Figure 13. The angle of list in this state is 18.3° when KGLC = 4.49 (m). Moreover, residual stability is extremely small, corresponding to approximately 0.03 m at maximum stability lever. From this, it can be inferred that the Vessel would be in a state in which capsizing is unavoidable. In the case of KGLC = 4.82 (m), the angle of list at the point of intersection between the stability curve and listing moment lever cannot be obtained, meaning that the Vessel would be in a capsizing state.

Light-condition height of center of gravity (m) (KGLC)	4.49	4.82
Fore draft (m)	5.87	
Aft draft (m)	5.46	
Mean draft (m)	5.67	
Displacement (t)	4800.74	
Height of center of gravity (m)	3.69	3.77
Metacentric height (m)	1.70	1.62
Angle of list (°)	18.27	-
Listing moment lever (m)	0.42	-

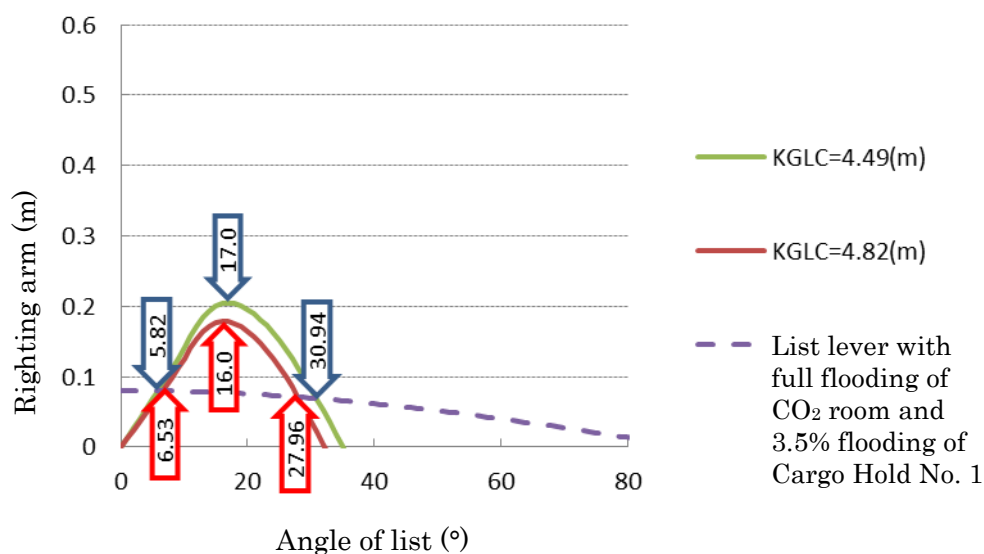
Figure 14 Stability Curves (Full Flooding of CO₂ Room and 3.5% Flooding of Cargo Hold No. 1)

Light-condition height of center of gravity (m) (KGLC)	4.49	4.82
Fore draft (m)	5.60	
Aft draft (m)	5.16	
Mean draft (m)	5.38	
Displacement (t)	4520.90	
Height of center of gravity (m)	3.71	3.78
Metacentric height (m)	0.78	0.69
Angle of list (°)	5.82	6.53
Listing moment lever (m)	0.08	0.08

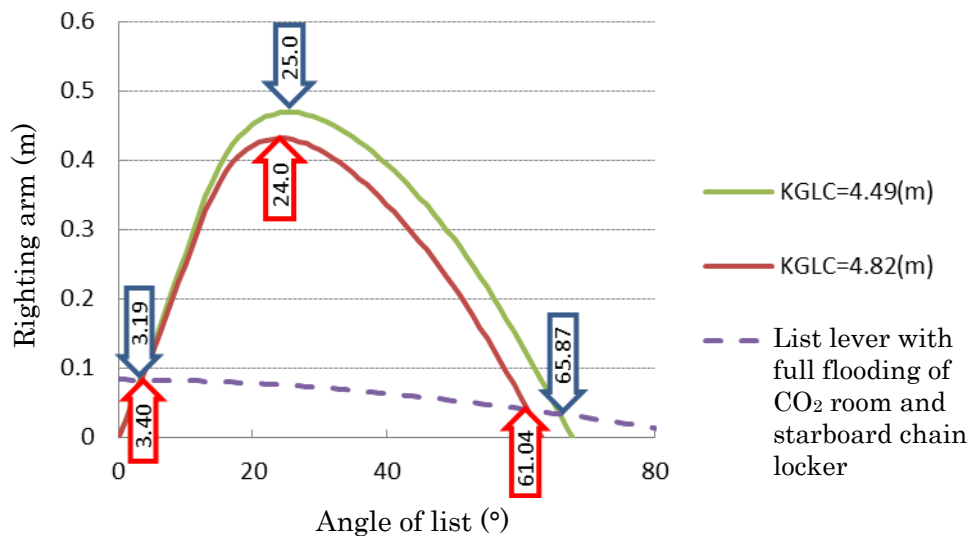
Figure A1 Stability Curves (Full Flooding of CO₂ Room and Starboard Chain Locker)

Light-condition height of center of gravity (m) (KGLC)	4.49	4.82
Fore draft (m)	5.50	
Aft draft (m)	5.17	
Mean draft (m)	5.33	
Displacement (t)	4481.76	
Height of center of gravity (m)	3.73	3.82
Metacentric height (m)	1.49	1.40
Angle of list (°)	3.19	3.40
Listing moment lever (m)	0.08	0.08

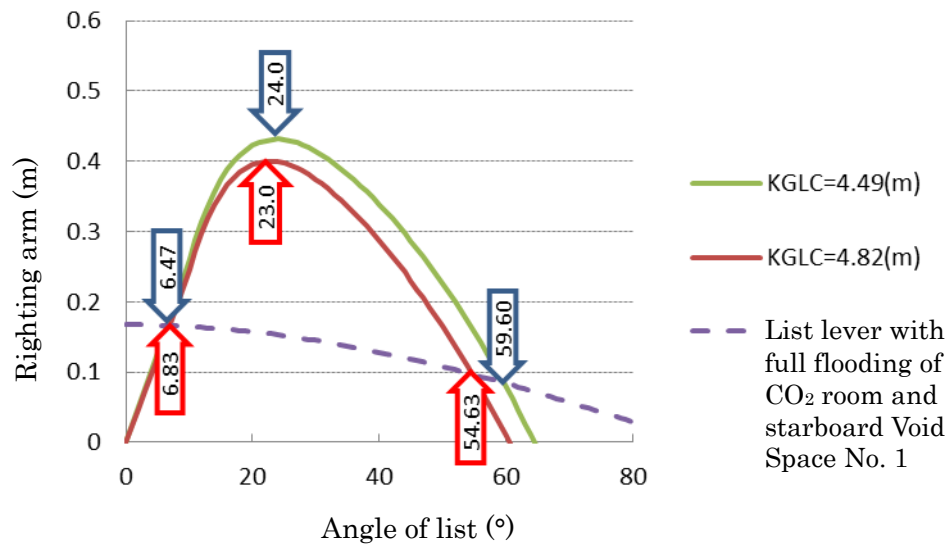
Figure A2 Stability Curves (Full Flooding of CO₂ Room and Starboard Void Space No. 1)

Light-condition height of center of gravity (m) (KGLC)	4.49	4.82
Fore draft (m)	5.66	
Aft draft (m)	5.15	
Mean draft (m)	5.40	
Displacement (t)	4542.86	
Height of center of gravity (m)	3.77	3.85
Metacentric height (m)	1.46	1.38
Angle of list (°)	6.47	6.83
Listing moment lever (m)	0.17	0.17

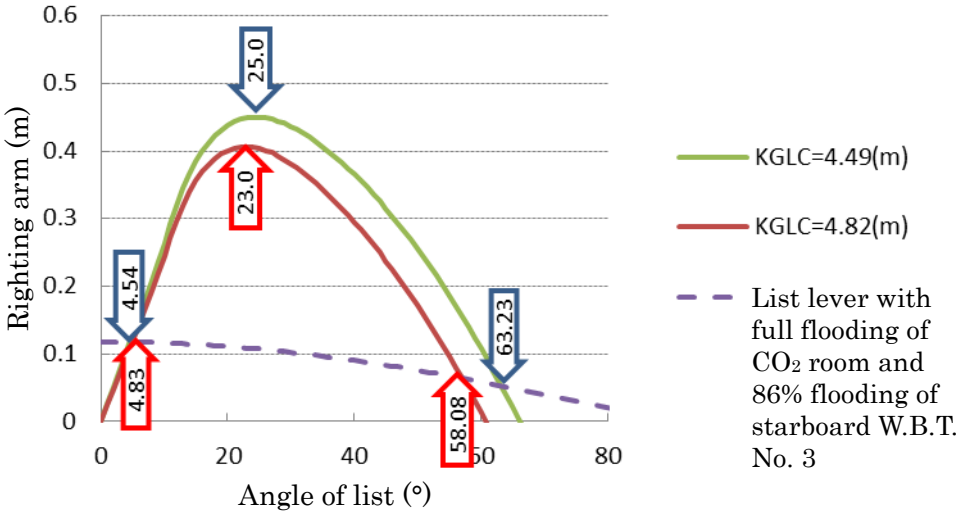
Figure A3 Stability Curves (Full Flooding of CO₂ Room and 86% Flooding of Starboard W.B.T. No. 3)

Light-condition height of center of gravity (m) (KGLC)	4.49	4.82
Fore draft (m)	5.50	
Aft draft (m)	5.25	
Mean draft (m)	5.37	
Displacement (t)	4520.84	
Height of center of gravity (m)	3.70	3.79
Metacentric height (m)	1.48	1.39
Angle of list (°)	4.54	4.83
Listing moment lever (m)	0.12	0.12

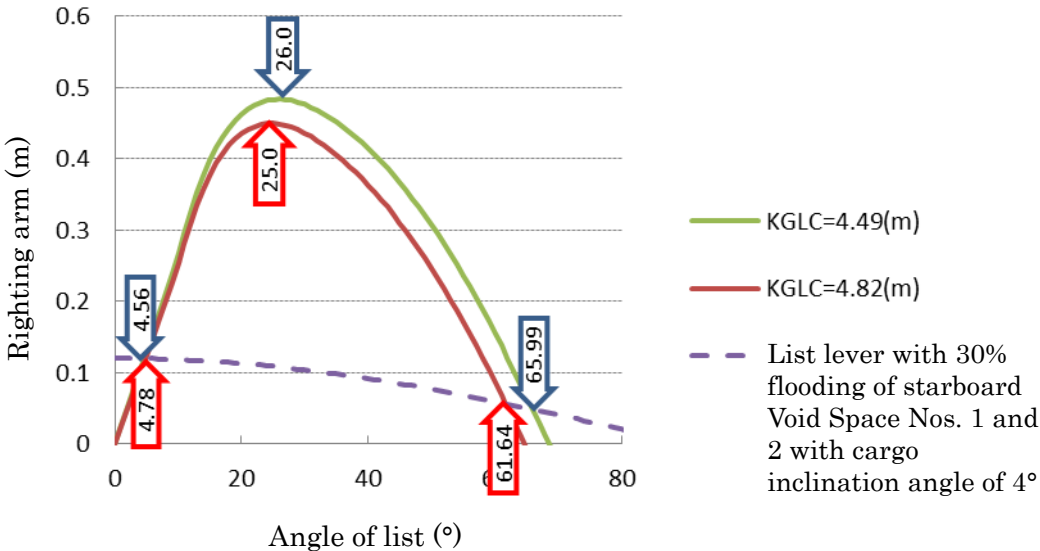
Figure A4 Stability Curves (30% Flooding of Starboard Void Space Nos. 1 and 2 with Cargo Inclination Angle of 4° [Lateral Shift in Cargo’s Center of Gravity of 0.30 m])

Light-condition height of center of gravity (m) (KGLC)	4.49	4.82
Fore draft (m)	5.27	
Aft draft (m)	5.33	
Mean draft (m)	5.30	
Displacement (t)	4456.36	
Height of center of gravity (m)	3.72	3.80
Metacentric height (m)	1.50	1.42
Angle of list (°)	4.56	4.78
Listing moment lever (m)	0.12	0.12

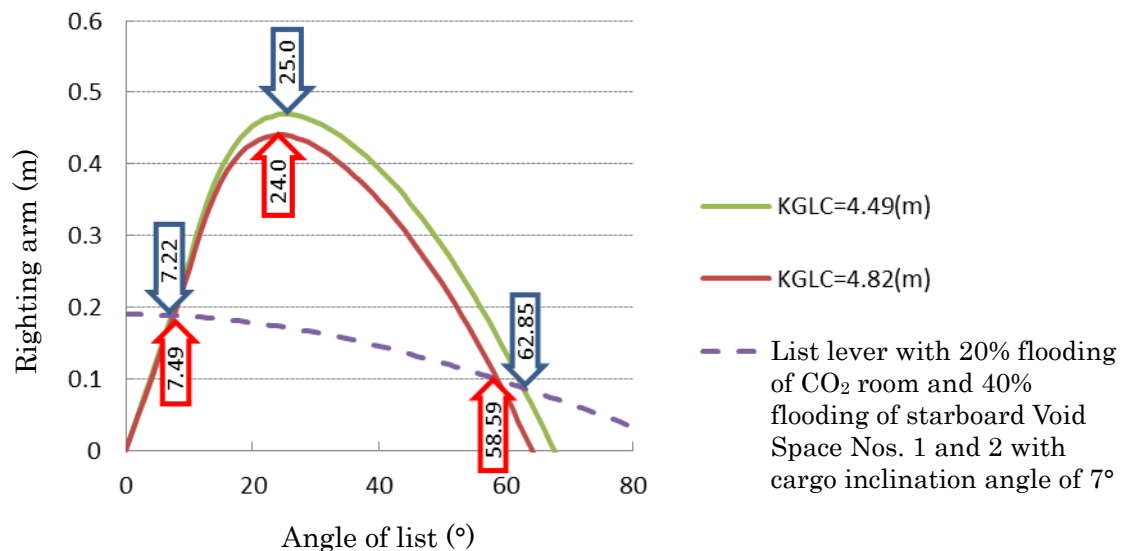
Figure A5 Stability Curves (20% Flooding of CO₂ Room and 40% Flooding of Starboard Void Space Nos. 1 and 2 with Cargo Inclination Angle of 7° [Lateral Shift in Cargo's Center of Gravity of 0.47 m])

Light-condition height of center of gravity (m) (KGLC)	4.49	4.82
Fore draft (m)	5.35	
Aft draft (m)	5.32	
Mean draft (m)	5.33	
Displacement (t)	4485.28	
Height of center of gravity (m)	3.73	3.81
Metacentric height (m)	1.49	1.42
Angle of list (°)	7.22	7.49
Listing moment lever (m)	0.19	0.19

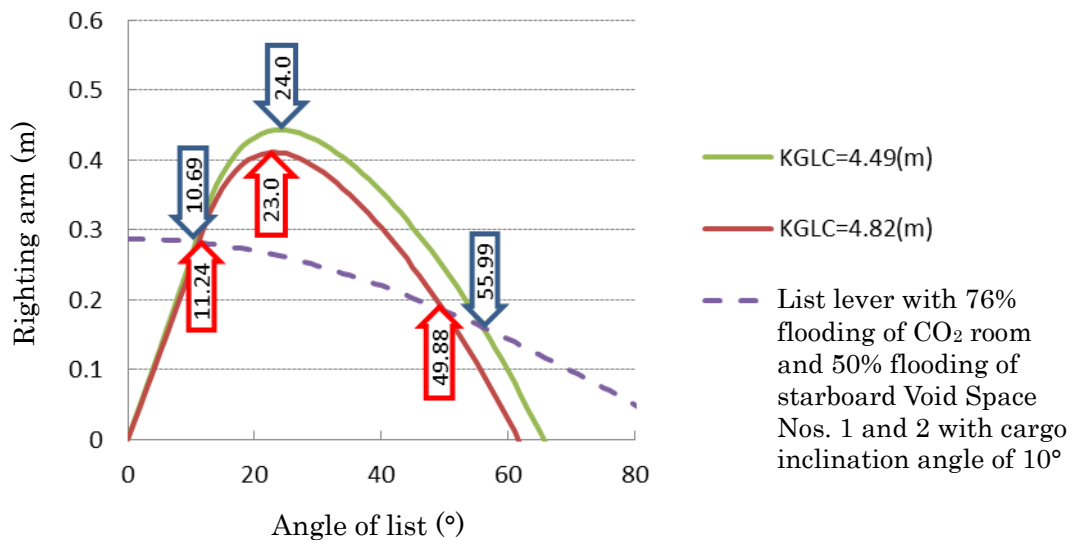
Figure A6 Stability Curves (76% Flooding of CO₂ Room and 50% Flooding of Starboard Void Space Nos. 1 and 2 with Cargo Inclination Angle of 10° [Lateral Shift in Cargo's Center of Gravity of 0.64 m])

Light-condition height of center of gravity (m) (KGLC)	4.49	4.82
Fore draft (m)	5.51	
Aft draft (m)	5.27	
Mean draft (m)	5.39	
Displacement (t)	4537.20	
Height of center of gravity (m)	3.75	3.83
Metacentric height (m)	1.48	1.40
Angle of list (°)	10.69	11.24
Listing moment lever (m)	0.28	0.28

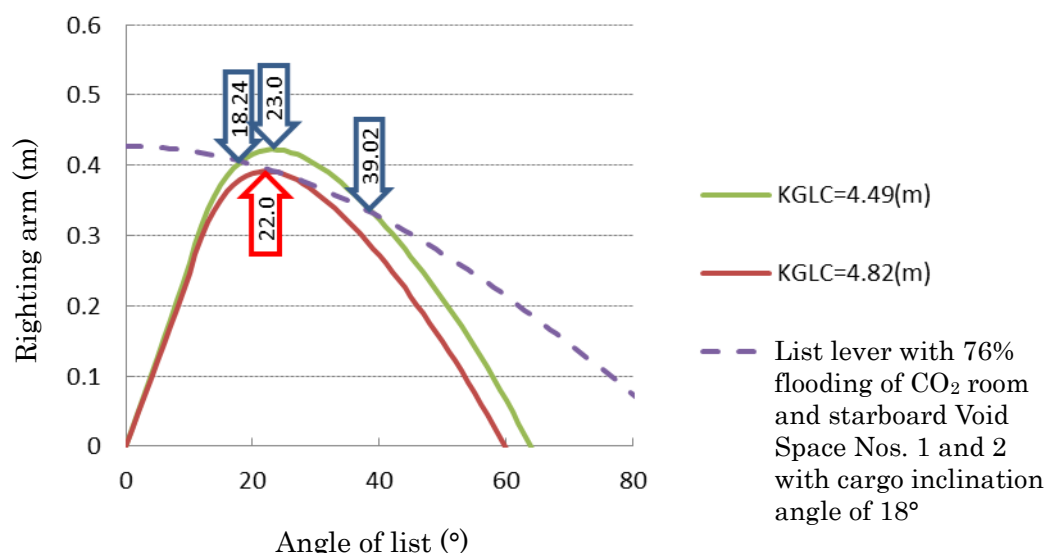
Figure A7 Stability Curves (76% Flooding of CO₂ Room and Starboard Void Space Nos. 1 and 2 with Cargo Inclination Angle of 18° [Lateral Shift in Cargo's Center of Gravity of 1.11 m])

Light-condition height of center of gravity (m) (KGLC)	4.49	4.82
Fore draft (m)	5.57	
Aft draft (m)	5.30	
Mean draft (m)	5.43	
Displacement (t)	4579.22	
Height of center of gravity (m)	3.77	3.85
Metacentric height (m)	1.46	1.38
Angle of list (°)	18.24	-
Listing moment lever (m)	0.41	0.41

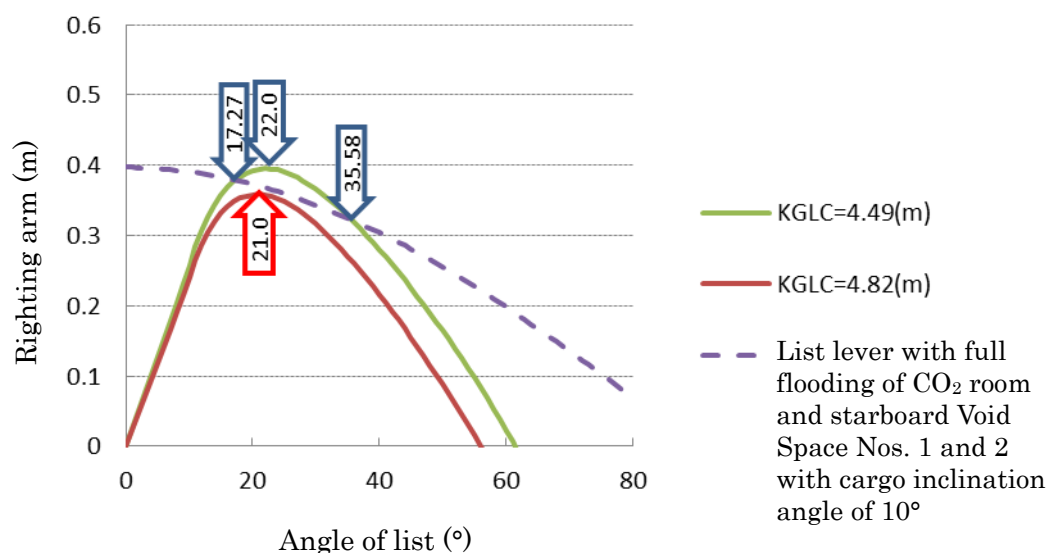
Figure A8 Stability Curves (Full Flooding of CO₂ Room and Starboard Void Space Nos. 1 and 2 with Cargo Inclination Angle of 10° [Lateral Shift in Cargo's Center of Gravity of 0.64 m])

Light-condition height of center of gravity (m) (KGLC)	4.49	4.82
Fore draft (m)	5.70	
Aft draft (m)	5.29	
Mean draft (m)	5.50	
Displacement (t)	4635.58	
Height of center of gravity (m)	3.80	3.91
Metacentric height (m)	1.45	1.34
Angle of list (°)	17.27	-
Listing moment lever (m)	0.38	-

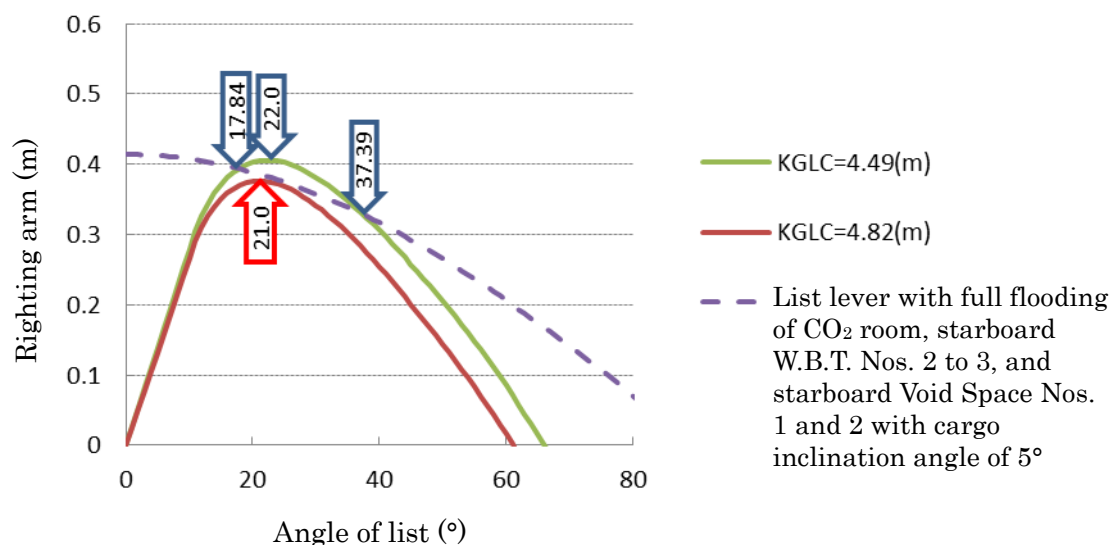
Figure A9 Stability Curves (Full Flooding of CO₂ Room, Starboard W.B.T. Nos. 2 and 3, and Starboard Void Space Nos. 1 and 2 with Cargo Inclination Angle of 5°
[Lateral Shift in Cargo's Center of Gravity of 0.35 m])

Light-condition height of center of gravity (m) (KGLC)	4.49	4.82
Fore draft (m)	5.88	
Aft draft (m)	5.35	
Mean draft (m)	5.61	
Displacement (t)	4747.88	
Height of center of gravity (m)	3.73	3.81
Metacentric height (m)	1.58	1.50
Angle of list (°)	17.84	-
Listing moment lever (m)	0.39	-
