MA2016-10

**MARINE ACCIDENT
INVESTIGATION REPORT**

Accident type	Fatality of a grain inspector
Date and time	Around 08:50 on October 19, 2015 (local time, UTC+9 hours)
Location	Kobe Section 2 Grain Wharf, Hanshin Port Around 050° true bearing, 2,610m from Kobe No.5 Breakwater East Lighthouse (approximately 34° 42.10' N, 135° 15.70' E)
Summary of the Accident	At around 08:50 on October 19, 2015, while the cargo ship TRITON SWAN was engaged in cargo handling work at Kobe Section 2 Grain Wharf, Hanshin Port, a grain inspector died inside the No. 3 cargo hold where there was an oxygen deficiency hazard.
Process and Progress of the Investigation	(1) Set up of the Investigation The Japan Transport Safety Board appointed an investigator-in-charge and one other marine accident investigator to investigate this accident on October 19, 2015. Three accident investigators from the Kobe Office also took part in the investigation of this accident. (2) Collection of Evidence October 19 and 20: On-site investigations and interviews October 21 and 22, December 25, 2015, February 19 and 23, April 27, 2016: Interviews December 20 and 21, 2015, January 7 and April 7, 2016: Collection of questionnaire

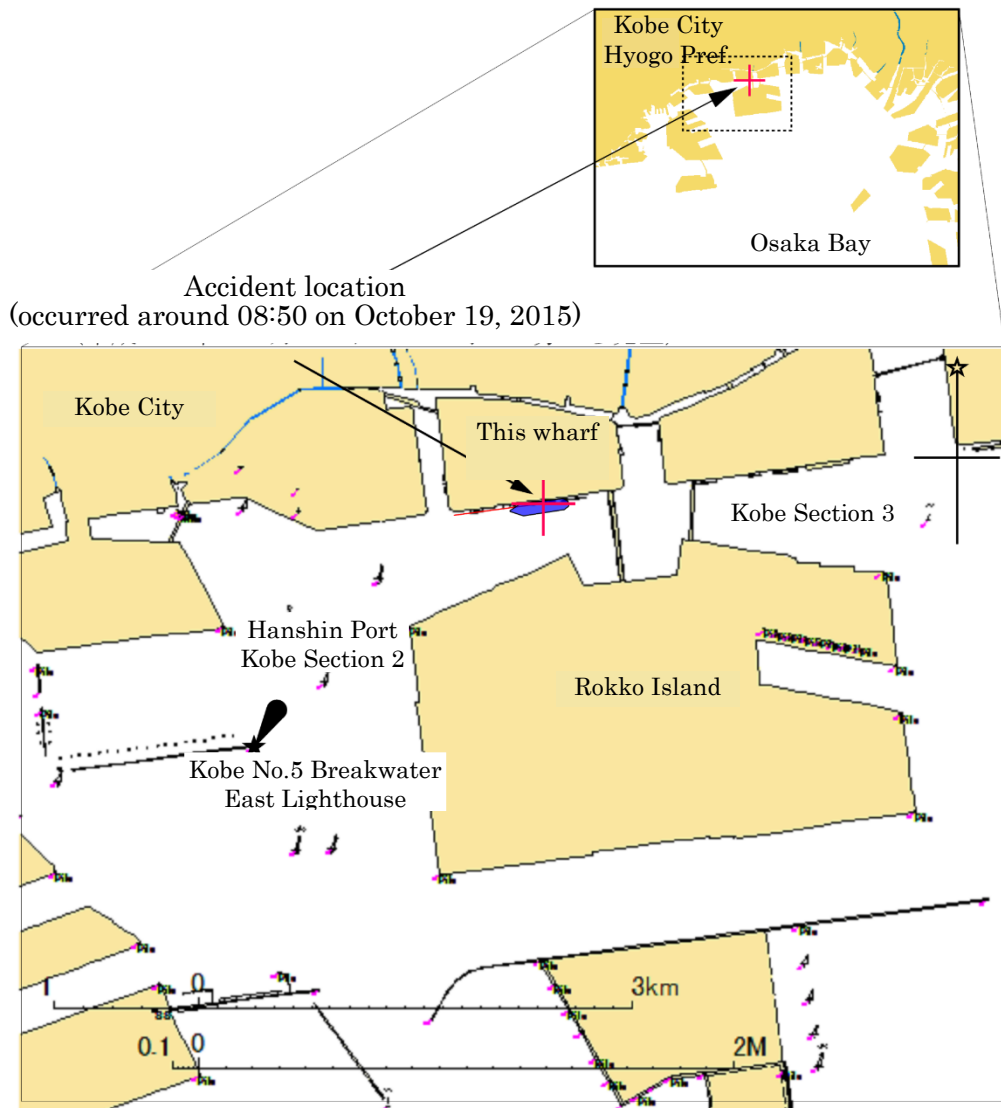
Fig. 1 Sketch map of the accident location

<p>day, the cause of death was certified as asphyxiation due to oxygen deficiency (tentative) and the time of death as 08:50 (tentative). (See Fig. 1 Sketch map of the accident location, Fig. 2 Sketch of the accident situation)</p>
<p>Other Matters</p>	<p>(1) The No. 3 cargo hold had been locked and this hatch had been sealed using a security tag from the time when the vessel left port in the USA until it docked at this wharf and the hatch was opened.</p> <p>(2) Upon request from the cargo owner, Association A was planning to have this inspector, Inspector A and Inspector B inspect the maize loaded on the vessel from the morning of October 19.</p> <p>(3) Although inspection work is normally carried out after staff of the Ministry of Agriculture, Forestry and Fisheries have undertaken plant quarantine, Association A sometimes carried out quality checks to confirm that there was no damage or other defect in the grain before plant quarantine, as part of this inspection work.</p> <p>(4) When its employees were to enter hazardous locations where there was a risk of oxygen deficiency when carrying out inspection work such as gauging grain temperature or sampling, Association A required them to enter only after asking the cargo handling manager for the result of oxygen concentration measurement and confirming safety, irrespective of whether before or after plant quarantine had been carried out.</p> <p>(5) Caution notices announcing “AUTHORISED ENTRY ONLY” (in English, red letters on a yellow background)” and “LACK OF O₂ (in English, black letters)” were permanently displayed on the top of the access hatch of the vessel.</p> <p>(6) If, after opening the access hatch and measuring the oxygen concentration in the cargo hold, it was judged safe to enter the hold, the cargo handling manager would display a sign marked “検査済み OK” (“Inspected OK”) in Japanese, and if the oxygen concentration was low, the sign would read “酸欠” (“Oxygen low”). (See Photos 8 and 9)</p> <div style="display: flex; justify-content: space-around; align-items: center;">     </div> <p style="text-align: center;">Photo 8 Caution notice on the top Photo 9 Sign permitting hold entry</p>
