**MARINE ACCIDENT  
INVESTIGATION REPORT**

Vessel type and name: Cargo Ship TAI YUAN

Accident type: Fire

Date and time: Around 13:20, April 24, 2017 (local time, UTC +9 hours)

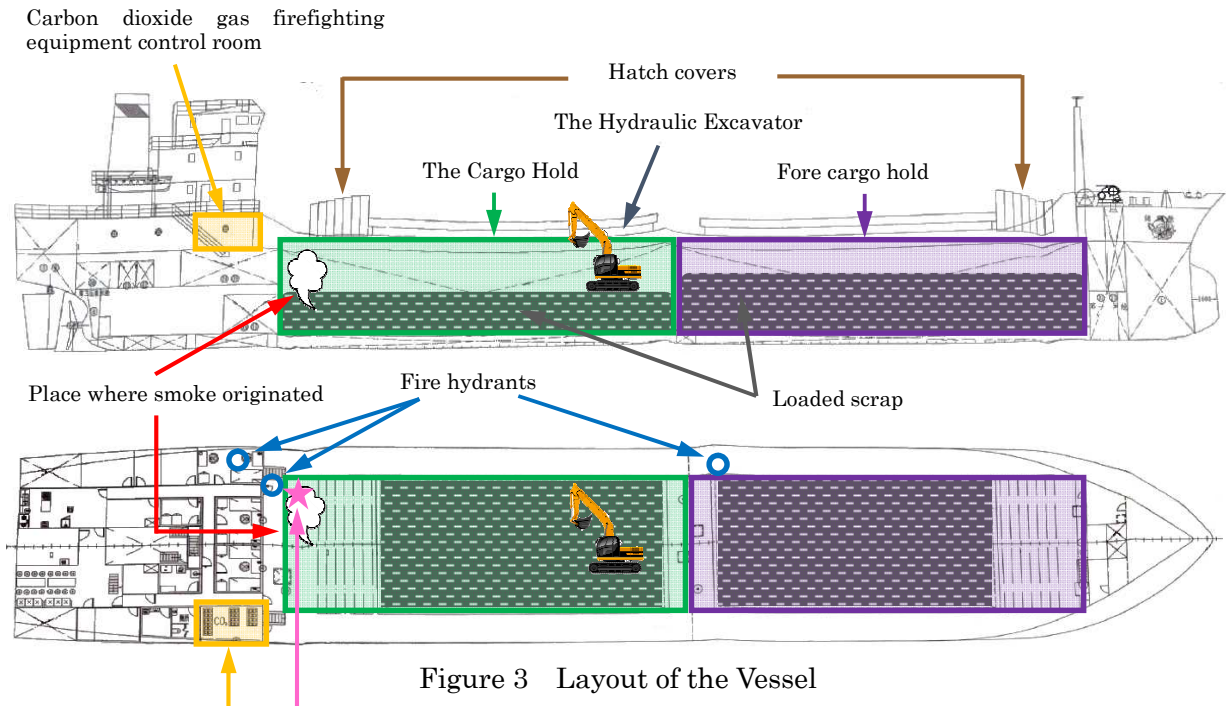
Figure 3 Layout of the Vessel

(See Figure 3 and Figure 4)

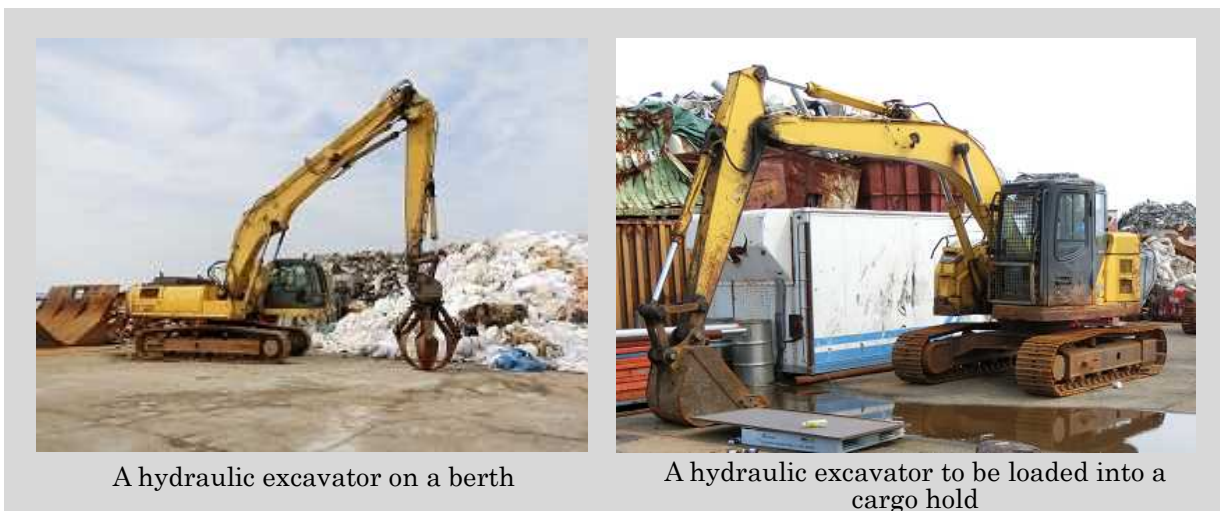
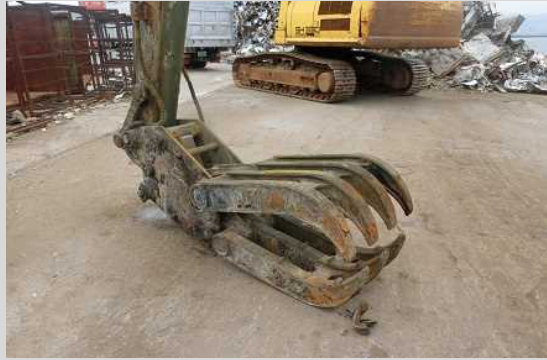
Figure 6 Hydraulic Excavators for Berths and aft cargo holds

A hydraulic excavator loaded into the cargo hold crushed the scrap with its fork claw and compressed and evened it out by driving on top of it so as to permit the loading of more scrap.

Company A was conducting the same work described above when it loaded the Vessel.  
(See Figure 6)

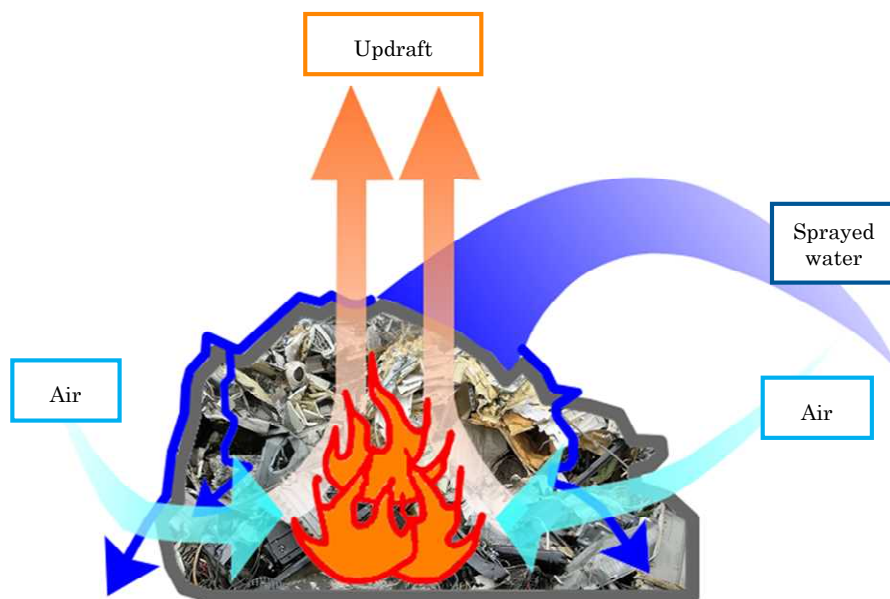
Figure 7 Conceptual Image of a Fire Inside Piled Scrap

- a A source of fire is generated from some cause. It ignites combustible material and immediately spreads.
- b A source of fire is generated from some cause. It ignites combustible material and then, due to surrounding circumstances, enters a state of flameless combustion before becoming combustion with flame after the passage of time.
- c A place of heat is generated from some cause. The place ignites or ignites combustible material after heat builds up with the passage of time.

- a Sparks created by contact between metal objects
- b Electrical cause created by a battery or electrical cell
- c Metal and acid reaction
- d Oxidation heat from unsaturated oil

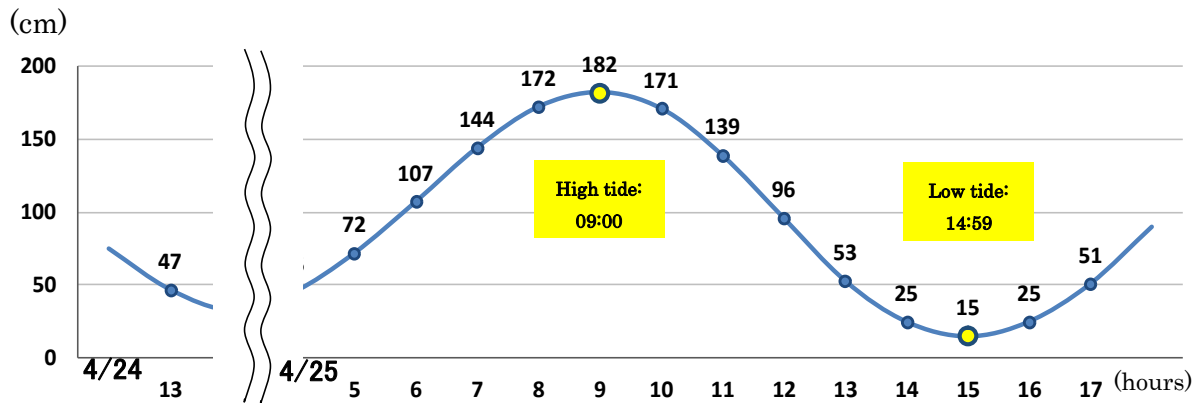
Figure 8 Changes in High/Low Tide and Height of Tide

According to the tide table published by Japan Coast Guard, the tide and the height of tide in Hakata Higashi-hama was as follows.
