MA2019-12

**MARINE ACCIDENT  
INVESTIGATION REPORT**

# MARINE ACCIDENT INVESTIGATION REPORT

<b>Accident type</b>	Collision with seawall
<b>Date and time</b>	Around 01:47 on October 1, 2018 (local time, UTC+9 hours)
<b>Location</b>	Kawasaki section, Keihin Port, Kanagawa Prefecture (seawall at JFE Steel in Ogishima) Around 355° true bearing, 550 m from Toden-Ogishima LNG Berth Light (approximately 35°28.5' N, 139°44.3' E)
<b>Summary of the Accident</b>	Under the situation where Typhoon No. 24 was approaching, while being anchored at an anchorage in Yokohama section, Keihin Port, a cargo ship, MARINA, with 12 crew members, including the master, dragged the anchor and drifted toward to the northeast, and collided with the seawall at Ogishima, Kawasaki section. MARINA suffered dents, etc. to her starboard stern. The seawall suffered collision damage, etc.
<b>Process and Progress of the Investigation</b>	(1) Set up of the Investigation The Japan Transport Safety Board appointed an investigator-in-charge and two other marine accident investigators to investigate this accident on October 1, 2018. (2) Collection of Evidence On-site investigation and interview on October 1 and 2, 2018; i

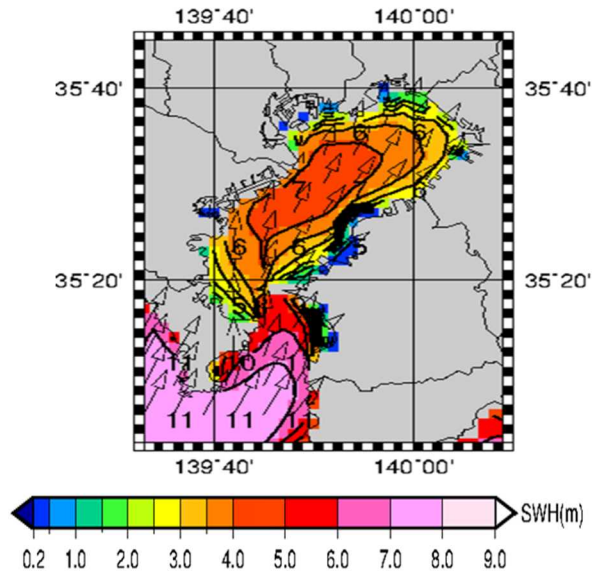
Figure 1: Estimates at 02:00 on October 1st based on the Shallow-water Wave Model

Regarding the estimates of waves at the site of occurrence of the accident around 02:00 (around the time of the accident) on October 1st based on the Japan Meteorological Agency's Shallow-water Wave Model, the wave period was 6 to 7 s and the wave height was about 3 to 5 m.

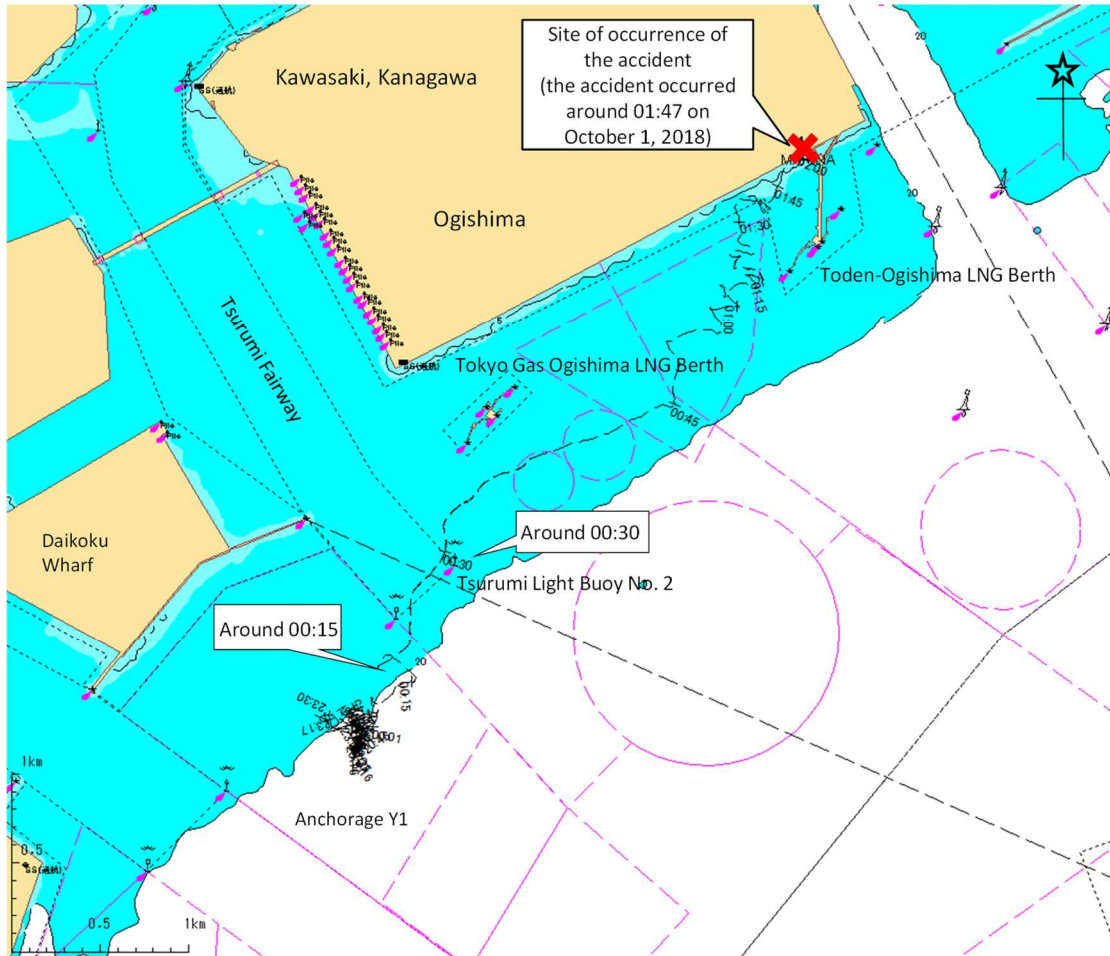
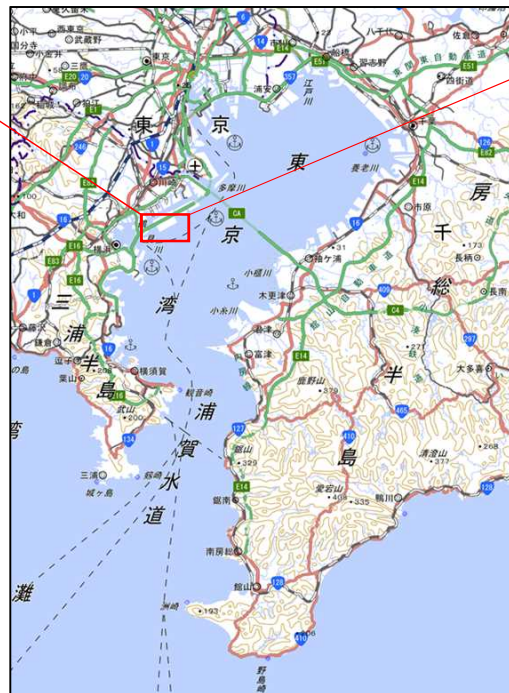
Attached Figure 1: Navigation Track (overall)

<p>windlass.</p> <p>Around 00:15 on October 1st, the master recognized that Vessel B was approaching the vessel and avoided Vessel B by using the main engine and rudder. However, during the maneuvering for this avoidance, the vessel started dragging the anchor. Therefore, the master set the main engine to full ahead but could not stop dragging of the anchor.</p> <p>The vessel drifted toward the northeast, and collided with the seawall from the starboard stern around 01:47.</p> <p>Around 02:00, the stern was flooded, and the vessel was hit by a strong wind and the starboard was pressed against the seawall.</p> <p>All the crew of the vessel got off the vessel and landed the seawall around 02:10.</p> <p>(See Attached Figure 1: Navigation Track (Overall) and Attached Table 1: AIS Records of the Vessel (Extract).)</p>
Other Matters	<p>The master conducted the confirmation operation of the windlass as a preparation for heavy weather on the day before the accident but found nothing wrong.</p> <p>When the vessel departed from the Port of Chiba, she was in ballast and the ballast tank was full, and the bow was of about 1.40 m draft and the stern was about 3.70 m draft.</p>
