**MARINE ACCIDENT
INVESTIGATION REPORT**

Vessel type and name: Cargo Ship BUNGO PRINCESS

Accident type: Collision (bridge)

Date and time: Around 03:12, September 9, 2019 (local time, UTC+9 hours)

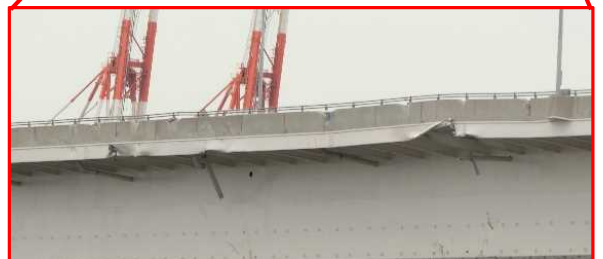
Photo 2 Damage to the Bridge

Steel plate deck box girder bridge

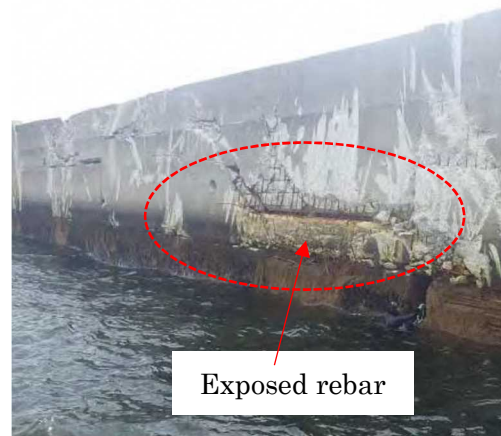
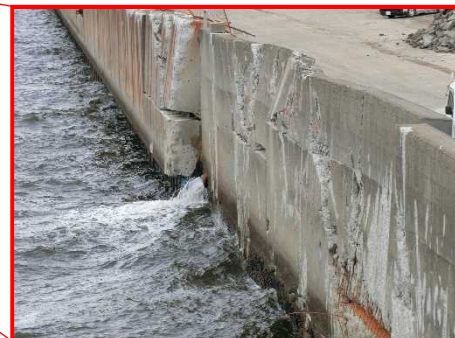
Photo 3 Damage to the Seawall (Excerpt)

According to the on-site investigation, the reply to the questionnaire by the Port and Harbor Bureau of the City of Yokohama, and the statement of the person in charge at said bureau, gouges, abrasions, and other damage were sustained by about 460 m of an approximately 560-meter-long seawall (concrete) that is adjacent to the eastern side of the Bridge. (See Photo 3)

Abrasions and detached concrete
