**MARINE ACCIDENT
INVESTIGATION REPORT**

Vessel type and name: Cargo Ship WAKASHIO

Accident/Incident type: Grounding

Location: Shallows off the southeast coast of the island of Mauritius, Republic of
Mauritius
(approximately 20°26.5'S, 057°44.7'E)

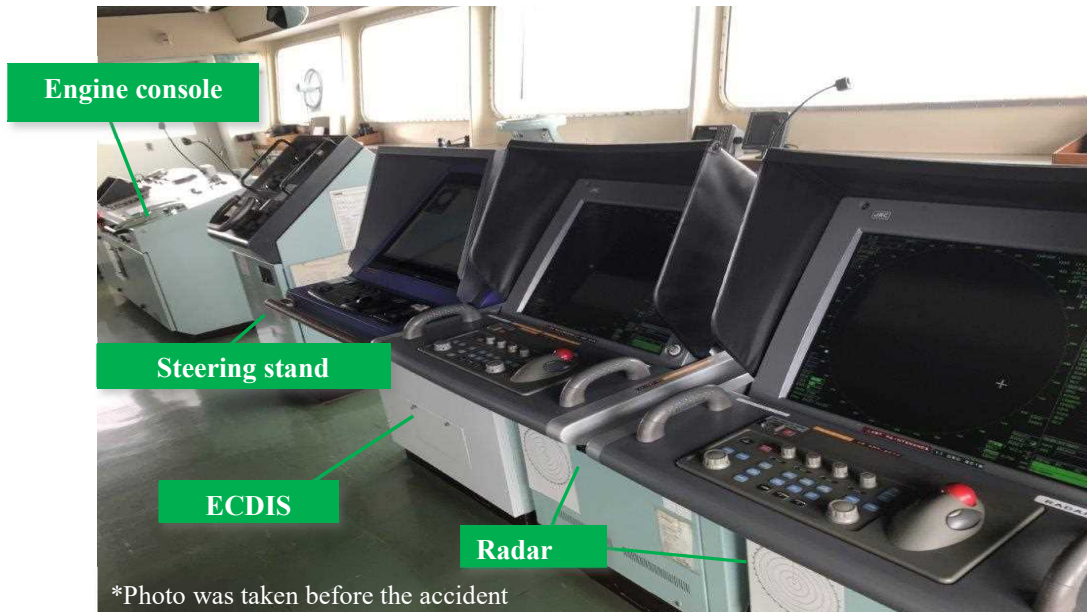
Photo 1 The Vessel's Bridge (Seen from the Rear Starboard Side)

At around 19:00, Navigation Officer A₁'s smartphone lost the signal and he was using the ship's satellite telephone to inquire with an acquaintance in his home country about ways of receiving a signal when, at around 19:18, the Master pointed out that the Vessel's distance from the shore was very close at 1.5 M. Navigation Officer A₁ responded turning to port and altering course to about 227°.

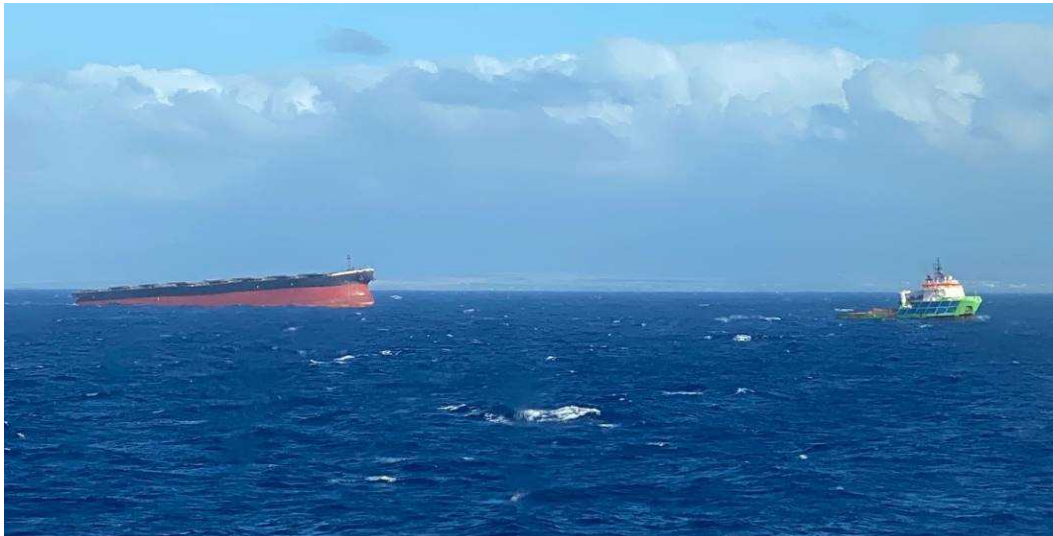
Photo 8 The Vessel's Bow Portion being Towed by Tugboat A

The Salvage Team received the instruction from the Government of Mauritius to dump the Vessel's bow portion at sea on August 19th. After obtaining Company A's confirmation for this, the team removed the hydraulic oil and other harmful substances from the bow portion, connected a tug line, and at around 18:00 on August 19th, began towing the portion to the dumping site using Tugboat A. (See Photo 8)

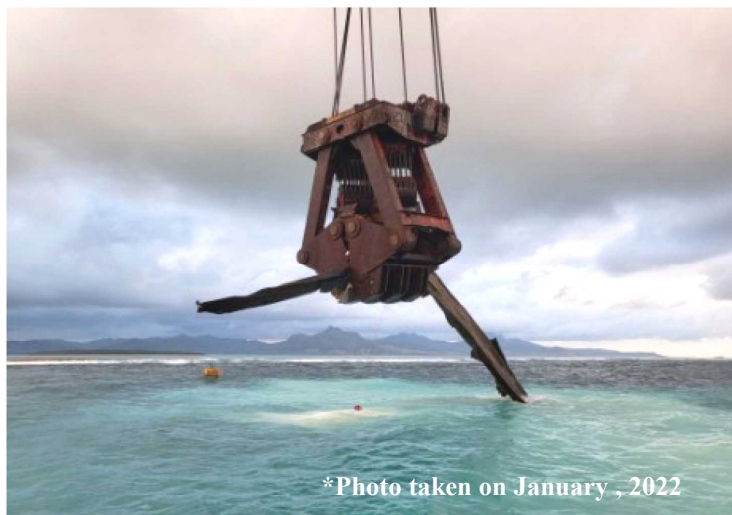
Photo 9 A Part of the Hull Being Lifted from the Seafloor

The salvage company began removing the Vessel's stern portion on February 17, 2021, and completed that work on January 16, 2022. (See Photo 9)

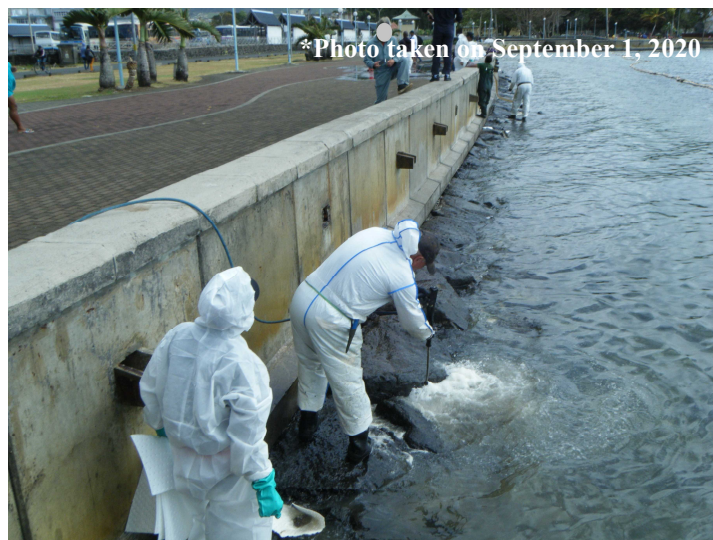
Photo 14 Cleanup Operations on the Embarkment (Mahébourg)

Immediately after the Accident, the Government of Mauritius's Special Mobile Force (hereinafter referred to as the "Special Mobile Force"), Mauritius Coast Guard, and fishermen and other local residents (about 200 people on weekdays and about 2,000 people on non-work days) carried out oil control operations that included recovering and cleaning up onshore oil. These operations were shifted to two cleaning companies that were mainly secured by the shipowner on August 19. (See Photo 14 and Photo 15)

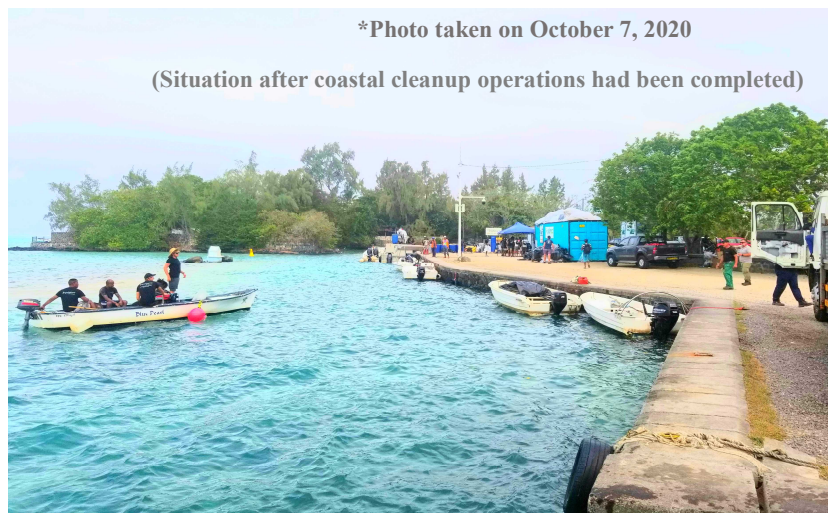
Photo 16 A Cleanup Operations Base (Pointe Jerome)

The two cleaning companies conducted oil control operations from August 19 until January 9, 2021. The Government of Mauritius and an environmental research company commissioned by the Government had conducted a completion survey from January 19 to 26, and the completion of the oil control operations was confirmed on January 27, 2021. (See Photo 16 and Photo 17)

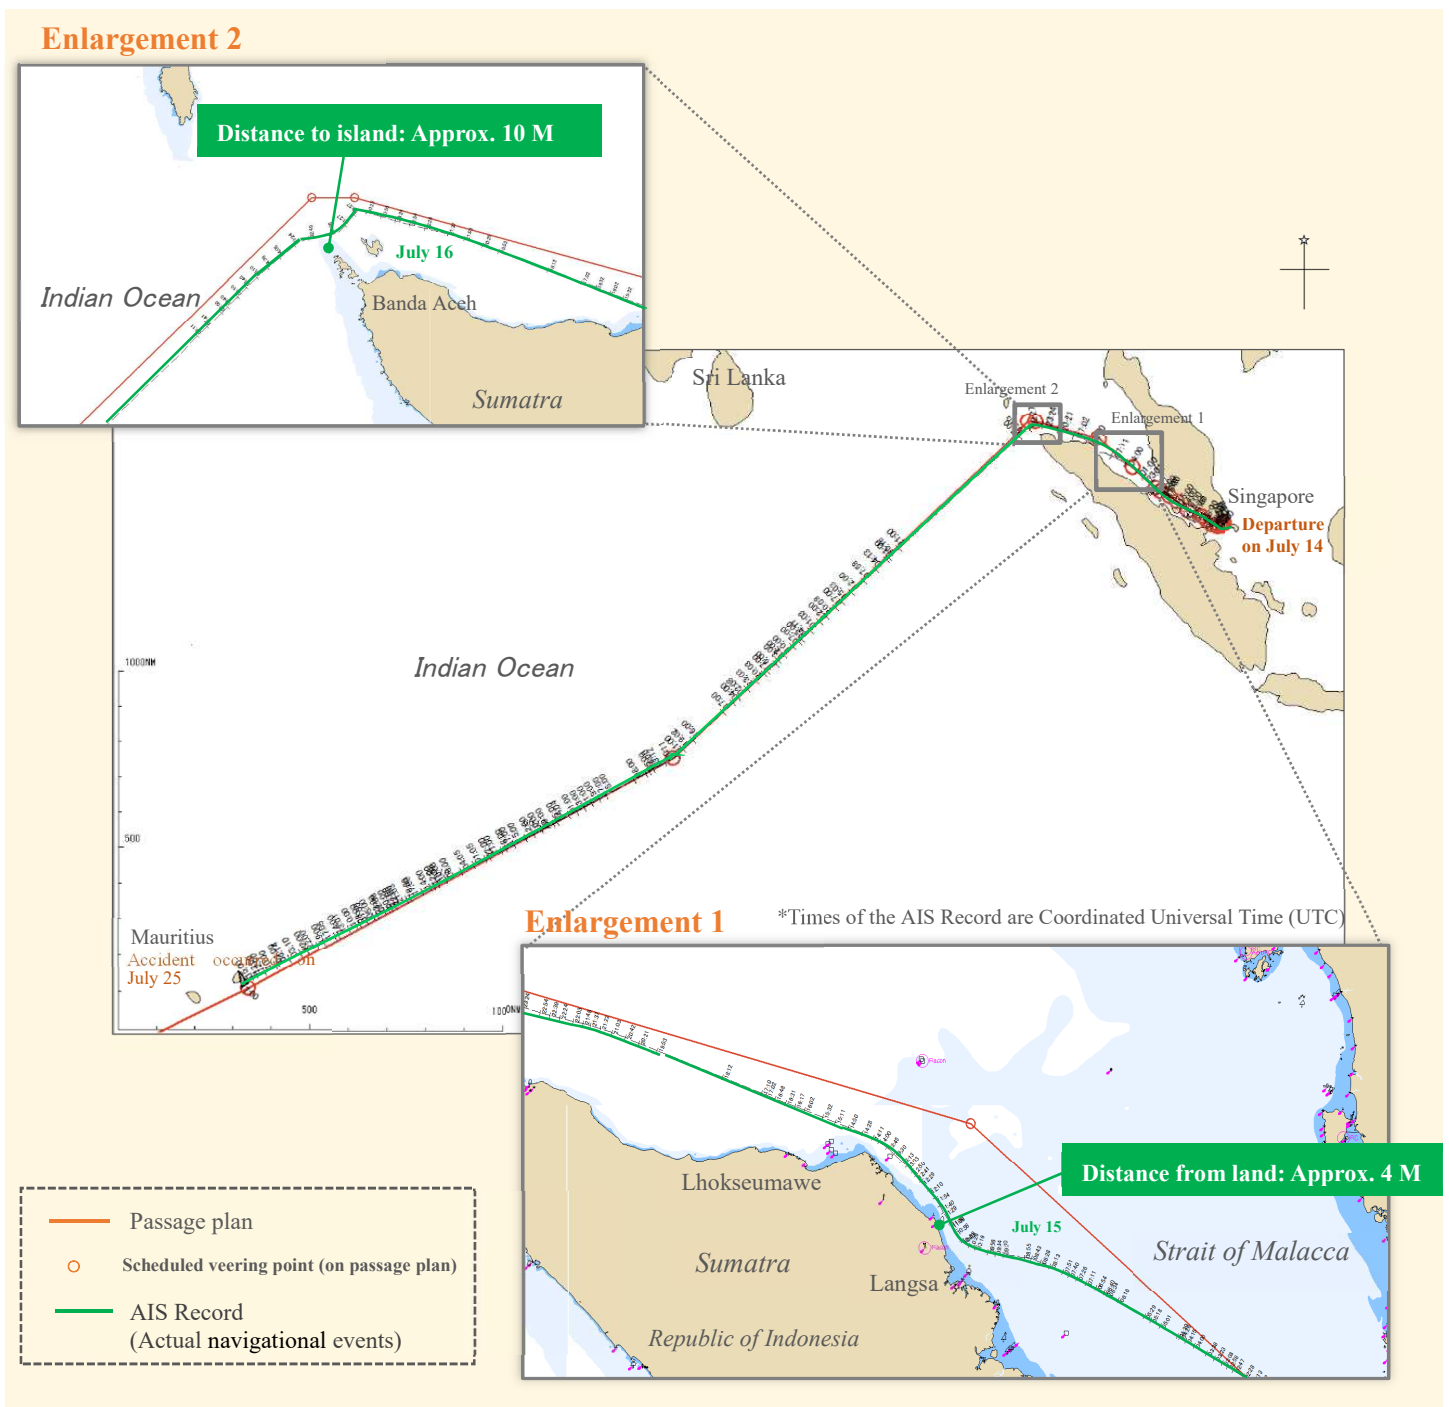
Figure 13 Passage Plan and Actual Navigational Events

Before the Vessel left her previous port (Port of Singapore), Navigator Officer A₂ prepared a passage plan up to the next port (Port of Tubarão) on the ECDIS and the Master approved the plan. However, because there was no requirement to submit the passage plan to either Company A or Company B, the Vessel did not submit the plan, including changes to the plan, to either company.

After leaving the Port of Singapore, the Vessel left her passage plan's planned course and approached land, etc., on July 15 and 16 (see Enlargement 1 and Enlargement 2 of Figure 13).

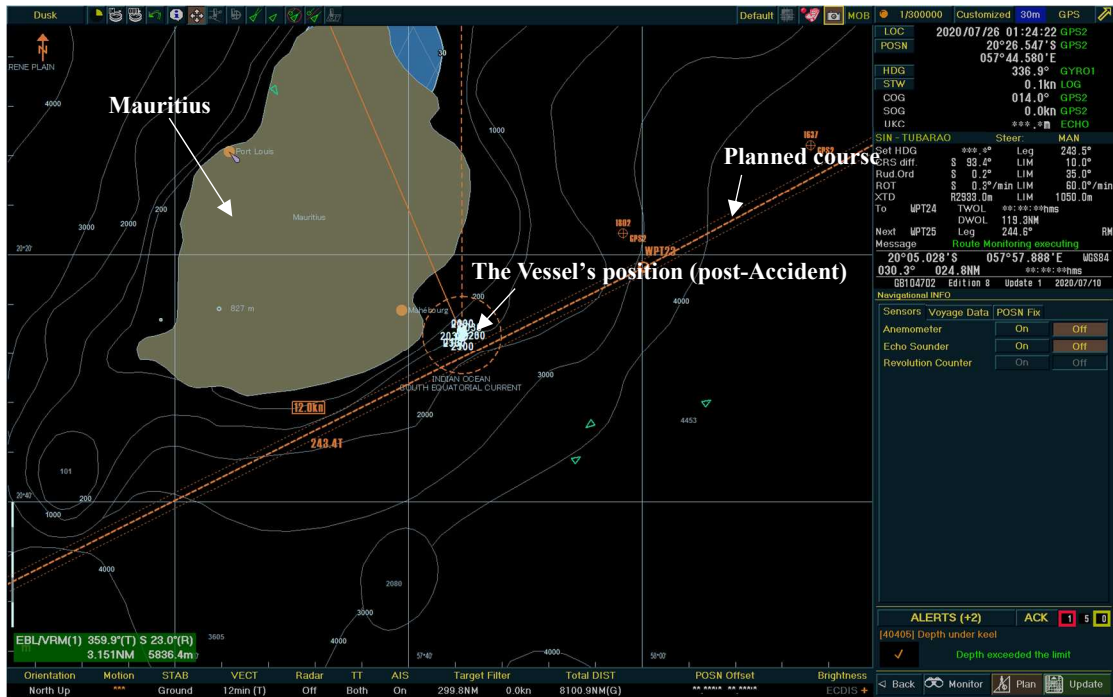
Photo 19 The Vessel's ECDIS Screen (Recorded after the Accident)

The “paper nautical charts and ENC” (hereinafter referred to as “Charts, etc.” that the Vessel was using at the time of the Accident were as shown in Table 6. The Vessel did not have Charts, etc., showing detailed depths, coastal topography, and other features for the area around Mauritius nor did she have the Sailing Directions providing information on the sea area around Mauritius. (See Photo 19)

Because the Vessel was not scheduled to enter port at Mauritius, the Master thought detailed Charts, etc., for the area around the island were unnecessary.
