MA2024-03

**MARINE ACCIDENT  
INVESTIGATION REPORT**

<b>Accident type</b>	Grounding
<b>Date and time</b>	Around 09:20 on January 24, 2023
<b>Location</b>	Off the northwest of Taketomi Island, Taketomi Town, Okinawa Prefecture Around 268° true bearing, 3.8 nautical miles (M) from Ryukyu Kannonzaki Lighthouse (Approx. 24°21.8'N 124°02.6'E)
<b>Summary of the Accident</b>	The cargo ship XIN HAI ZHOU 2 was drifting for the purpose of time adjustment off the west of Ishigaki Island, Ishigaki City, Okinawa Prefecture, when she was pushed by the wind and waves. She therefore started her main engine and navigation; however, she continued to be pushed without gaining sufficient propulsion or rudder effect and ran aground on a shallow reef off the northwest of Taketomi Island. XIN HAI ZHOU 2's hull subsequently broke in two at her center section.
<b>Process and Progress of the Investigation</b>	The Japan Transport Safety Board appointed an investigator-in-charge and two other marine accident investigators to investigate this accident on January 24, 2023. January 26 and 27, 2023: Interviews January 28, 2023: On-site investigation February 1, 7 to 9, 14, and 15; March 3 and 31; April 19 and 2

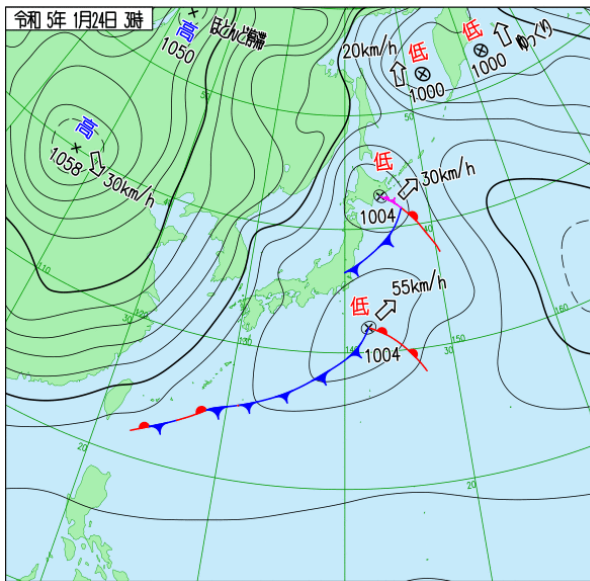
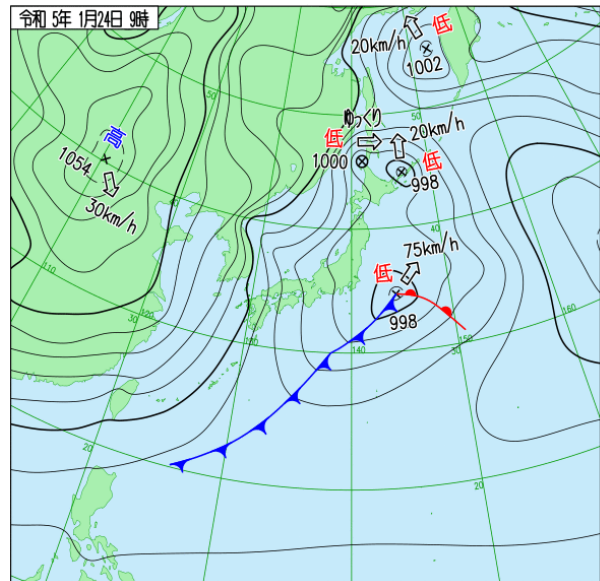
# Annex Figure 1 Weather Charts

(See Annex Figure 1 Weather Charts)

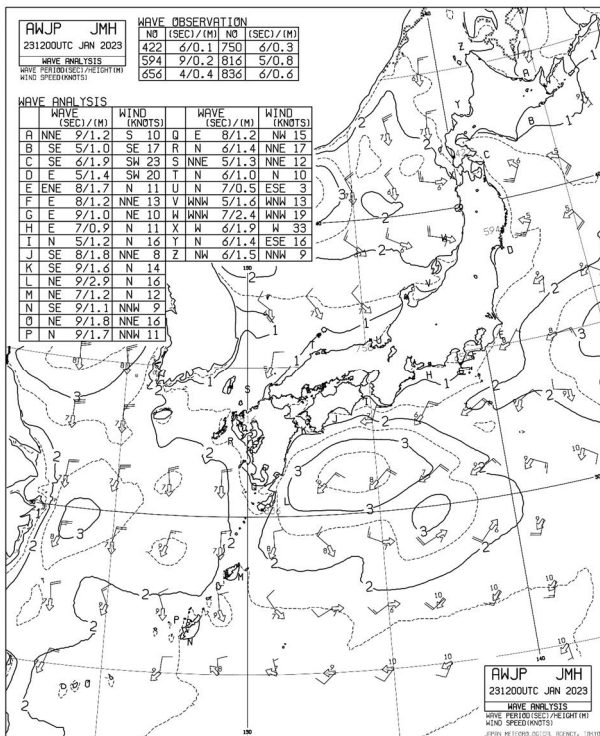
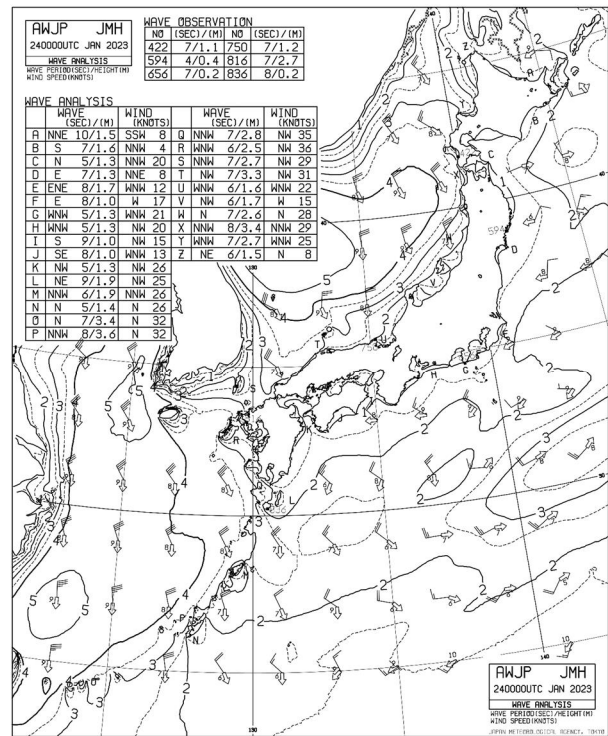
# Annex Figure 2 Coastal Wave Analysis Chart

(4) According to the coastal wave analysis chart, significant wave heights in the sea area near the location of the accident were under 2 meters at 21:00 on January 23 and between approximately 2 and 3 meters at 09:00 on January 24. (See Figure 2 and Annex Figure 2 Coastal Wave Analysis Chart)

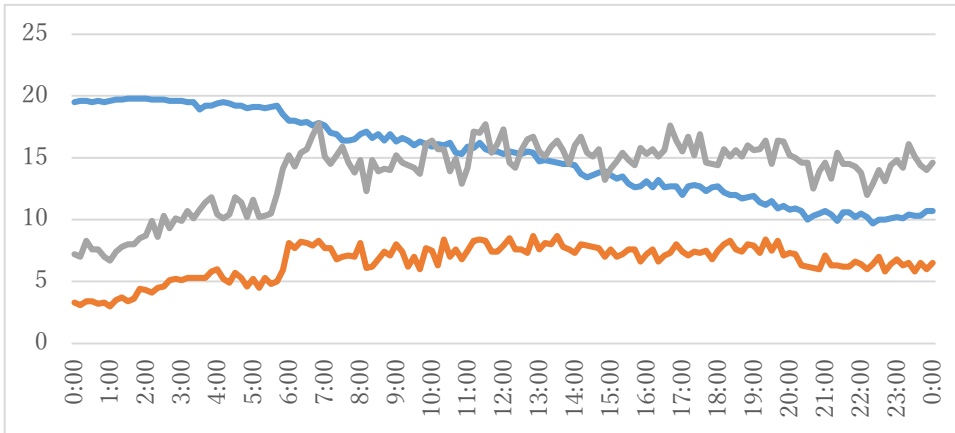
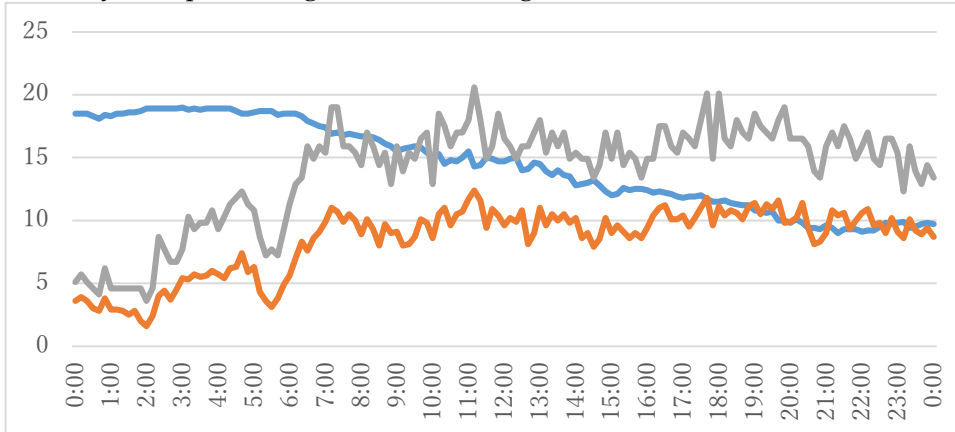
### Annex Figure 3 AMeDAS Observations

wind subsequently gained intensity at Iriomote Island and Ishigaki Island as well, and at 09:00, the wind speed was 13 m/s at Ishigakijima Meteorological Observation Station, located approximately 6.8 M east-southeast of the accident site. (See Figure 3 and Annex Figure 3 AMeDAS Observations)
