Railway Accident Investigation Report

Train Derailment Accident between Urasa station and Nagaoka station
of the Joetsu Shinkansen of the East Japan Railway Company

November 30, 2007

Aircraft and Railway Accidents Investigation Commission

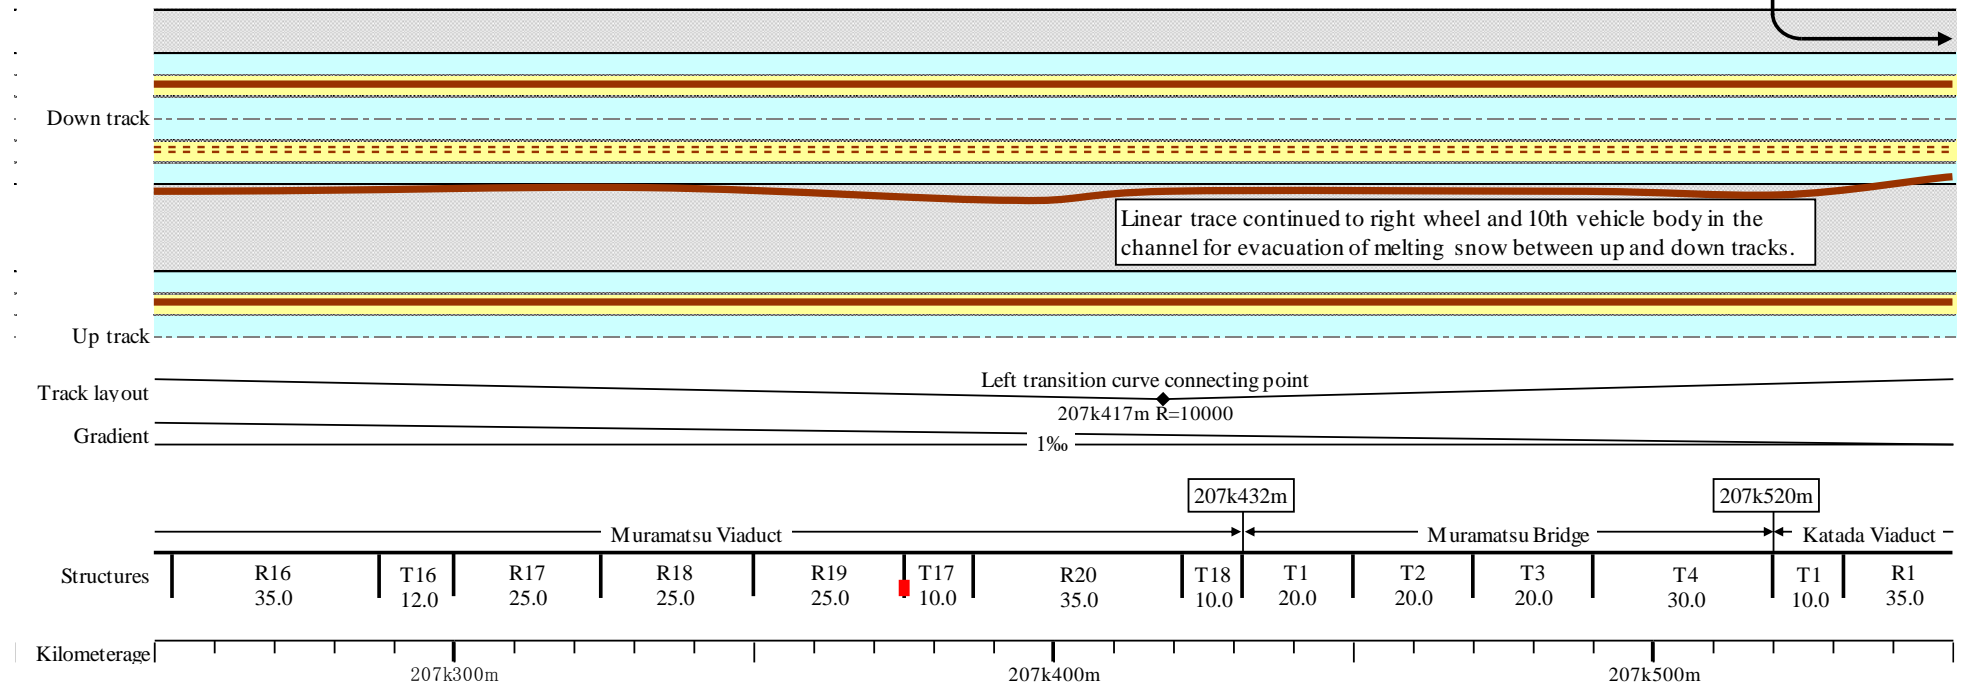
Figure 2. Status of Damages of the Tracks I (6/7)

10th vehicle had leaned as right wheels fell into channel for evacuation of melting snow. Photo was taken from around 207,550m on Oct. 24.

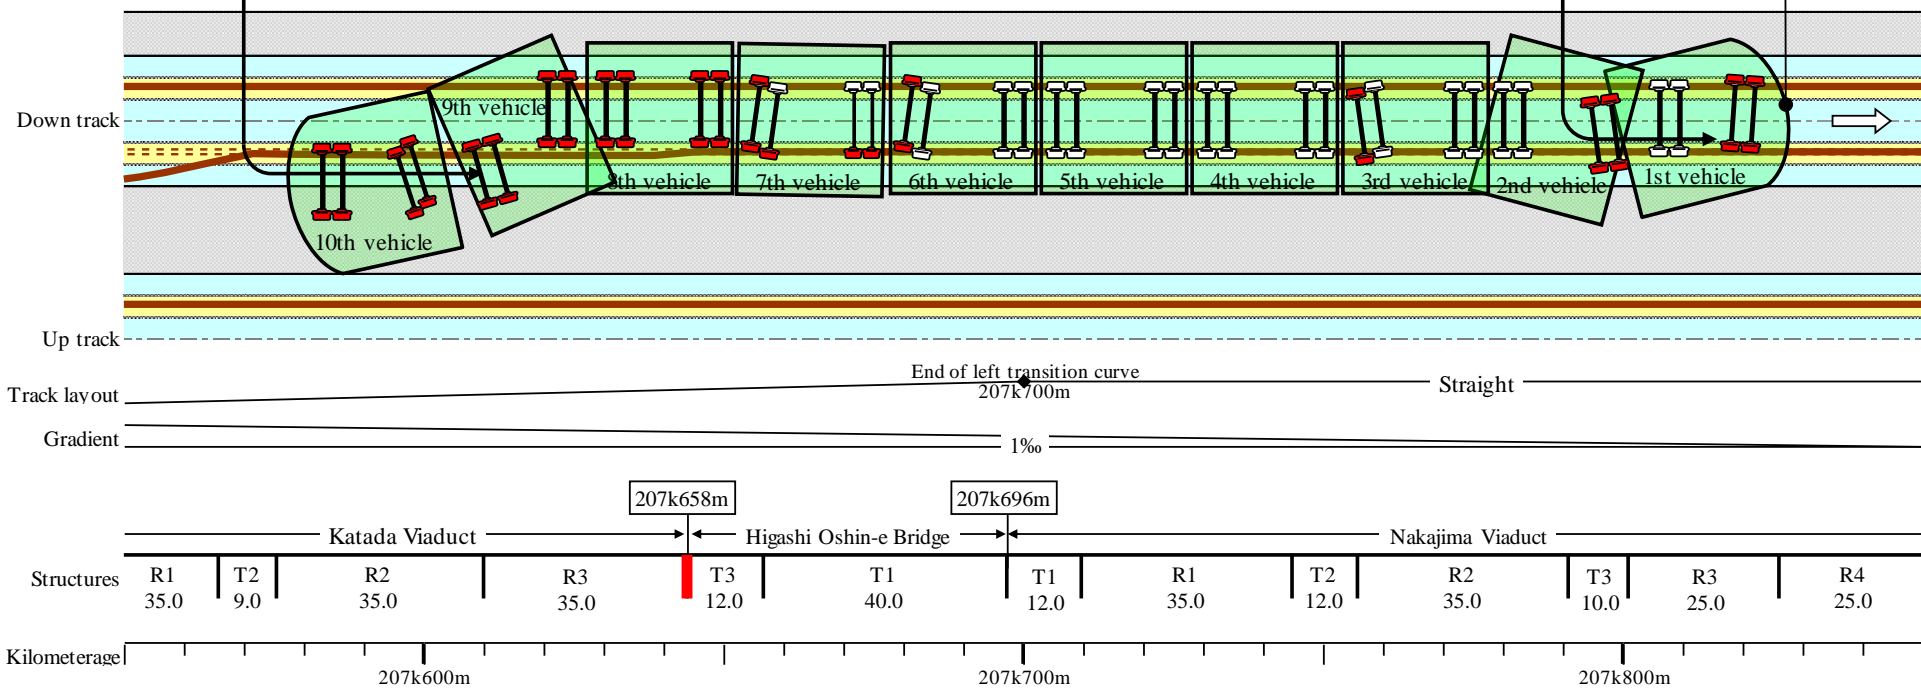
Stopped position of the train, around 207,828m.

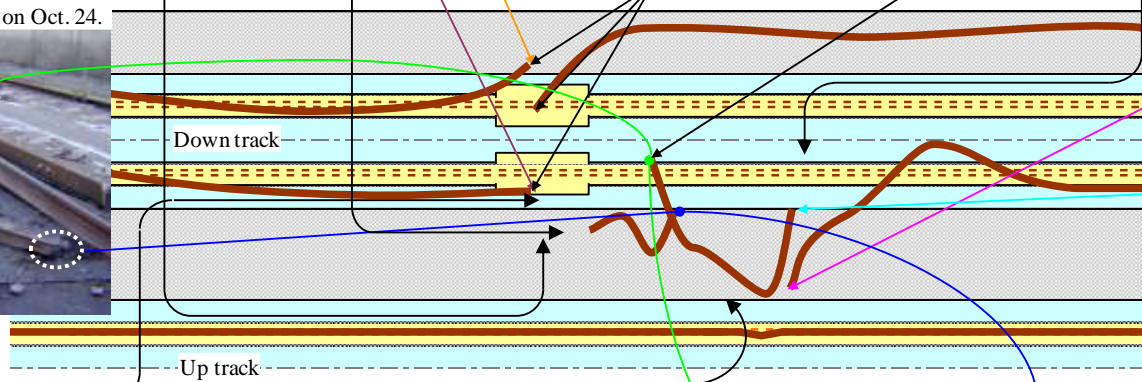
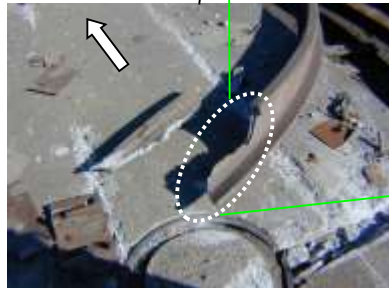
(4) Broken right rail and pieces of rail scattered in around. Photo was taken around 206,717m on Oct. 24.

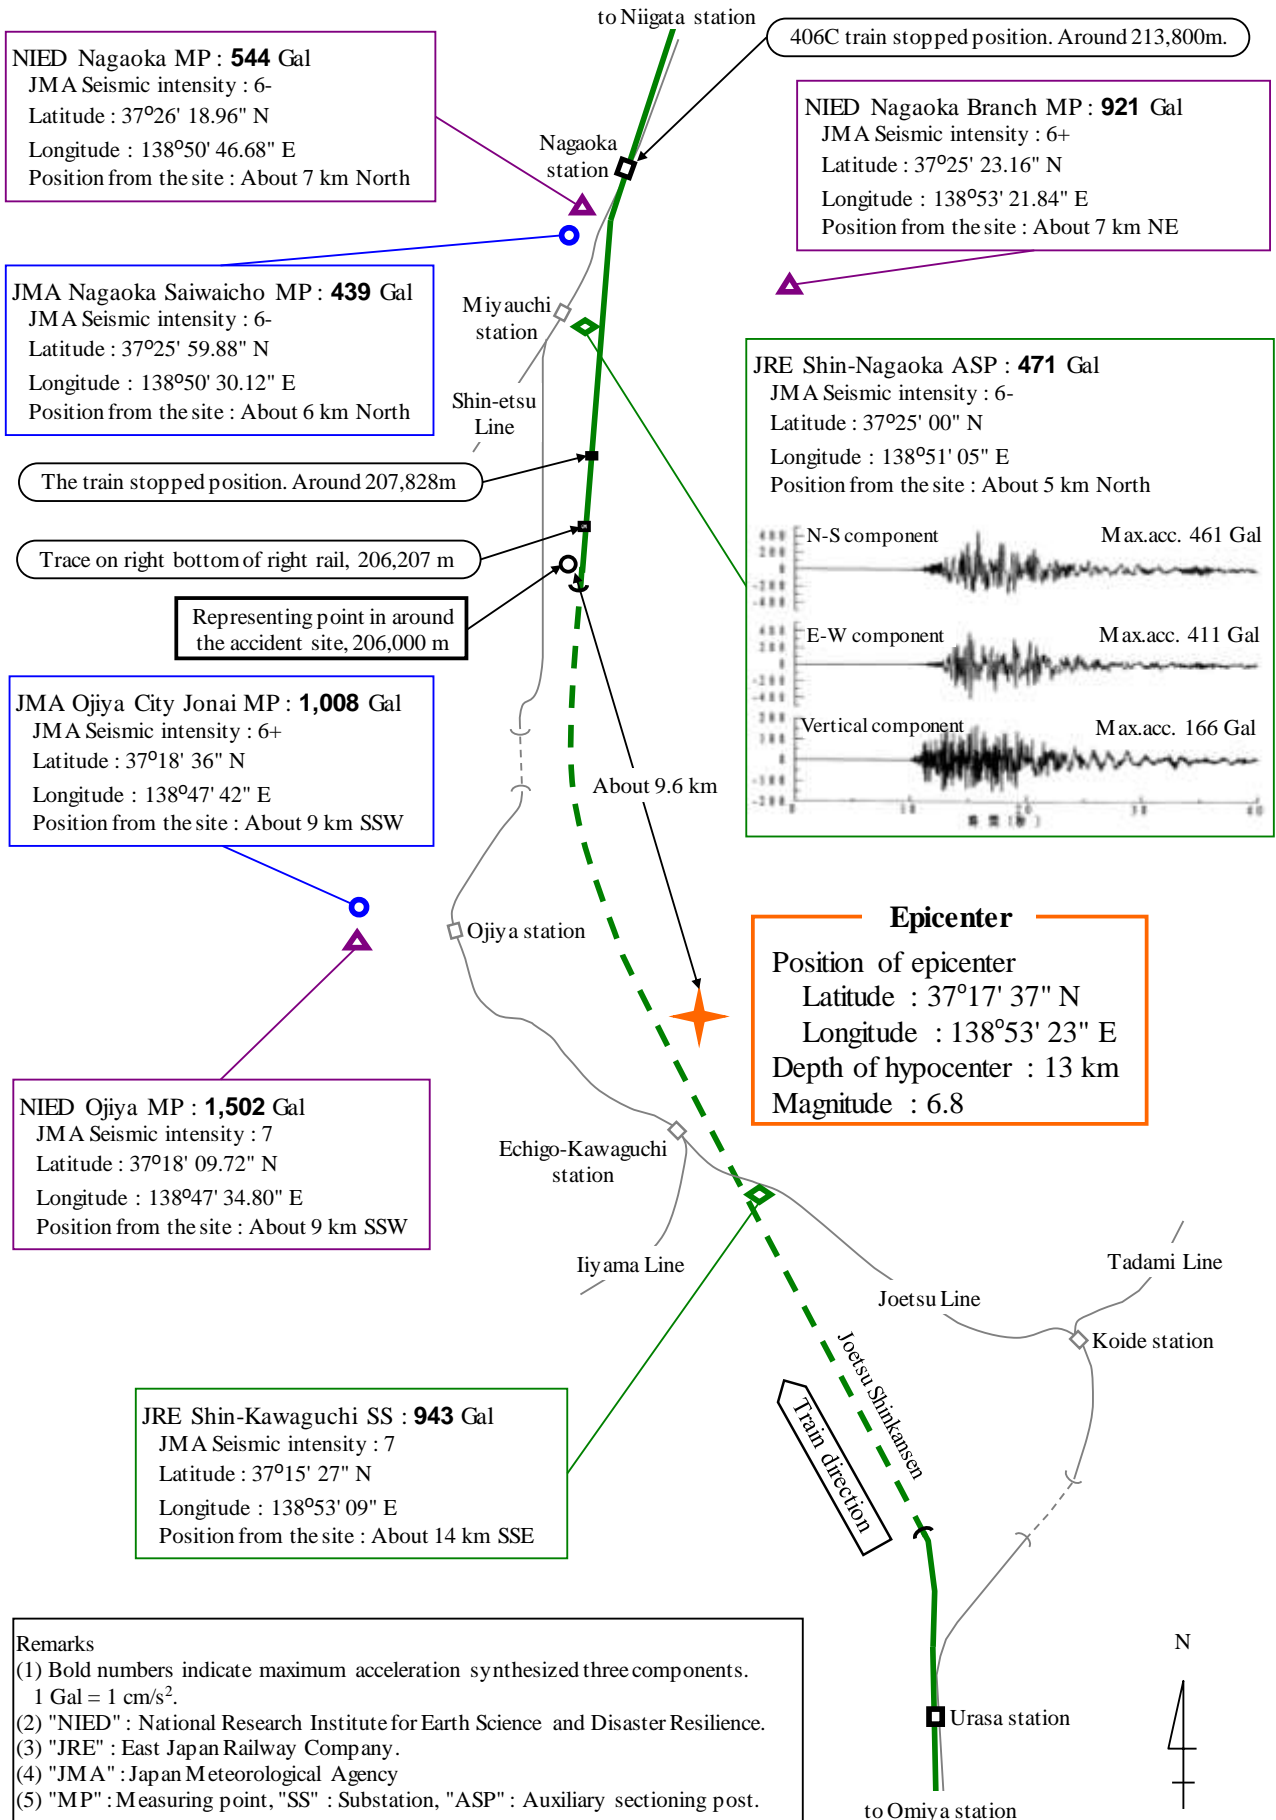
Figure 5. The Maximum Acceleration of the Niigata Prefecture Chuetsu Earthquake Observed in around the Accident Site

The estimated arrival times of P-wave and S-wave at the representing point selected in around the accident site, 206,000m, *i.e.*, 37°22' 25.55" N, 138°50' 49.31" E, were 17:56:02.87 ±0.20 second, and 17:56:05.03 ±0.28 second, respectively. Here, distance from the epicenter to the above representing point was about 9.6 km, and about 11 km to the position where the train had halted. [Refer to Figure 5]

The maximum acceleration etc., by the Niigata Prefecture Chuetsu Earthquake observed in the seismographs located around the accident site were shown in Figure 5.

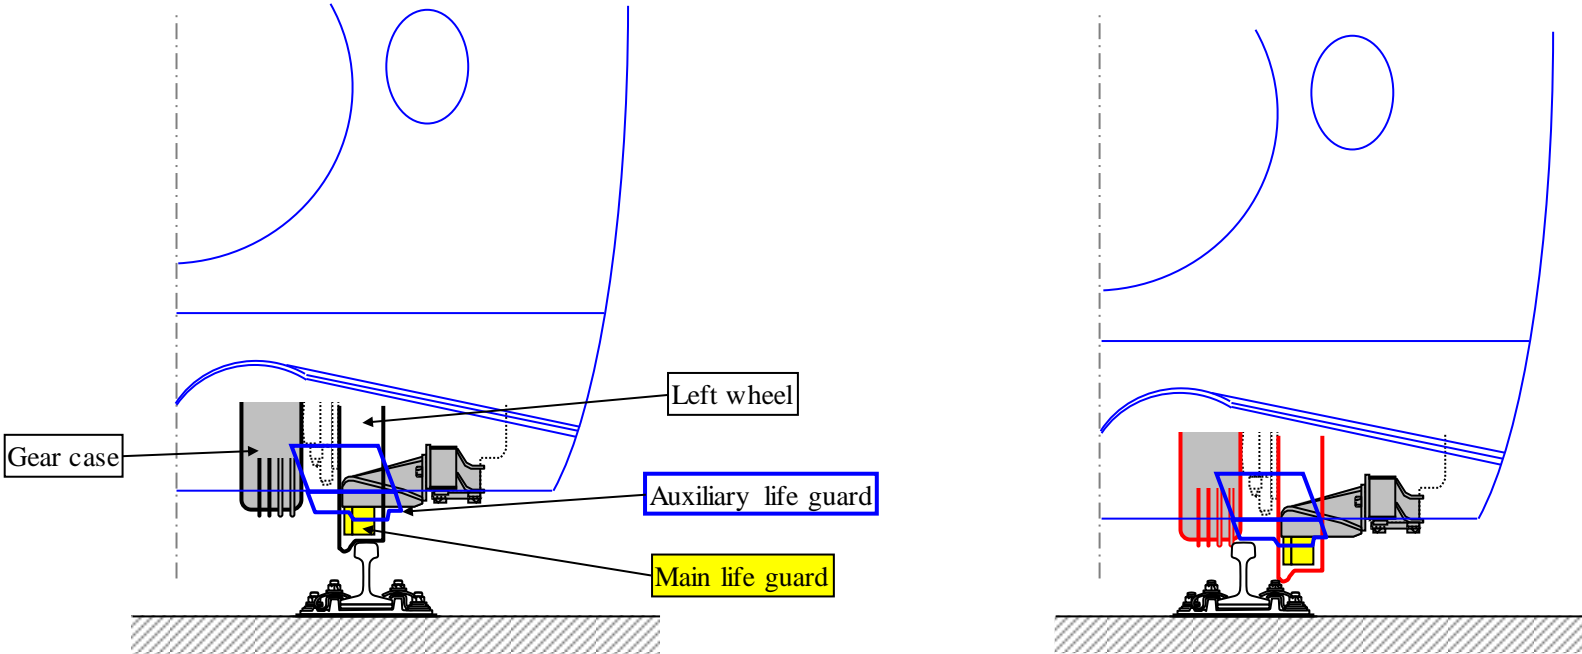
Figure 6. Positional Relationship between Life Guard and Wheels, and Status of the Left Rail Sandwiched by the Left Wheel and the Gear Case
 (a-1) Positional relationship between lifeguard and wheel. (b) Status of the left rail sandwiched by left wheel and gear case

In addition, the life guards were equipped in the 1st and the 10th vehicles. There were the main life guard and the auxiliary life guard in the life guard. The main life guard in the 1st vehicle was attached to the lower part of the axle box of the 1st axle in the front bogie by the fitting arm of the life guard, and the brushing rubber was attached to its bottom edge. On the other hand, the auxiliary life guard was attached to the skirt of the vehicle body, and the brushing rubber was attached to its bottom edge. Distance in the front to rear direction between the brushing rubber of the auxiliary life guard and the 1st axle in the front bogie of the 1st vehicle was about 2 m. [Refer to Figure 6]

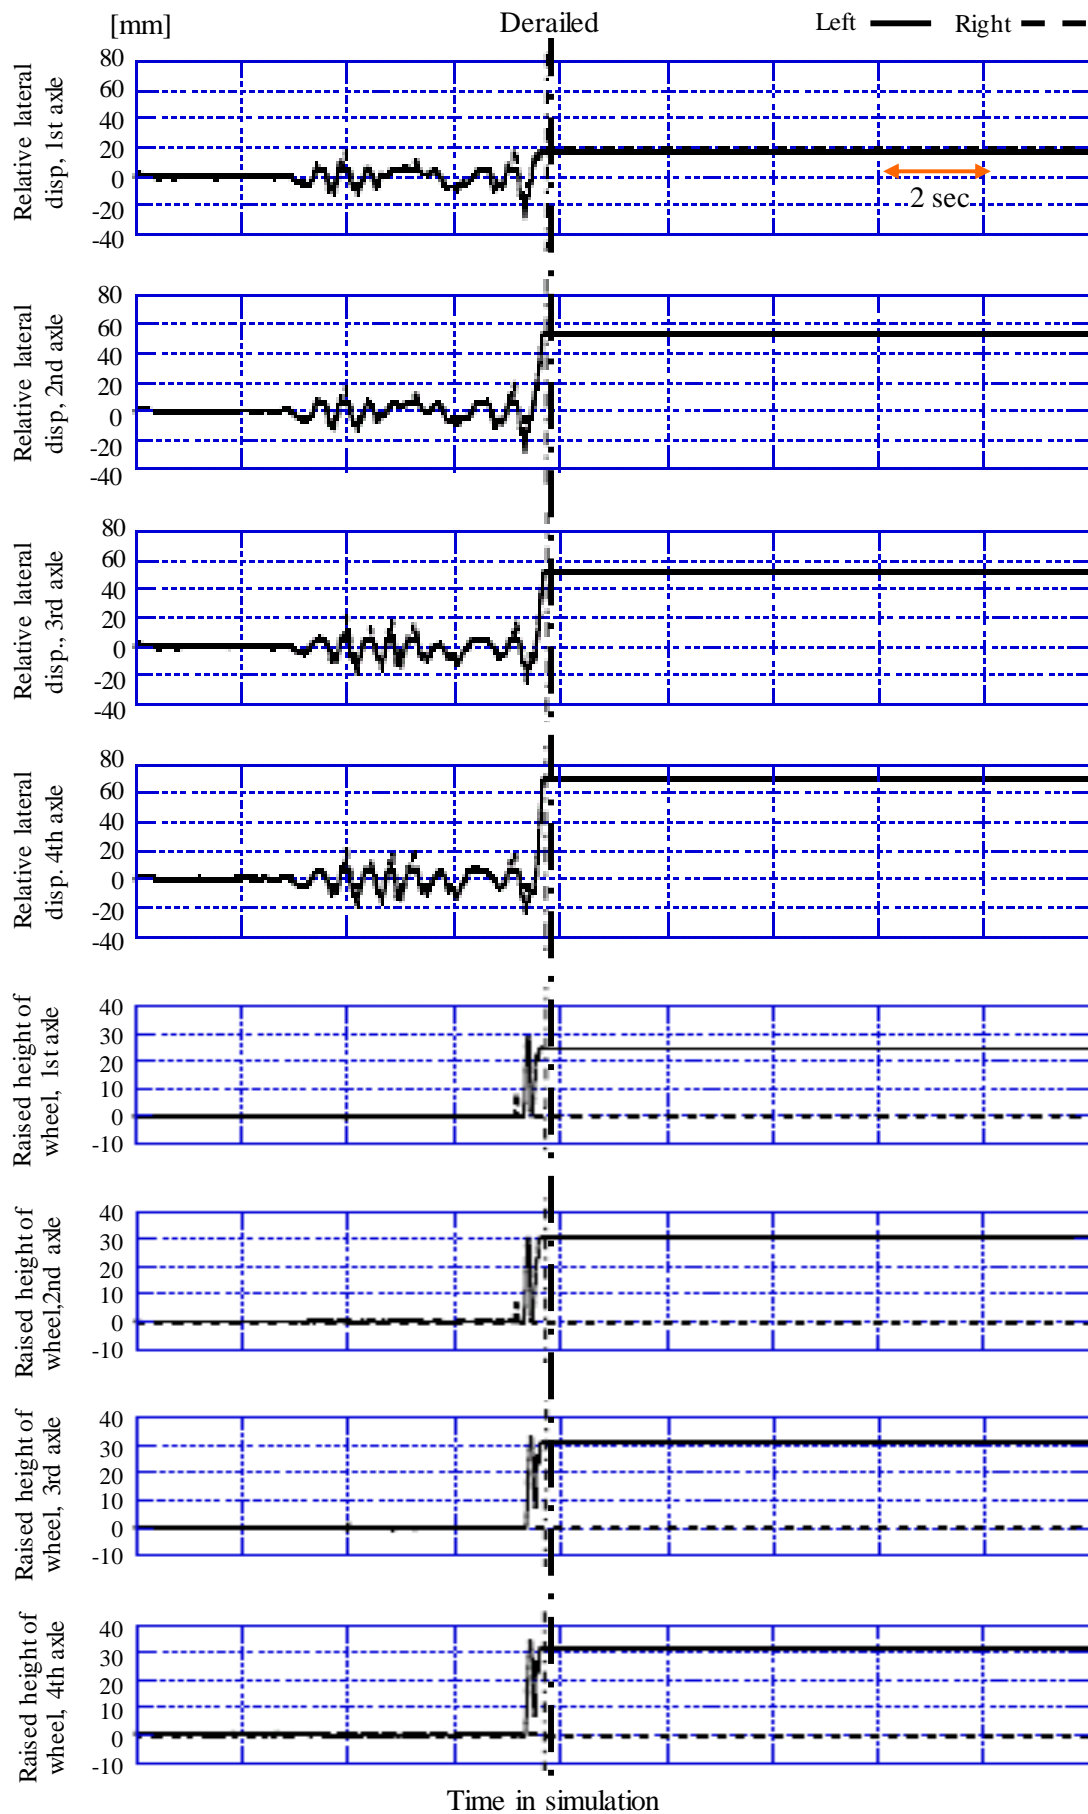
(h) Relative Lateral Displacement between Wheel and Rail and the Raised Height of Wheel

* Simulation was stopped when one of the axles became to the derailed status.
