"The accident that the train derailed because the gauge widened significantly while the train was passing through the curved track"

Railway operator : Konan Tetsudo Co., Ltd.
 Accident type : Train derailment
 Date and time : About 18:52, April 14, 2019
 Location : Around 13,280 m from the origin in Owani station, between Chuo-Hirosaki station and Hirokoshita station, single track, Owani Line, Hirosaki City, Aomori Prefecture

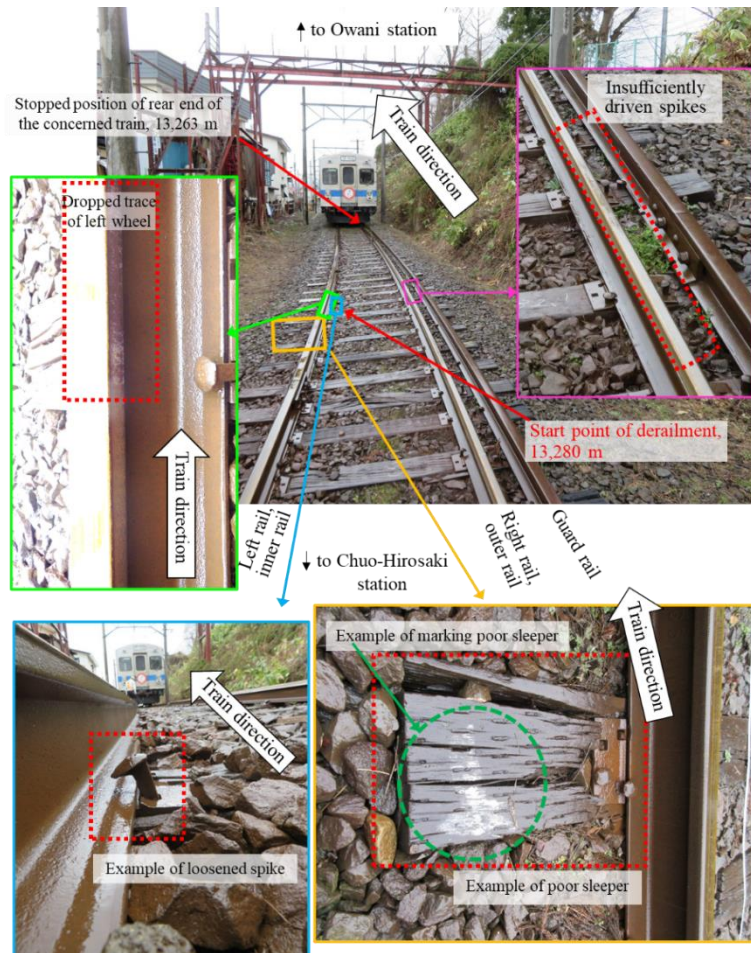
After the train stopped, the driver checked the situation and found that the 1st axle in the front bogie of the forefront vehicle had been derailed.

It is probable that the concerned accident was caused as that the left wheel of the 1st axle in the front bogie of the forefront vehicle fell to inside gauge because the gauge widened significantly while the train was passing through the 160 m radius left curved track.

As for the significantly widened gauge, it is probable that the gauge widened dynamically by the rail tilting, etc., due to the lateral force caused by the running train, because of the large static irregularity of gauge and the continuously existed poor sleepers and the poor rail fastening status in the concerned curved track.

It is probable that the poor sleepers and the poor rail fastening status had been continuously existed, related with the insufficient repairing works for the sleepers and the rail fastening devices due to the inadequate records and measuring methods in the sleeper inspections.
