RAILWAY ACCIDENT INVESTIGATION REPORT

**Railway accident with train derailment in the premises of Takamiya station,
single track, Toga Line, Hikone City, Shiga Prefecture
OHMI Railway Co., Ltd.**

| Date and Time | About 21:17, February 7, 2022 |
| Location | In the premises of Takamiya station, single track, Taga Line, Hikone City, Shiga Prefecture |

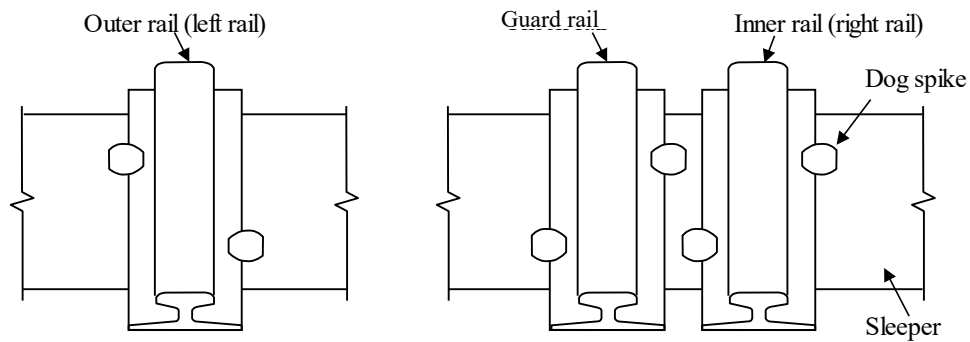
Figure 1. Main Rail Fastener at a Wooden Sleeper Spot on the Curve

(8) A 40 kgN guard rail is installed inside the gauge of the right rail along the entire length of the Curve. The guard rail is fastened to wooden sleepers by one dog spike each on the inside and outside. [Refer to Figure 1] However, as shown in Figure 3, there were spots where it was not fastened with dog spikes.

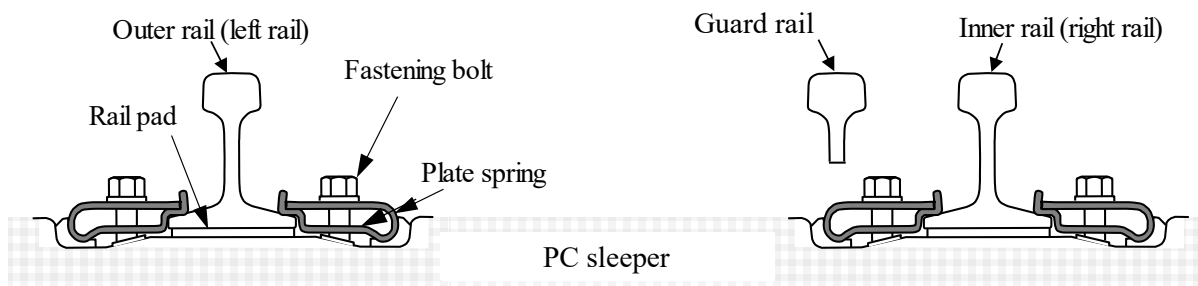
Figure 2. Rail Fastener at a PC Sleeper Spot on the Curve

Also, the base of the guard rail is cut at spots with PC sleepers so that it does not interfere with the rail fastening system. [Refer to Figure 2]

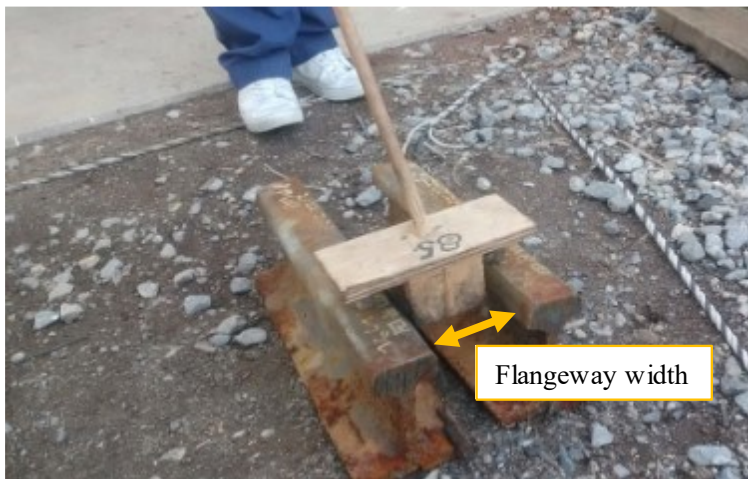
Figure 5. Measuring Tools for Flangeway Width

The guard rails were inspected on November 8, 2021. No particular issues were noted in the inspection records for the checks performed on the fastening status and flangeway width of the guard rails. According to the Company, the design value for the flangeway width on the Curve was 85 mm, and flangeway width values were measured using the measuring tool shown in Figure 5 and recorded on the inspection sheet only for spots that were too narrow and caused the tool to get caught on the guard rail and spots that were too wide and had gaps.

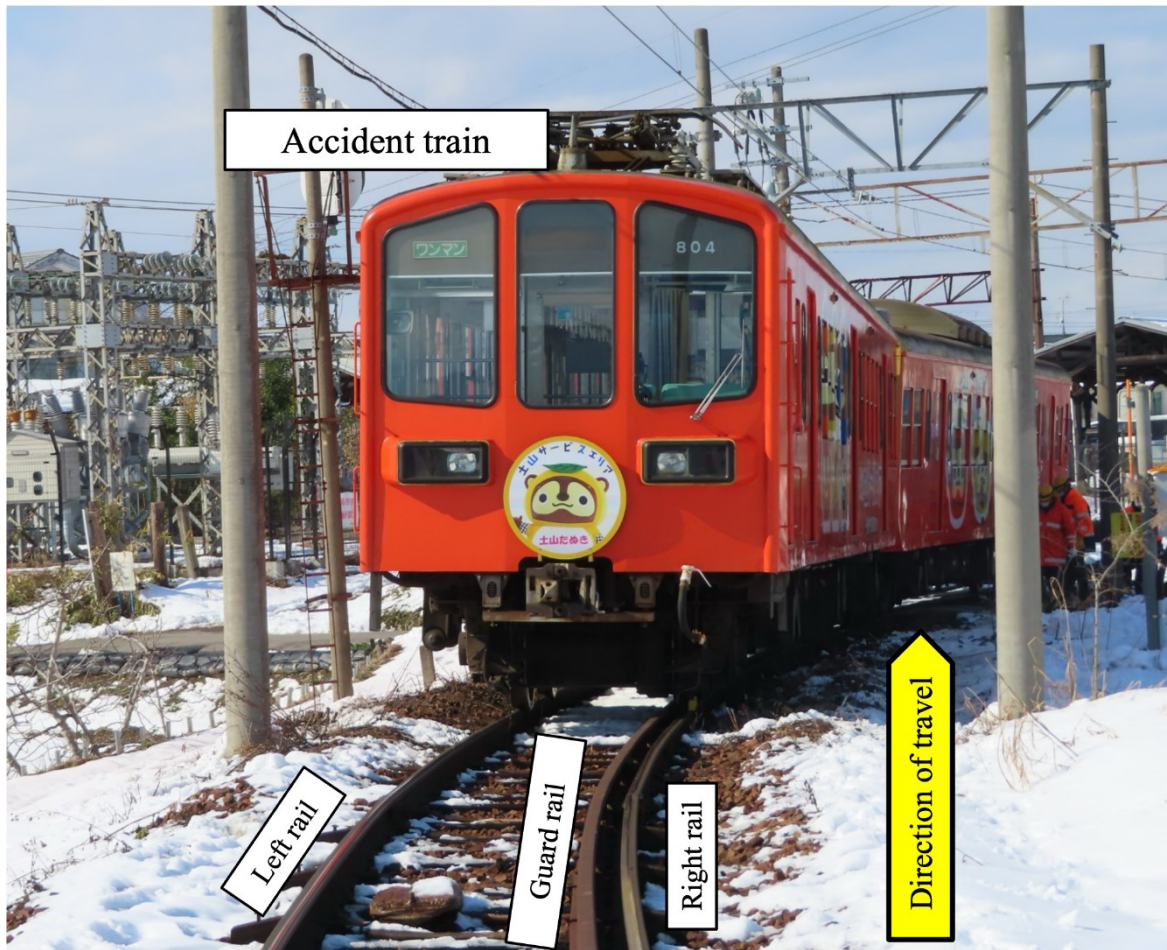
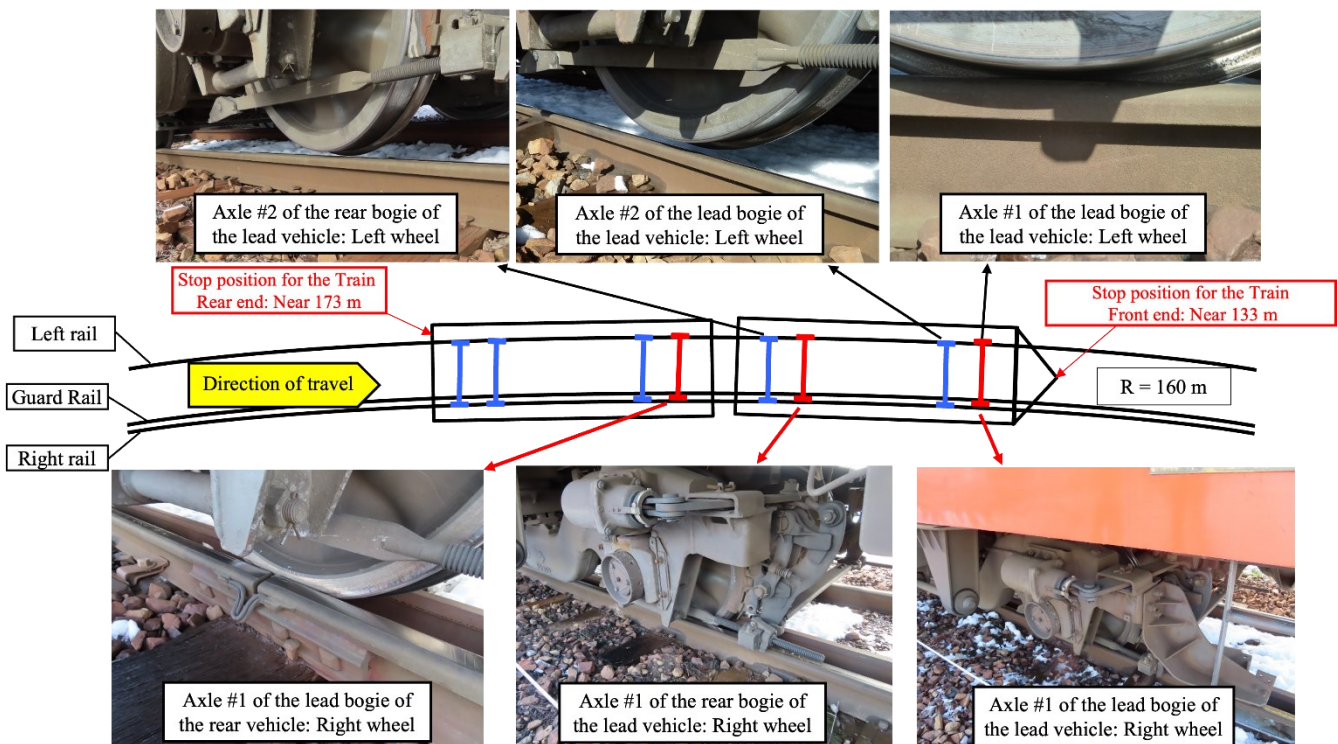
Attached Figure 3. Rough Map of the Accident Site and the Status of the Derailment

The derailment status for the rear vehicle was that the right wheel of the lead axle of the lead bogie was derailed between the right rail and the guard rail. *[Refer to Attached Figure 3]*
