RAILWAY SERIOUS INCIDENT INVESTIGATION REPORT

Vehicle damage, Suminoe Vehicle Inspection Division,
Nankai Electric Railway Co. Ltd.

November 26, 2020

Railway Serious Incident Investigation Report

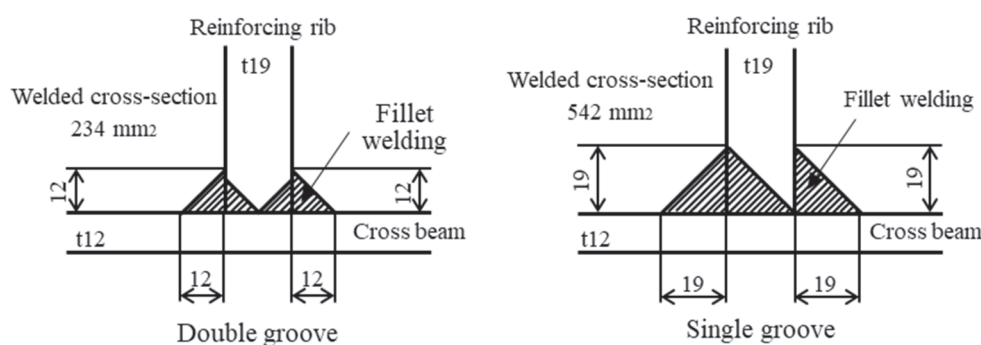
Figure 2. Comparison of welding amount between single groove and double groove

According to the bogie maker, the result of comparison on the welding amount in design between double groove and single groove, is shown in Figure 2.

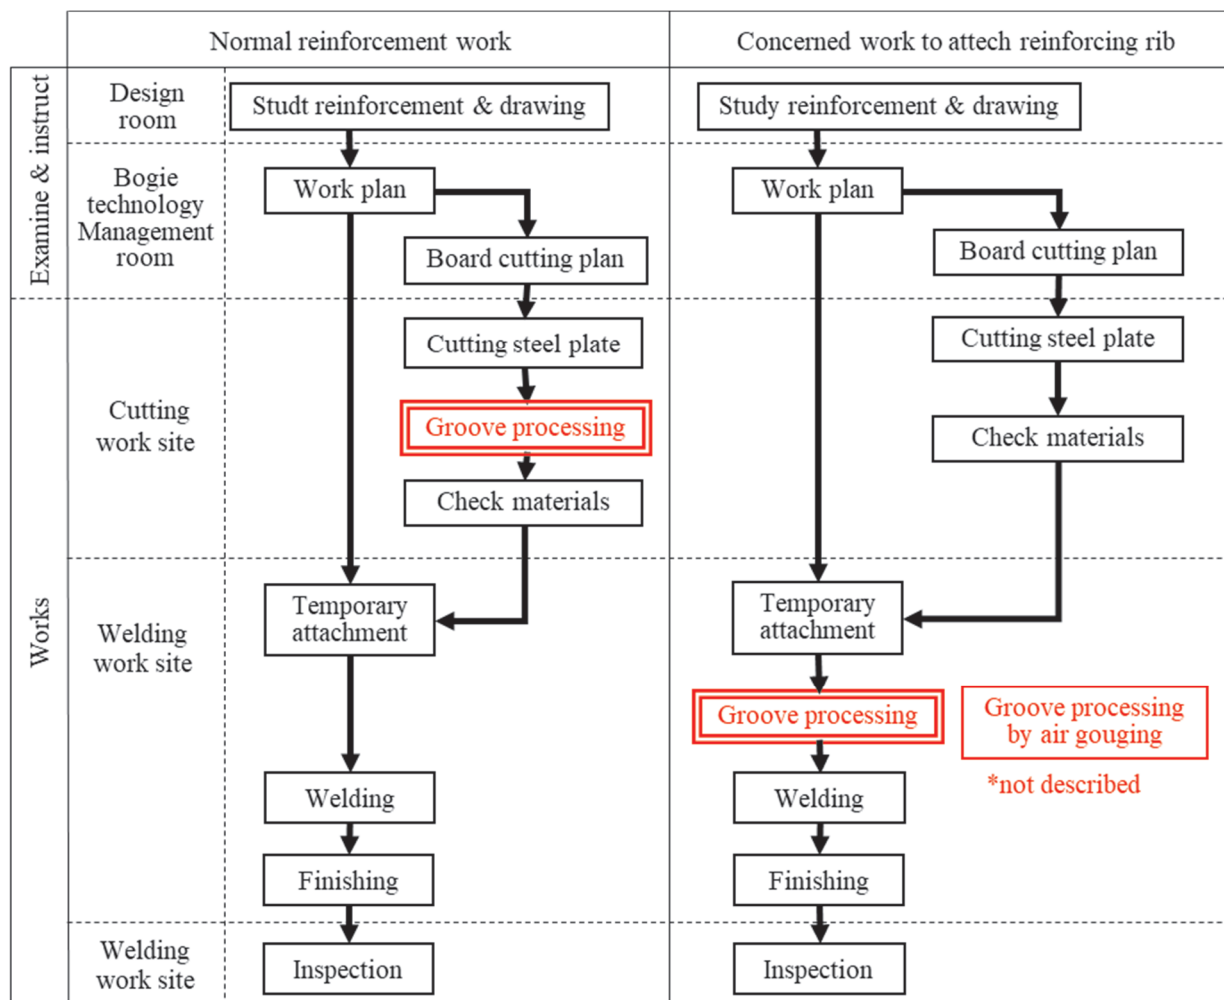
Figure 3. Comparison of the reinforcement work flow created by the bogie maker
2.5.3.3. Reinforcing rib installation work

The flow of usual reinforcement work and the flow of the reinforcing rib installation work are shown in Figure 3.

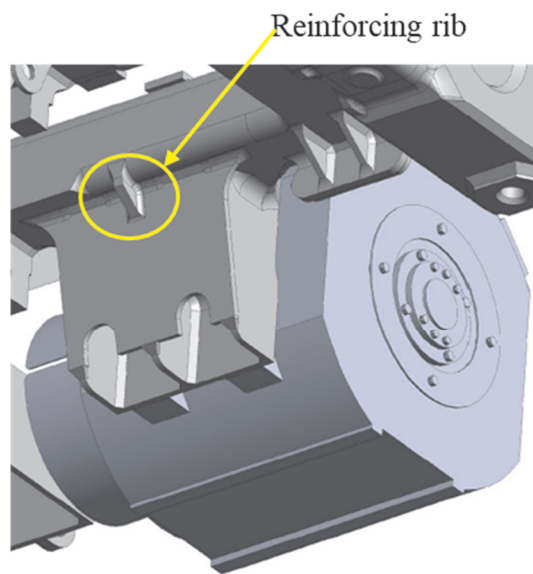
CAD drawing of traction motor and traction motor support

When the vehicle inspection staff C conducted a vehicle inspection at the Suminoe Vehicle Inspection Division of the company, where the serious incident occurred, the crack was found in the upper part of the reinforcing ribs, *hereinafter referred to as "the reinforcing rib"*, attached to the welded part between the cross beam and the traction motor support of the bogie.

- (1) The crack was generated at the welded part between the backside of the traction motor support in the cross beam and the reinforcing rib, and was about 140 mm in length and about 1 mm in width.
- (2) When observed the broken surface of the crack, multiple ratchet marks^{*11} were found as extended outward.
