Kazuhiro Nakahashi, Chairman,
Japan Transport Safety Board

On the opinion concerned with the prevention of the train derailment accident
caused by the gauge widening

On the prevention of the train derailment accident by the widening gauge

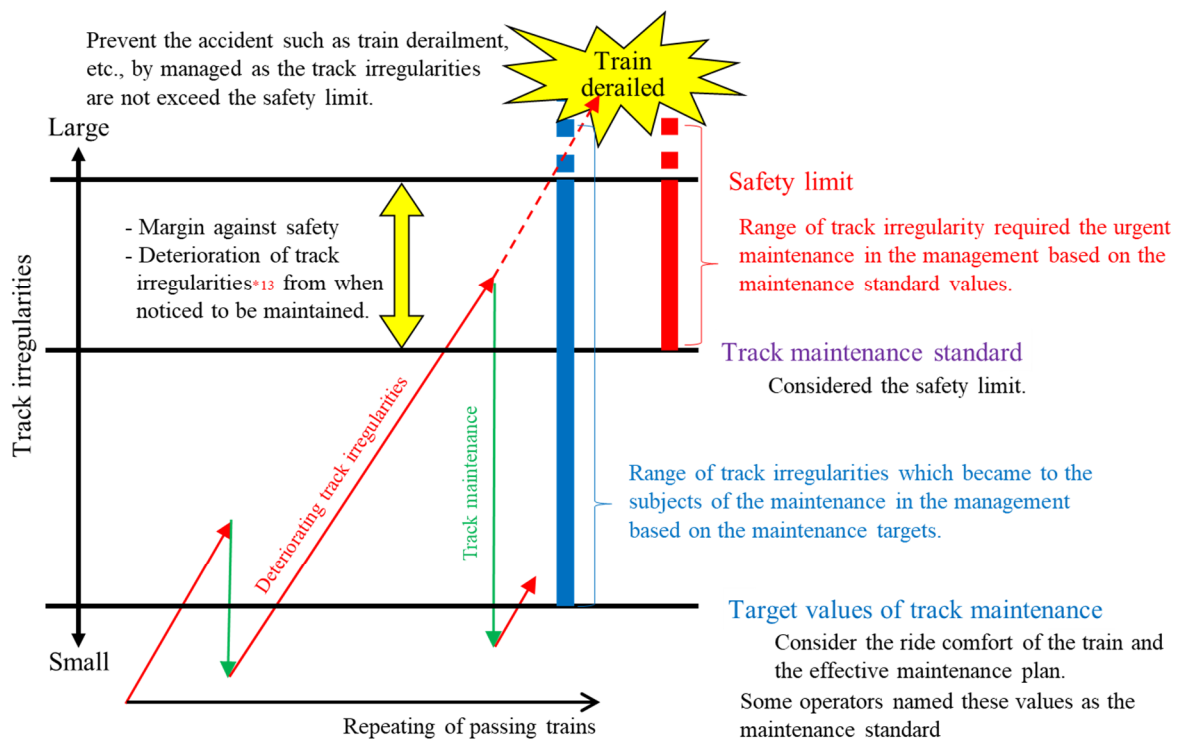
Figure 5. Image of the maintenance standard of the track irregularities

The standards of the maintenance of the track irregularities is categorized as to decide in order to secure the safe operation of the trains and to decide in order to maintain effectively as being preserved the good ride comfort of the train. The former is called as the standard values for track maintenance^{*11}, and the latter is called as the target values for track maintenance^{*12}, generally.

Notes : Maintenance standard of track irregularities are decided corresponding to the status of facilities in each track section and the running vehicles by each railway and tramway vehicles.

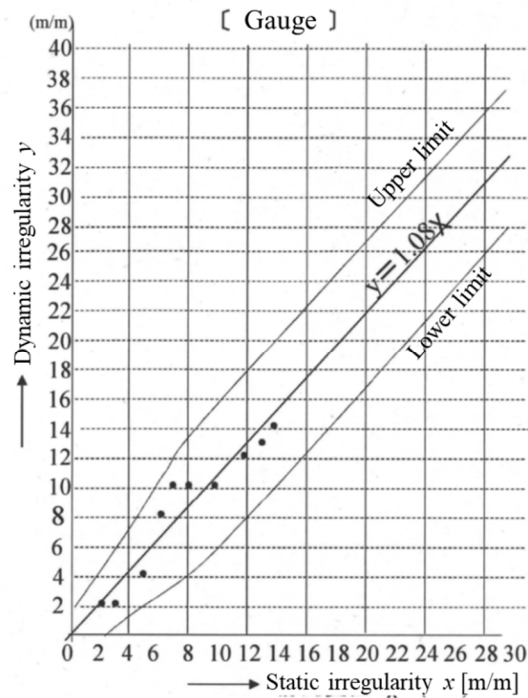
Figure 7. Relations between dynamic irregularity of gauge and static irregularity of gauge

Note that the standard value for track maintenance of the irregularity of gauge shown in Table 1, was decided as the track irregularity including the slack did not to exceed the limit value of the irregularity of gauge shown in Figure 6. Furthermore, the static values are set as the value corresponded to the upper limit value of the distribution in the relationship of the static irregularity of gauge and the dynamic irregularity of gauge shown in Figure 7, and decided considering as to convert the dynamic irregularity of gauge, against the static irregularity of gauge as the standard value, in the safety side as possible.
