Annual Report 2017

JTSB Mission

Chapter 1 Summary of Recommendations and Opinions Issued in 2016

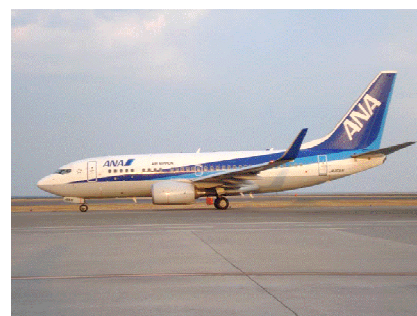
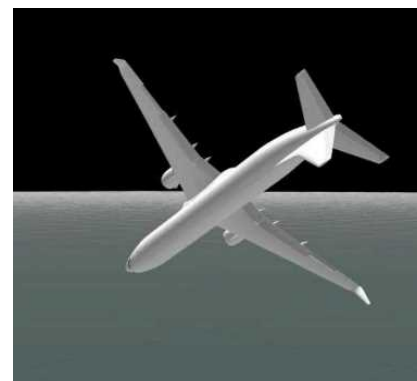
It is probable that the followings contributed to the first officer's erroneous operation of the rudder trim control while having an intention of operating the door lock control; he had

not been fully corrected his memories of operation about the door lock control of the Boeing 737-500 on which he was previously on duty; the door lock control of the Boeing 737-500 series aircraft was similar to the rudder trim control of the Boeing 737-700 series aircraft in their placement, shape, size and operability. It is somewhat likely that his memories of operation about the switch for the door lock control of the Boeing 737-500 aircraft had not been fully corrected because he failed to be fully accustomed with the change in the location of the switch for the door lock control. It is somewhat likely that this resulted from lack of effectiveness in the current system for determining the differences training contents and its check method, under which the Air Nippon Co., Ltd. and other airlines considered and adopted specific training programs to train pilots about how to operate the flight deck switches when their locations changed and the Civil Aviation Bureau of the Ministry of Land, Infrastructure, Transport and Tourism reviewed and approved them. It is probable that the first officer's failure to properly manage tasks contributed to his erroneous operation of the rudder trim control.

It is somewhat likely that the similarities between the switches for the door lock control and the rudder trim control in their operability contributed to the delay in his recognition of the erroneous operation. Moreover, he was excessively dependent on autopilot flight and he failed to be fully aware of monitoring the flight condition.

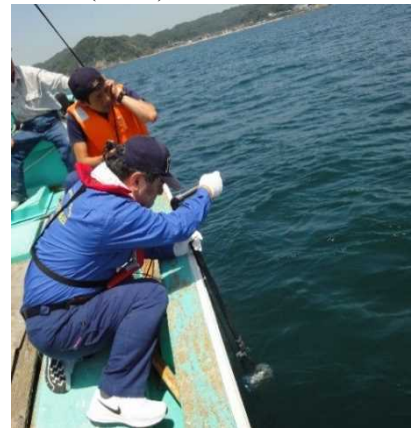
To detect the ULB signal, a dedicated detector is required. When a ULB detector receives a ULB signal, it converts the ultrasound signal into audible sound (referred to below as “received sound”). Since the receiver antenna has directionality, the reception level is high if the receiver is facing toward the transmitted signal but becomes lower if it is facing in the wrong direction. The reception level also decreases as the distance from the ULB increases; as the level decreases, so the received sound also decreases, becomes mixed with noise and is harder to distinguish. It is therefore important to know how to recognize the received sound, so that it can be distinguished even at low volume levels.

The ULB signal converted by the detector sounds like the NTT time signal (marking seconds). Once the received sound can be heard, we record our own position on a GPS receiver while also measuring the bearing of the transmitter. By doing this in three or more locations and working out the point of intersection between them, we can specify the location of the flight recorder, etc. However, vessels tend to drift in currents while taking measurements, meaning that measurements and recordings have to be made quickly and accurately. It is important that we carry out training continuously, so that aircraft accident investigators can learn the necessary knowledge and skill to this end, and carry out underwater detection efficiently whenever necessary. This is also important in order to maintain or improve the underwater detection skills of aircraft accident investigators.

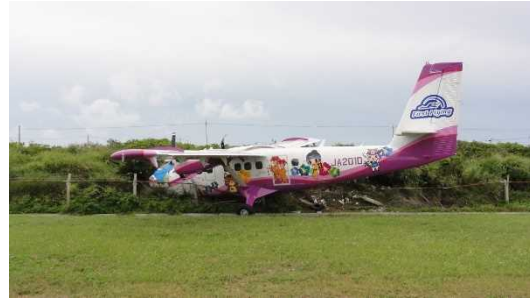
Situation when the Aircraft stopped

It is somewhat likely that the PF could not properly control the aircraft as it started to deflect after touchdown, because his knowledge concerning the aircraft system of the aircraft was inadequate, as a result of which he did not fully understand situations that cause deflection to start. It is somewhat likely, moreover, that the insufficient response by the PIC when an unforeseen situation arose contributed to this.

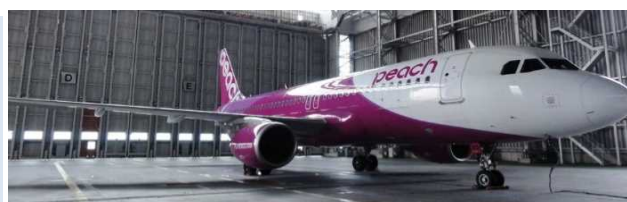
Operation of the VS knob by the PIC

- After finishing the checklist, the FO noticed that the altitude of the aircraft was falling, and alerted the PIC.
- On realizing that the aircraft was descending, the PIC pressed the VS knob and commenced maneuvers to stop the descent.
- At the same time as the VS knob was operated, a warning was issued by the EGPWS (Enhanced Ground Proximity Warning System).
- At around the same time, the air traffic controller issued an instruction to “Maintain 1,000”.
→ It is highly probable that the PIC initiated an approach go-around as an emergency maneuver to avoid colliding with the water surface.

- It is somewhat likely that the PIC intended to stay true to the PAR approach, his first in a while and first in this type of aircraft, and overestimated his impression of the behavior of the aircraft after the glide path convergence.
- It is somewhat likely that, as a result, the PIC did not make a callout, preset the VS knob on the FCU panel to a sink rate of -900fpm, and following this, or some time after this, pulled the VS knob without intending to start the descent.

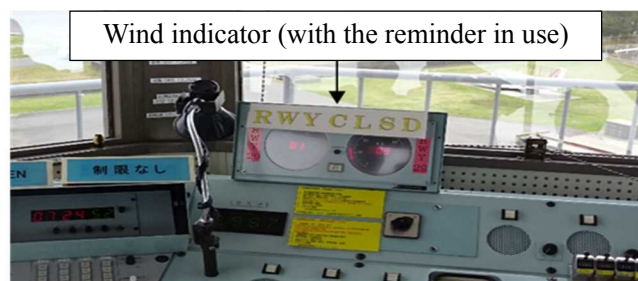
Situation of the reminder in use

The supervisor, thinking that he could cope by memory alone as there were few takeoffs and landings scheduled, did not use the reminder (*).

* A sign used to show broadly that the runway was closed.

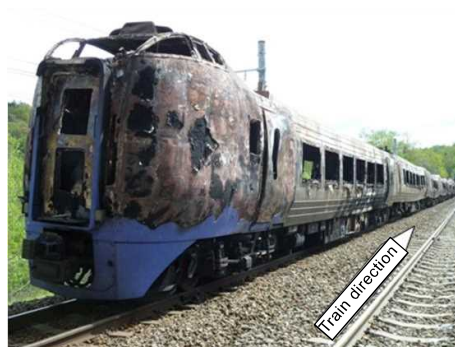
Status of the burnt cars

It was found that the first axle of the rear bogie of the fifth vehicle of the train had derailed to the left. There were many parts of the dropped power transmission device, etc. scattered along the track for about 2 km length away from the halted point of the train. Moreover, all the 6 vehicles of the train were burnt by the fire.

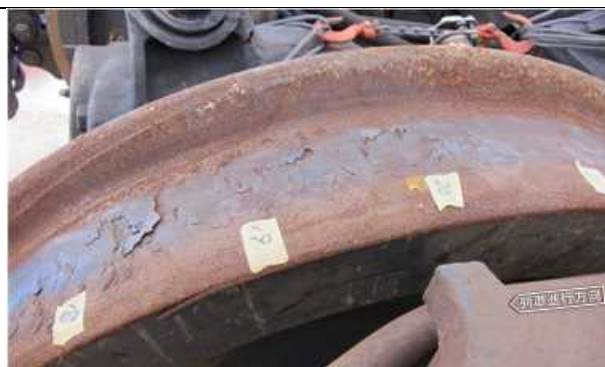
Wheel tread exfoliation condition

Hokkaido Railway Co. should establish the proper inspection system, i.e., inspection period and methods for monitoring the condition of the wheel tread, and should manage the condition of the wheel tread throughout, and never use the wheel which should be treated as the wheel whose size of the tread defects or exfoliation are exceeded the limit to be used.

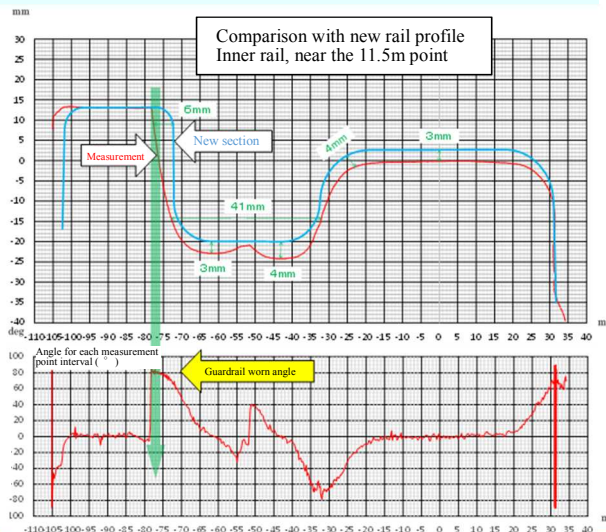
Probable causes (Excerpt): It is probable that the accident occurred as follows, while the tram was running in the right curved branch line in the turnout, as the back side of the right wheel of the first axle in the rear bogie was contacting with side surface of the rail, having the role of guard rail, in the diamond crossing, the back side of the right wheel climbed up the guard rail and derailed to left, and after that, the left wheel of the first axle climbed up the left rail and derailed to left, furthermore, the second axle on the rear bogie also derailed to left.

It is probable that the right wheel of the first axle in the rear bogie derailed due to the increased derailment coefficient against the derailment from the back surface of the inner wheel, as the wheel load decreased and the lateral force on the back surface in the right wheel increased in the diamond crossing existed in the very small radius curve, also, due to the derailment coefficient exceeded the critical derailment coefficient as the critical derailment coefficient against derailment was decreased.

When this accident occurred, the worn angle of the guardrail near the derailment start point was about 80° , smaller than the 90° at new. It is somewhat likely that the occurrence of the derailment was influenced by the resultant decrease in the critical derailment coefficient for the inner wheel back surface derailment.

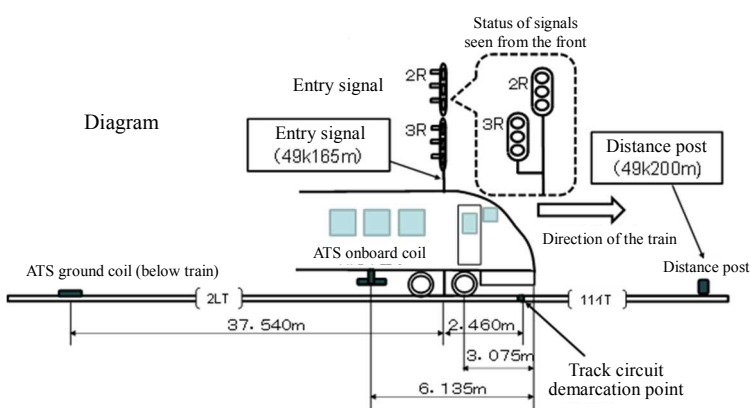
It is probable that, after starting again, the train involved in this incident by entering to the section in which a stop signal was shown. However, because the train had already passed over the ATS ground coil (below the train), the ATS brake was not activated.

Probable causes (Excerpt): It is probable that the railway serious incident occurred as the outbound limited express train, stopped beyond the down line entry signal of Hizen-Ryuo station indicating proceed signal, restarted operation obeying the instruction by the train dispatcher after the entry signal indicated stop signal, resulted in the state of red signal violation against the entry signal, and entered into the safety margin for overrunning section for the inbound limited express train scheduled to stop in the No.1 line of the station, induced the possibility that the two trains were operating at the same time in the section of the safety margin for overrunning, when the inbound limited express train, operated obeying the instruction of the train dispatcher and signal indication, passed through the entry signal for the up line.

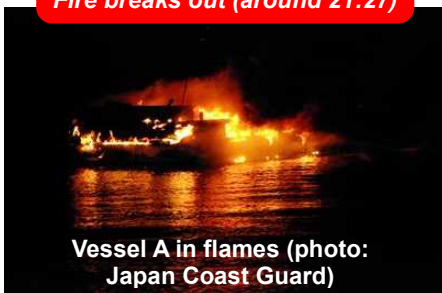
Vessel A in flames (photo: Japan Coast Guard)

Structures on the upper deck caught fire, and although a Japan Coast Guard patrol boat discharged firefighting water, the fire was not extinguished, and at around 23:55 the vessel sank in the sea off to the southwest of Oge Port.
