## 2. Statistics on accidents caused by dozing

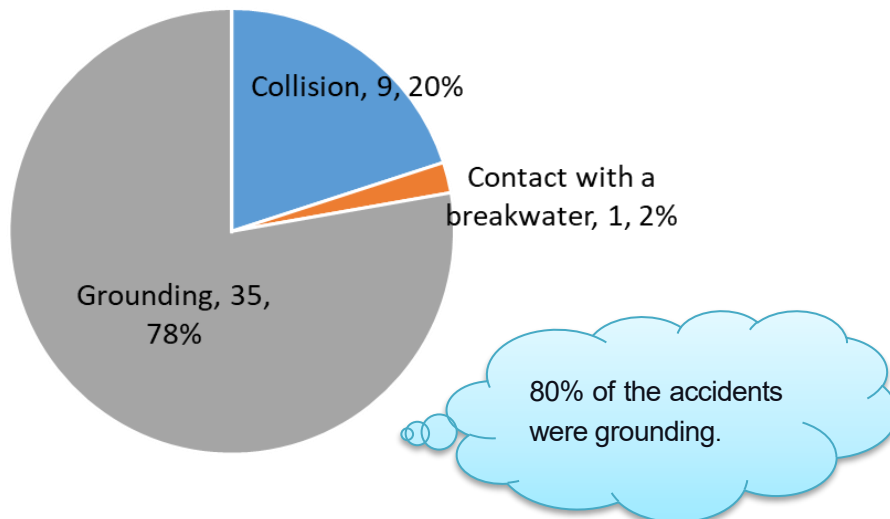
Figure 2. Occurrence by accident type

By accident type, 35 (78%), or approximately 80%, were grounding, followed by 9 (20%) collisions between vessels and 1 (2%) contact with a breakwater. (See Figure 2)

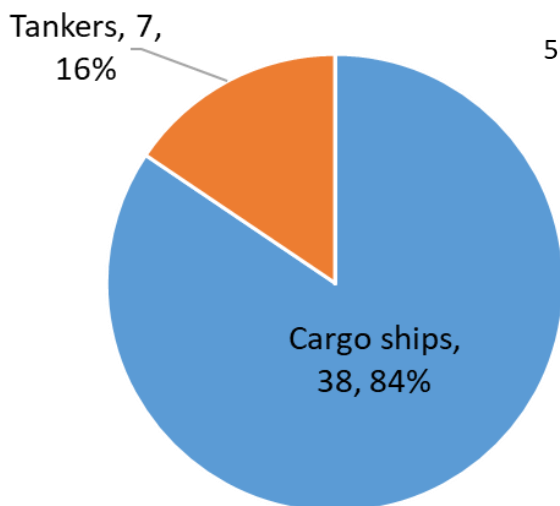
Figure 3. Occurrence by vessel type

By vessel type, 38 (84%), or more than 80%, were cargo ships. (See Figure 3)

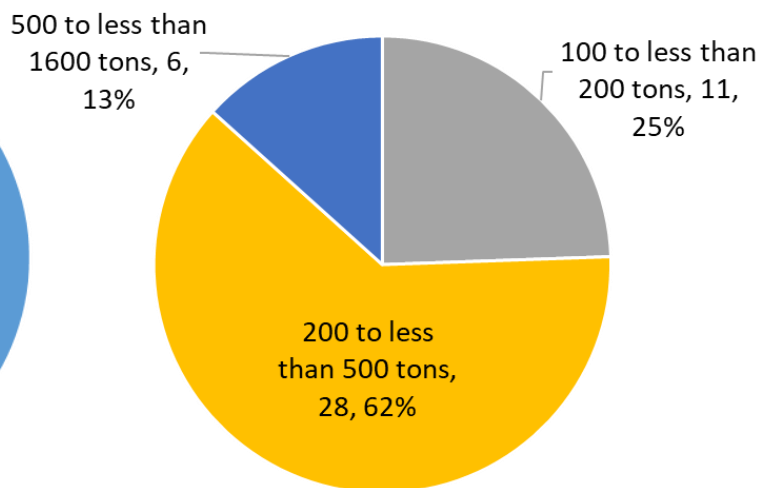
Figure 4. Occurrence by gross tonnage

By gross tonnage, 28 vessels (62%), or more than 60%, were between 200 and 500 tons, followed by 11 vessels (25%) between 100 and 200 tons and 6 vessels (14%) between 500 and 1600 tons. (See Figure 4)

The majority were of 200 to less than 500 gross tonnages.

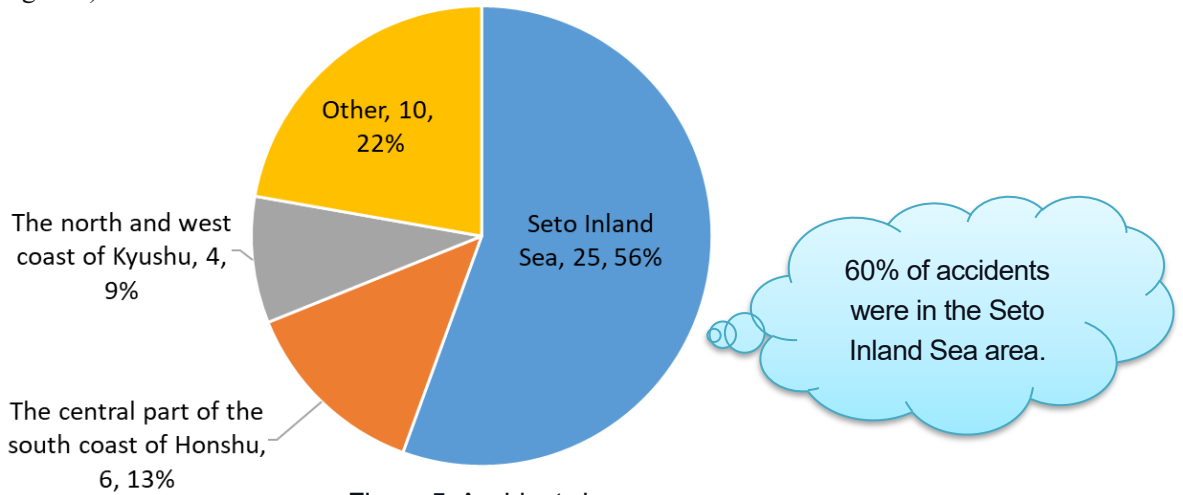
Figure 5. Accidents by area

By area, 25 (56%), or approximately 60%, were accidents in the Seto Inland Sea and around (Osaka Bay to the Kanmon Strait), followed by 6 (13%) in the central part of the south coast of Honshu (Tokyo Bay to the coast of Wakayama Prefecture) and 4 (9%) in the north and west coast of Kyushu (northern coast of Fukuoka Prefecture to western coast of Kagoshima Prefecture). (See Figure 5)

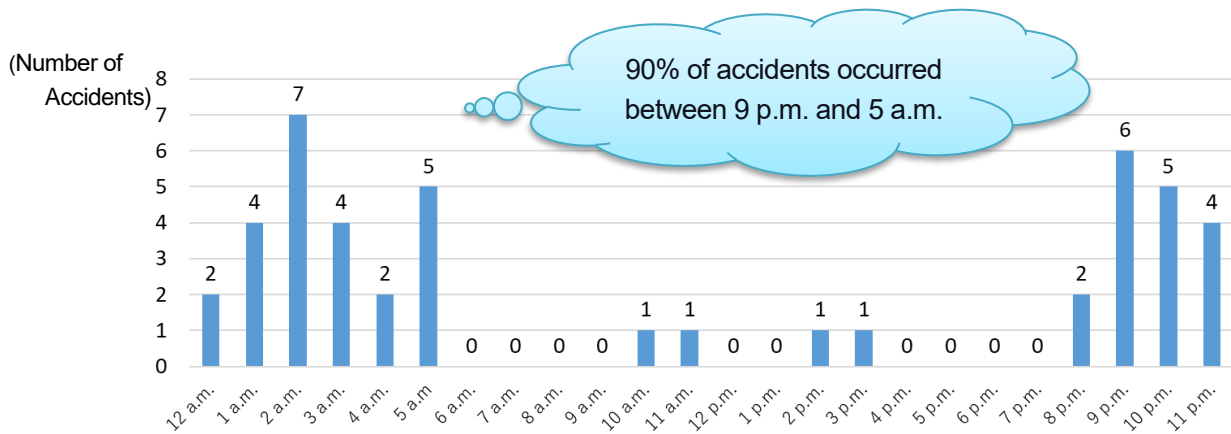
Figure 7. Accidents by time range of the day

By time range of the day, the highest number of accidents is 7 (16%) between 2 and 3 a.m., followed by 6 (13%) between 9 and 10 p.m., and 39 (87%, approximately 90%) between 9 p.m. and 5 a.m. (See Figure 7)

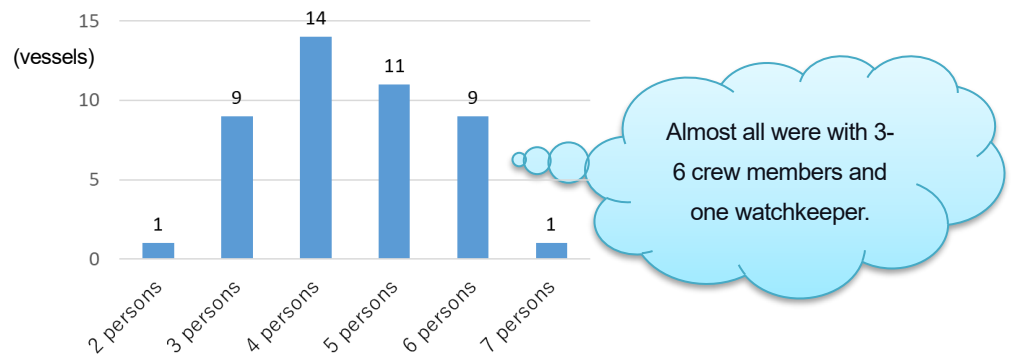
Figure 8. Vessels by number of crew members

By the number of crew members, the highest occurrence was at 14 vessels (31%) with four crew members, followed by 11 vessels (24%) with five crew members, and 43 vessels (96%) with three to six crew members. (See Figure 8)

By the number of bridge watchkeepers, 43 vessels (96%) were with one watchkeeper, followed by two vessels (4%) with two watchkeepers.

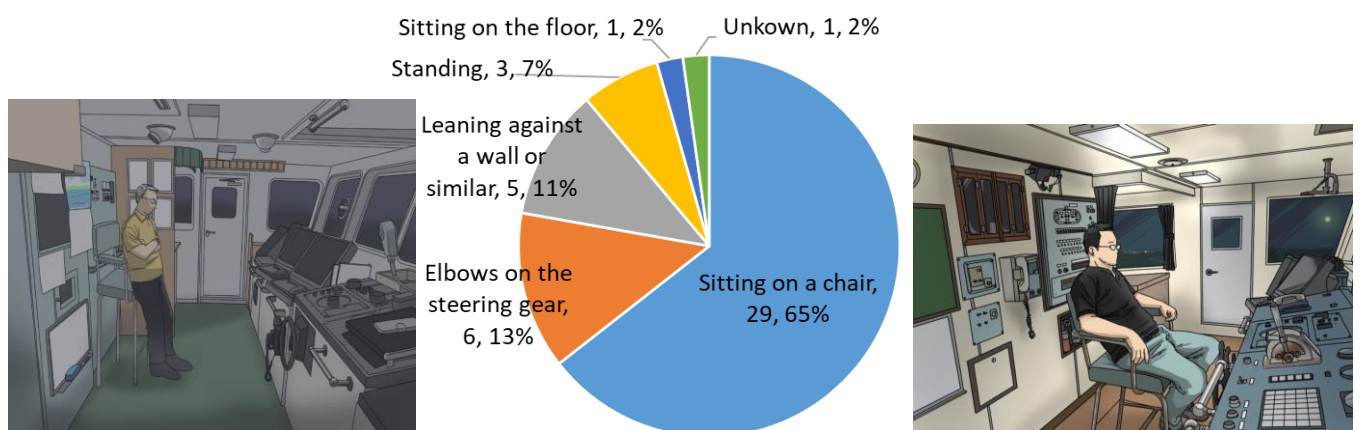
Figure 9. Vessels by bridge watchkeeper posture

By bridge watchkeeper posture, 29 vessels (65%), or approximately 70%, were with the watchkeepers on their chair, followed by six vessels (13%) with their elbows on the steering gear, and five vessels (11%) leaning against a wall or similar. (See Figure 9)

As for the autopilot, 43 vessels (96%) deployed it.

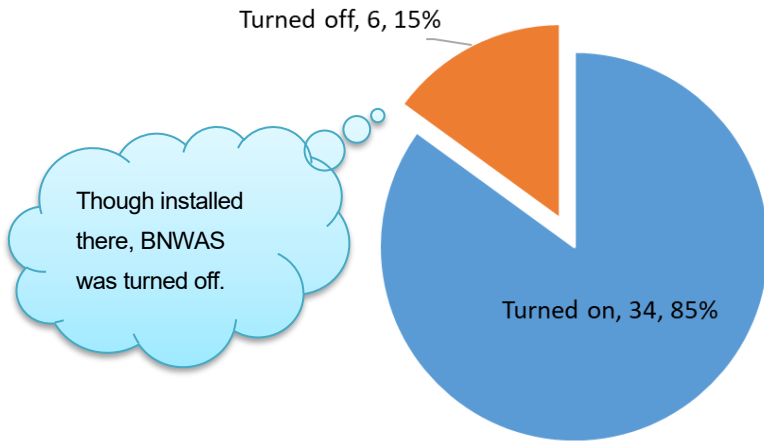
Figure 10. Vessels by BNWAS activation

40 of the 45 vessels were equipped with the Bridge Navigational Watch Alarm System (BNWAS) as of the accident. These 40 vessels, 34 (85%) had their BNWAS activated, and 6 (15%) did not, such as having turned them off. (See Figure 10)

At 33 out of the 34 vessels that had activated their BNWAS, the alarm did not work.

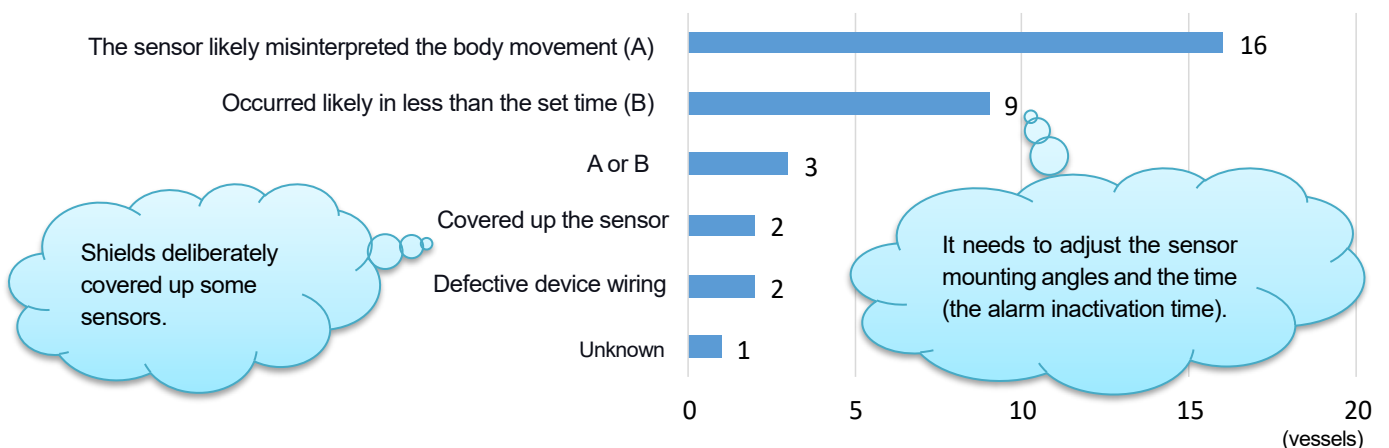
Figure 11. Reasons why the alarm did not work

As for possible reasons for the alarm not working, at the 16 vessels (48%), or almost half of the total, the sensors could have misinterpreted the operator's body movements as regular movement, even though dozing (e.g. the case study on page 6). On the other hand, the operator dozed at 9 vessels (27%), and the accident occurred in less than the set time (the alarm inactivation time) (e.g. the case on page 7). (See figure 11)

Of those that may not have passed the set time (the alarm inactivation time), 4 vessels had the time (the alarm inactivation time) set to be more than 10 minutes.
