**AIRCRAFT ACCIDENT
INVESTIGATION REPORT**

**UNITED AIRLINES, INC.
N29968**

INJURY TO FLIGHT ATTENDANT
BY THE JOLT OF THE AIRCRAFT
AT AN ALTITUDE OF APPROX. 15,600 FT,
APPROX. 64 KM SOUTHWEST OF FUKUSHIMA AIRPORT
AT AROUND 13:10 JST, JULY 1, 2017

UNITED AIRLINES, INC.,
BOEING 787-9, N29968

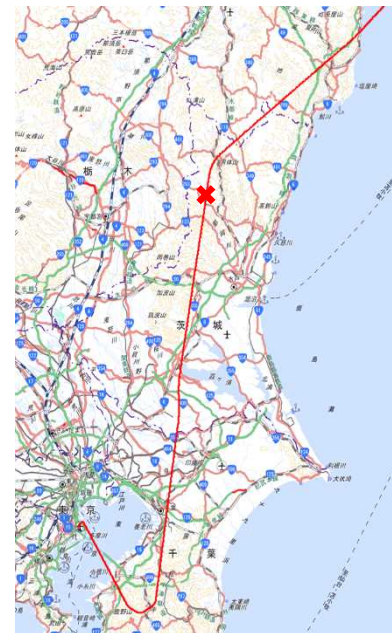
Figure 1 Estimated Flight Route

During its descent through clouds, the Aircraft encountered heavy rain showers. However, no information predicting a large jolt was displayed by the onboard weather radar, either in the auto mode or when the tilt angle was adjusted in the manual mode. The Aircraft jolted at an altitude of about 15,600 ft, and one FA who was working in the aft galley suffered an injury when she lost her balance and her knee struck the floor. At this time, the Aircraft's vertical acceleration became +0.82 G, followed by +1.68 G, followed 1 second later by +1.13 G, and followed 3 seconds later by +0.76 G. The Aircraft was flying with autopilot and auto-throttle engaged. The Aircraft descended to an altitude of about 14,000 ft using the speed brakes in order to get out of the clouds as soon as possible.

The weather information that was checked prior to the flight did not predict turbulence or other significant weather that would affect the flight on its route. Additionally, there was no information concerning significant weather during the flight as well. (See Figure 1 and Figure 2)

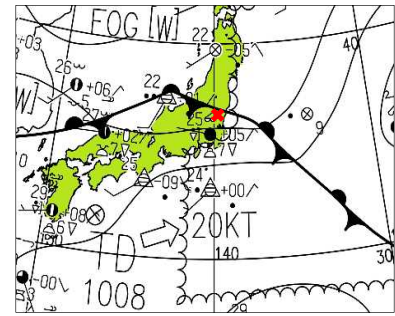
Figure 3 Asia-Pacific Analysis Chart for East and Pacific

According to the Analysis chart for East and Pacific issued by the Japan Meteorological Agency at 09:00 (Figure 3), a tropical depression with a central pressure of 1,008 hPa was situated over the sea south of Shikoku and moving east at 20 kt. In addition, a stationary front was extended from off the coast of the San'in Region to the Noto Peninsula and the northern Kanto Region.

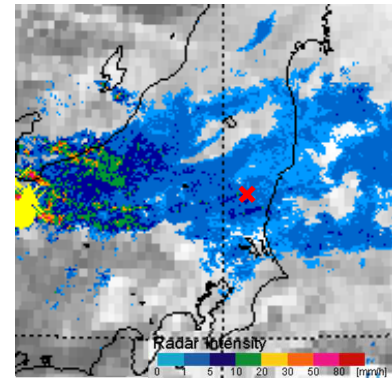
Figure 4 Domestic Significant Weather observation Chart

According to the domestic significant weather observation chart issued by the Japan Meteorological Agency at 13:10 (Figure 4), radar echoes equivalent to hourly rainfall of between 0 and 5 mm were observed in a wide area of the northern Kanto Region. Within those echoes were scattered radar echoes equivalent to hourly rainfall of at least 5 mm but less than 10 mm.

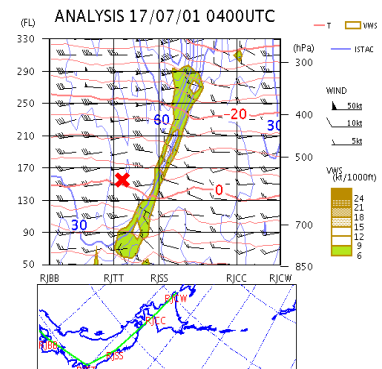
Figure 5 Hourly Atmosphere Analysis Chart (Cross-Section)

According to the hourly atmosphere analysis chart for 13:00 on July 1, 2017, in the cross-section (Figure 5), it was analyzed that vertical wind shear (VWS) indicating a change in wind direction and wind speed for an altitude difference of 6 to 9 kt/1,000 ft existed near the location where the accident occurred.

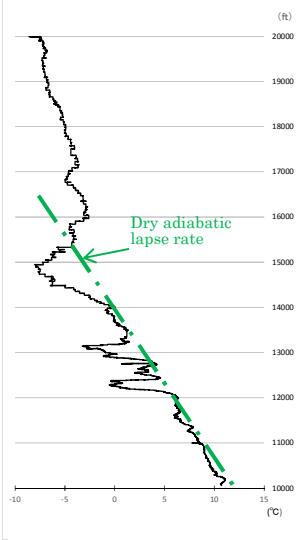
<p>2.7 Additional Information</p>	<p>(1) Atmospheric stability</p> <p>Atmospheric temperature decreases as altitude increases, and when the rate of decrease in temperature from altitude (temperature lapse rate) is larger than approximately 10°C per 3,300 ft (dry adiabatic lapse rate), the atmosphere enters an unstable condition.</p>

<p>Figure 6 Altitude and Outside Air Temperature</p> <p>(2) Change in outside air temperature during descent</p> <p>According to the records of CPL, the relationships between altitude and outside air temperature, and between altitude and vertical acceleration were as shown in Figure 6 and Figure 7.</p>
